St. \_\_\_\_\_  
Pl. \_\_\_\_\_  
Ave. No. 148

Sanford

Labor and Mat'l. Report Sept. 21 1939

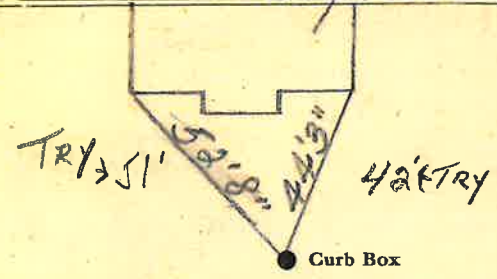
6" Main Elev. of Main at tap 5'

10' to MAIN ● Curb Box  
3/4" COPPER  
NEW HOUSE
