St. Shippy
 Pl. 24
 Ave. No. 24

Name of Owner
Michael Carusone

Labor and Mat'l. Report Apr. 21 1964.

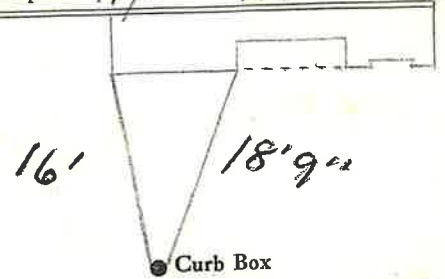
6" C.I. Main Elev. of Main at tap 5'

22' to main
3/4" copper
 • Curb Box

Curb box in lawn
 inside of walk.
