Ave. No. 216

Labor and Mat'l. Report

July 12, 1938

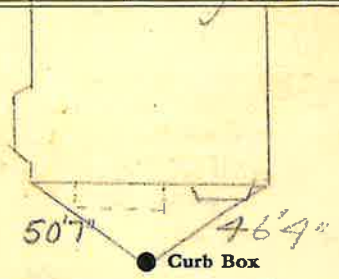
6 Main

9' to main
 $\frac{3}{4}$ " copper

● Curb Box

old shut off
