LABOR AND MATERIALS

Name of Owner  
Hotel Madden

Labor and Mat'l. Report Sept. 13 19 50

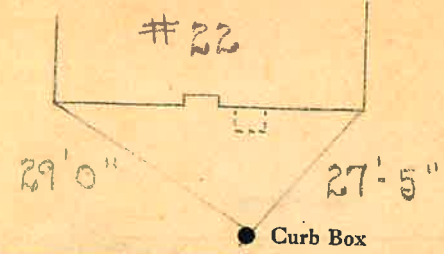
10" Main Elev. of Main at tap 7'

9 1/2' to main

• Curb Box  
6" Tap.  
#20 - #24 - part of Bank
