St. \_\_\_\_\_  
 Pt. \_\_\_\_\_  
 Ave. No. 53

TAX ID # 309.11-12-1

Labor and Mat'l. Report Oct 1988

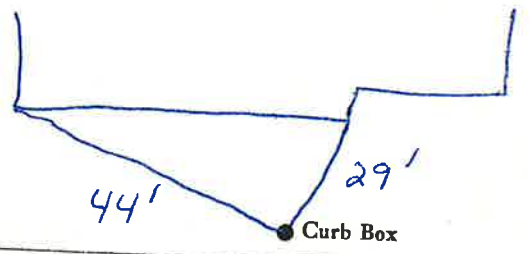
29'5" to MAIN

3/4" COPPER • Curb Box
