East State

St. Pt. Ave. No. 1

TAX ID # 309.16-20-4

Labor and Mat'l. Report

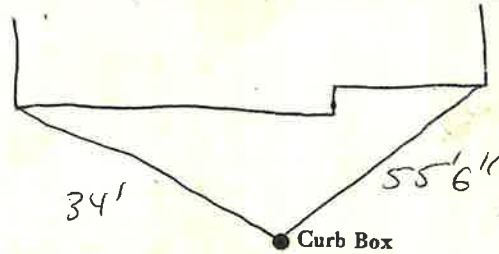
● Curb Box

Gate at ●

¾" Copper 9' to main
