160

Third

Labor and Mat'l. Report

Nov 19 1948

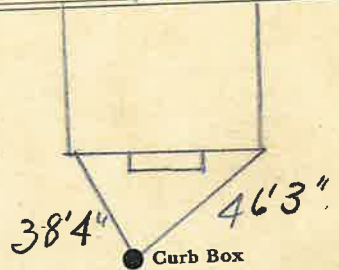
6 Main

Elev. of Main at tap 7

3/4" copper 25' to MAIN

This top in center house

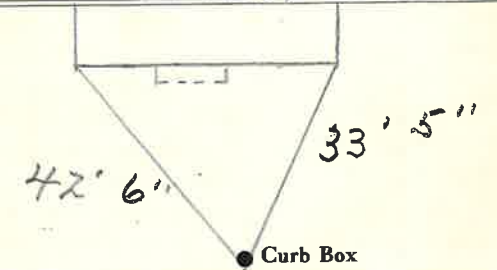
6" Main

Elev. of Main at tap 7'

3/4" copper 28' to MAIN
