THOMSON Ser. No. 37  
 Ave. No. 37

Name of Owner  
 Preston HARRINGTON

Labor and Mat'l. Report July 18 1973

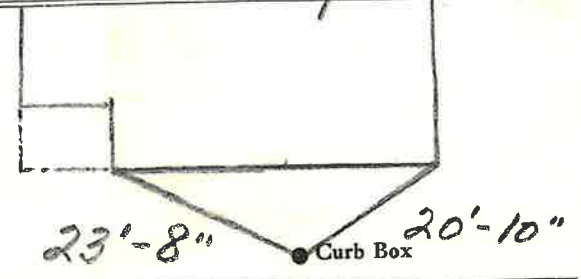
6" Main Elev. of Main at tap 5'

Gate at • Gate at  
 $\frac{3}{4}$ " copper 23' to main  
 • Curb Box
