Thronberry Dr. Se. Pl. Ave. No. 18

Name of Owner *Alfred EIKS*

Labor and Mat'l. Report *Aug. 22 1975*

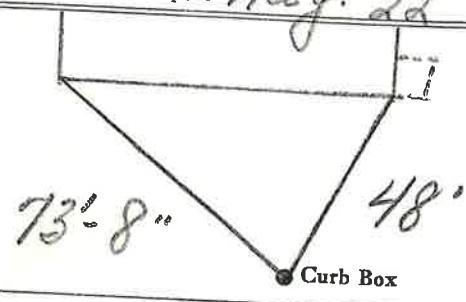
8" Main Elev. of Main at tap *5 1/2'*

Gate at • Gate at •  
*3/4" Copper 7' to main*  
 • Curb Box
