Name of Owner
Rhomberry
 TAX ID# 309.19-6-5

Labor and Mat'l. Report 19 90

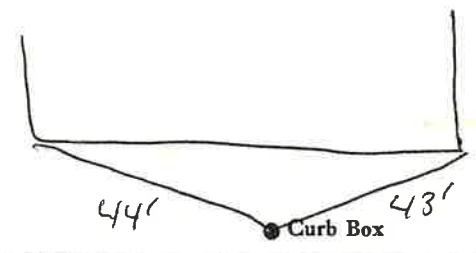
8" Main Elev. of Main at tap _____
 Gate at • Gate at •

¾" Copper 28' to main
 • Curb Box

Depth - 5½'
