St. Uccas
Pl. 34
Ave. No. 34

Name of Owner _____
TAX ID# 303.13-5-1
Reed

Labor and Mat'l. Report Aug. 12 1965

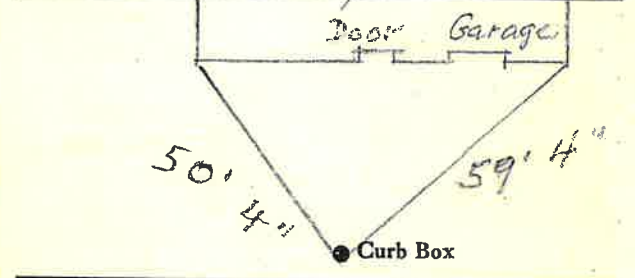
6" C.I. Main Elev. of Main at tap 4'

Gate at ● Gate at ●
24' to main
