### Labor and Materials

St. **30**  
Pl. **16**  
Ave. No. **16**

Labor and Mat'l. Report *June 21* 19*38*

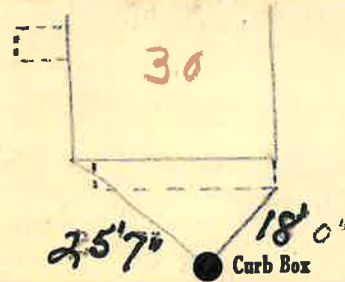
6 Main Elev. of Main at tap *9 1/2*

Gate at • 3/4" copper 9' to main • Gate at

● Curb Box
