LABOR AND MATERIALS

Vanderheyden St. Pt. Ave. No. 21

Name of Owner LUNT

Labor and Mat'l. Report Oct. 27 1965

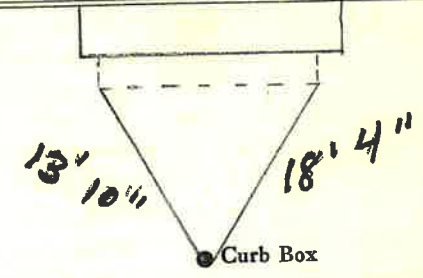
6" Main Elev. of Main at tap 4'

Gate at • Gate at
 $\frac{3}{4}$ " Copper 24' to main
 • Curb Box
