St. Pt. Ave. No. 5

Name of Owner Dan Fragassi

Labor and Mat'l. Report Sept 16, 1977

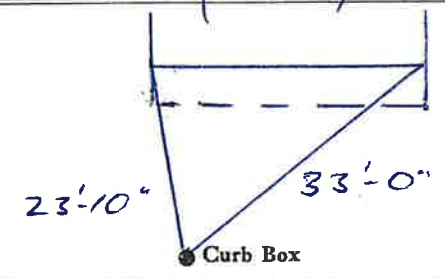
6" Main Elev. of Main at tap 5'

Gate at 3/4" Copper Gate at 8' to main

● Curb Box
