27-129 Labor and Material Report Aug 4 1927

3/4 tap at 47-449 Walnut st

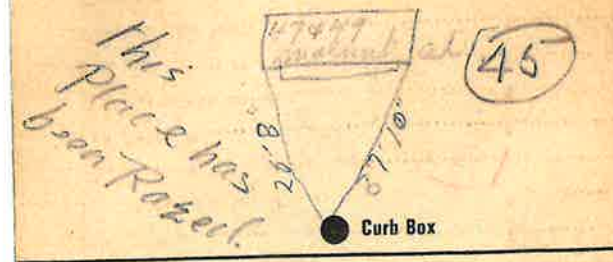
4 Main Elev. of Main at tap 4 ft

Gate at Gate at  
No of this place is old 45

Curb Box 9' to main

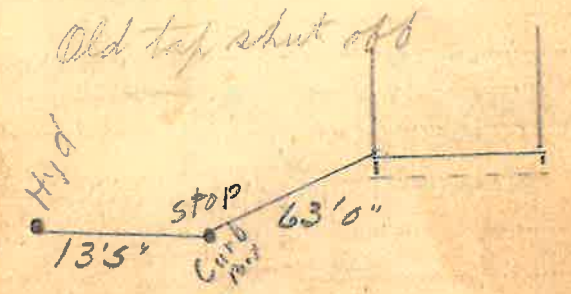
This place has been razed +  
Curb Box taken out  
Not shown  
effort
