St. _____
Pl. _____
Ave. No. 68

Name of Owner
Hardley

Labor and Mat'l. Report Oct 14 1949

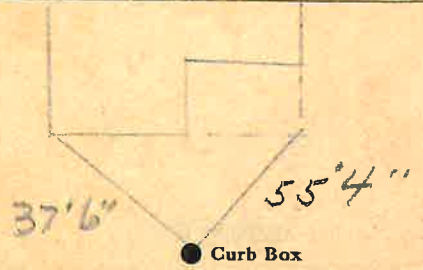
12 Main Elev. of Main at tap 6'
Gate at ● Gate at ●

10' to main

● Curb Box
