SUNY
ADIRONDACK

Facilities Master Plan

February 2022

Site and Building Conditions Assessment

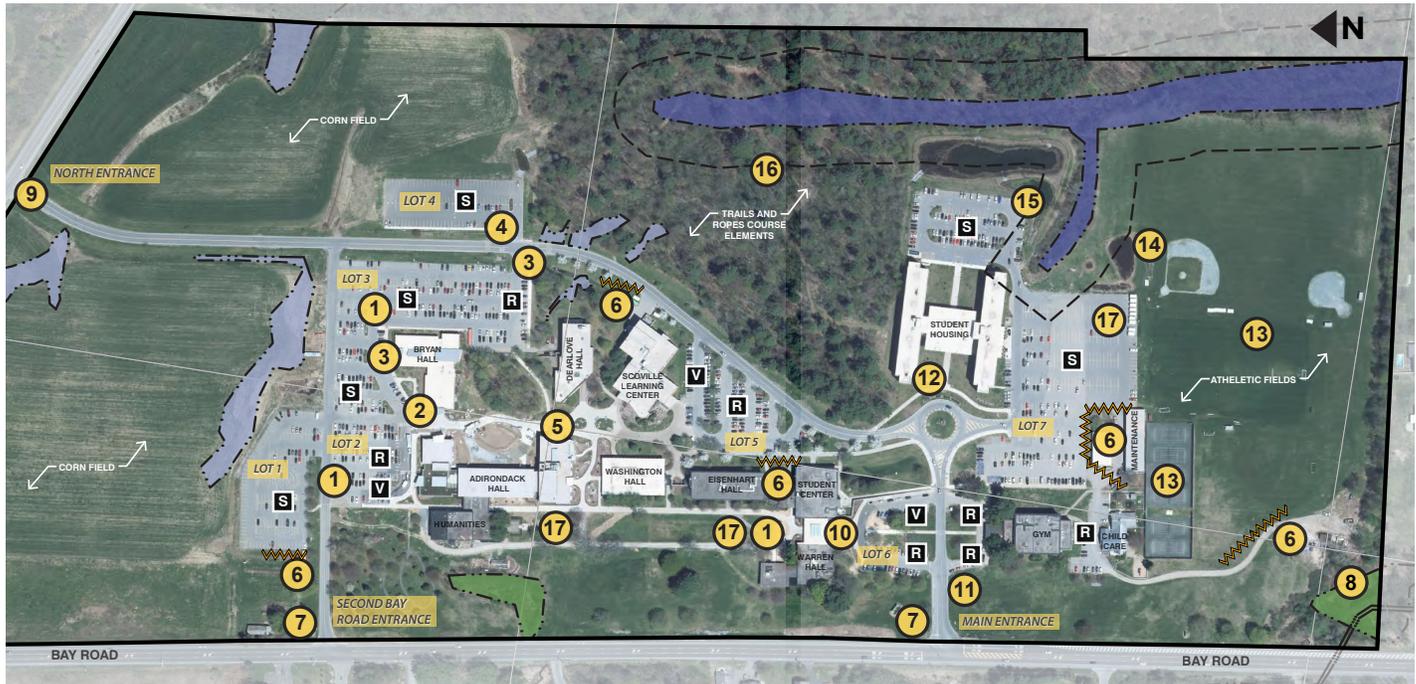
Site Analysis Diagram

| <ul style="list-style-type: none"> 1 Light Fixtures Do Not Match in This Vicinity (At Least 2 Varieties) 2 Minimal Benches and Trash Cans in Vicinity 3 Detectable Warning Strip in Poor Condition 4 Lack of Signage 5 Plaza Areas Are in Good Condition 6 View of Dumpsters, Storage, and/or Maintenance | <ul style="list-style-type: none"> 7 Sign and Plantings in Good Condition 8 Concrete Headwall in Poor Condition 9 Haviland Road Entrance Lacks Sense of Announcement 10 New Decorative Stone Wall and Plantings in Good Condition 11 Large Tree in Decline / Moderate Risk of Falling 12 Lawn in Need of Repair; Damage from Maintenance / Plow Vehicles | <ul style="list-style-type: none"> 13 Fields and Tennis Courts in Fair Condition 14 Baseball Facilities Needs Maintenance 15 Garbage and Debris in Drainage Swale 16 Trails and Ropes Course Elements in Good Condition 17 Low Sight Lighting | <ul style="list-style-type: none"> R Faculty & Staff Reserved Permit Parking Only S Student Parking V Visitor Parking ZZZZ Undesireable View Wetland per NYS DEC Maps Wetlands per National Wetland Inventory Maps Wetlands per Other Sources (Field Verified) --- 100' Buffer (NYSDEC Wetlands) |

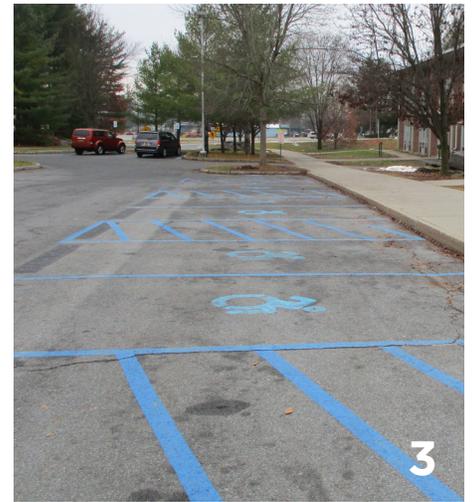
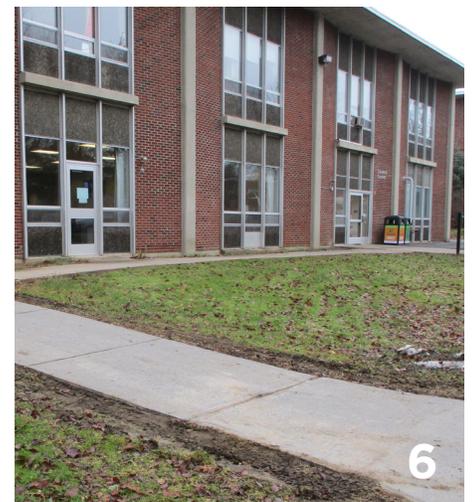
- All of Lot 6 is in poor condition (1).
- A portion of Lots 2, 3, and 7 are in poor condition. A portion of Lot 2 is deteriorating with upheaval, potholes, and large cracks in the asphalt (2).
- ADA parking spaces in Lot 5 exceed allowable cross slopes and there is no reserved parking signage (3).

- The steep walk in front of the Gymnasium from parking lot 6 exceeds ADA maximum recommended slope (4).
- Ramp at the west entrance of Eisenhart Hall does not meet ADA requirements for rail configuration (5).
- The asphalt walks, site walls, and gravel road north of the Student Center are in poor condition.
- Stairs located outside Dearlove are in poor condition.
- Hardscape is used for maintenance vehicle access campus-wide. In areas where walks are too narrow to accommodate the College's full-sized pickup trucks, the edges of the walks are rutted and muddy (6).
- Walks on the north end of campus are in excellent condition.
- Areas of insufficient sight lighting were noted in a campus security study conducted by others (marked 17 on site analysis diagram).

- Install removable bollards to prevent unauthorized vehicular use of walks.
- Remedy erosion at the sanitary manhole adjacent to the maintenance yard.
- Repair or replace damaged asphalt campus wide.

- Where possible, adjust slopes at walks and parking areas where ADA-recommended maximum slopes are exceeded.
- Continue to update exterior signage.
- Continue to upgrade landscape seating, lighting, and trash receptacles.

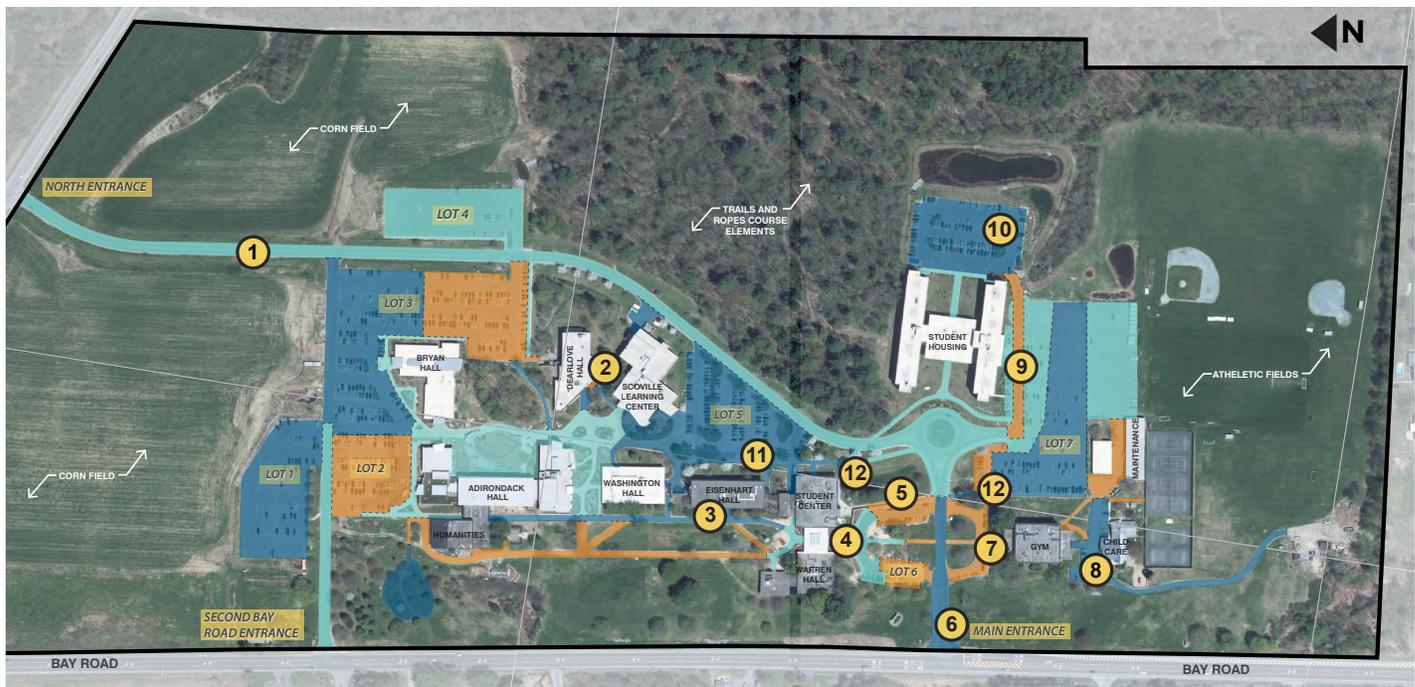
Figure 7 - Pavement Condition Diagram

| <p>1 Campus Drive in Good Condition; Some Large Cracks Need to Be Sealed</p> <p>2 Stairs Next to Dearlove Hall in Poor Condition</p> <p>3 Ramp Exceeds ADA Slope; Handrails Are Not Continuous and Don't Meet Shape Requirements</p> <p>4 New Walk and Crosswalk in Good Condition</p> | <p>5 Retaining Wall, Curb, and Concrete Walk in Poor Condition</p> <p>6 Entry Drive Asphalt in Fair Condition; Some Cracking and Potholes</p> <p>7 All Concrete Walk, Curb, and Asphalt Drive in Poor Condition</p> <p>8 Swale in Asphalt Pavement; Erosion Problems Occurring</p> | <p>9 Travel Lane in Poor Condition</p> <p>10 Asphalt Parking Lot in Fair Condition; Wing Swale Gutter in Poor Condition in Some Spots</p> <p>11 Entire Row of ADA Parking Lacking Signage; Slope Exceeds Requirements</p> <p>12 Accessible Route Does Not Meet ADA Slope and/or Surface Requirements</p> | <p>■ Pavement in Good Condition</p> <p>■ Pavement in Fair Condition</p> <p>■ Pavement in Poor Condition</p> |

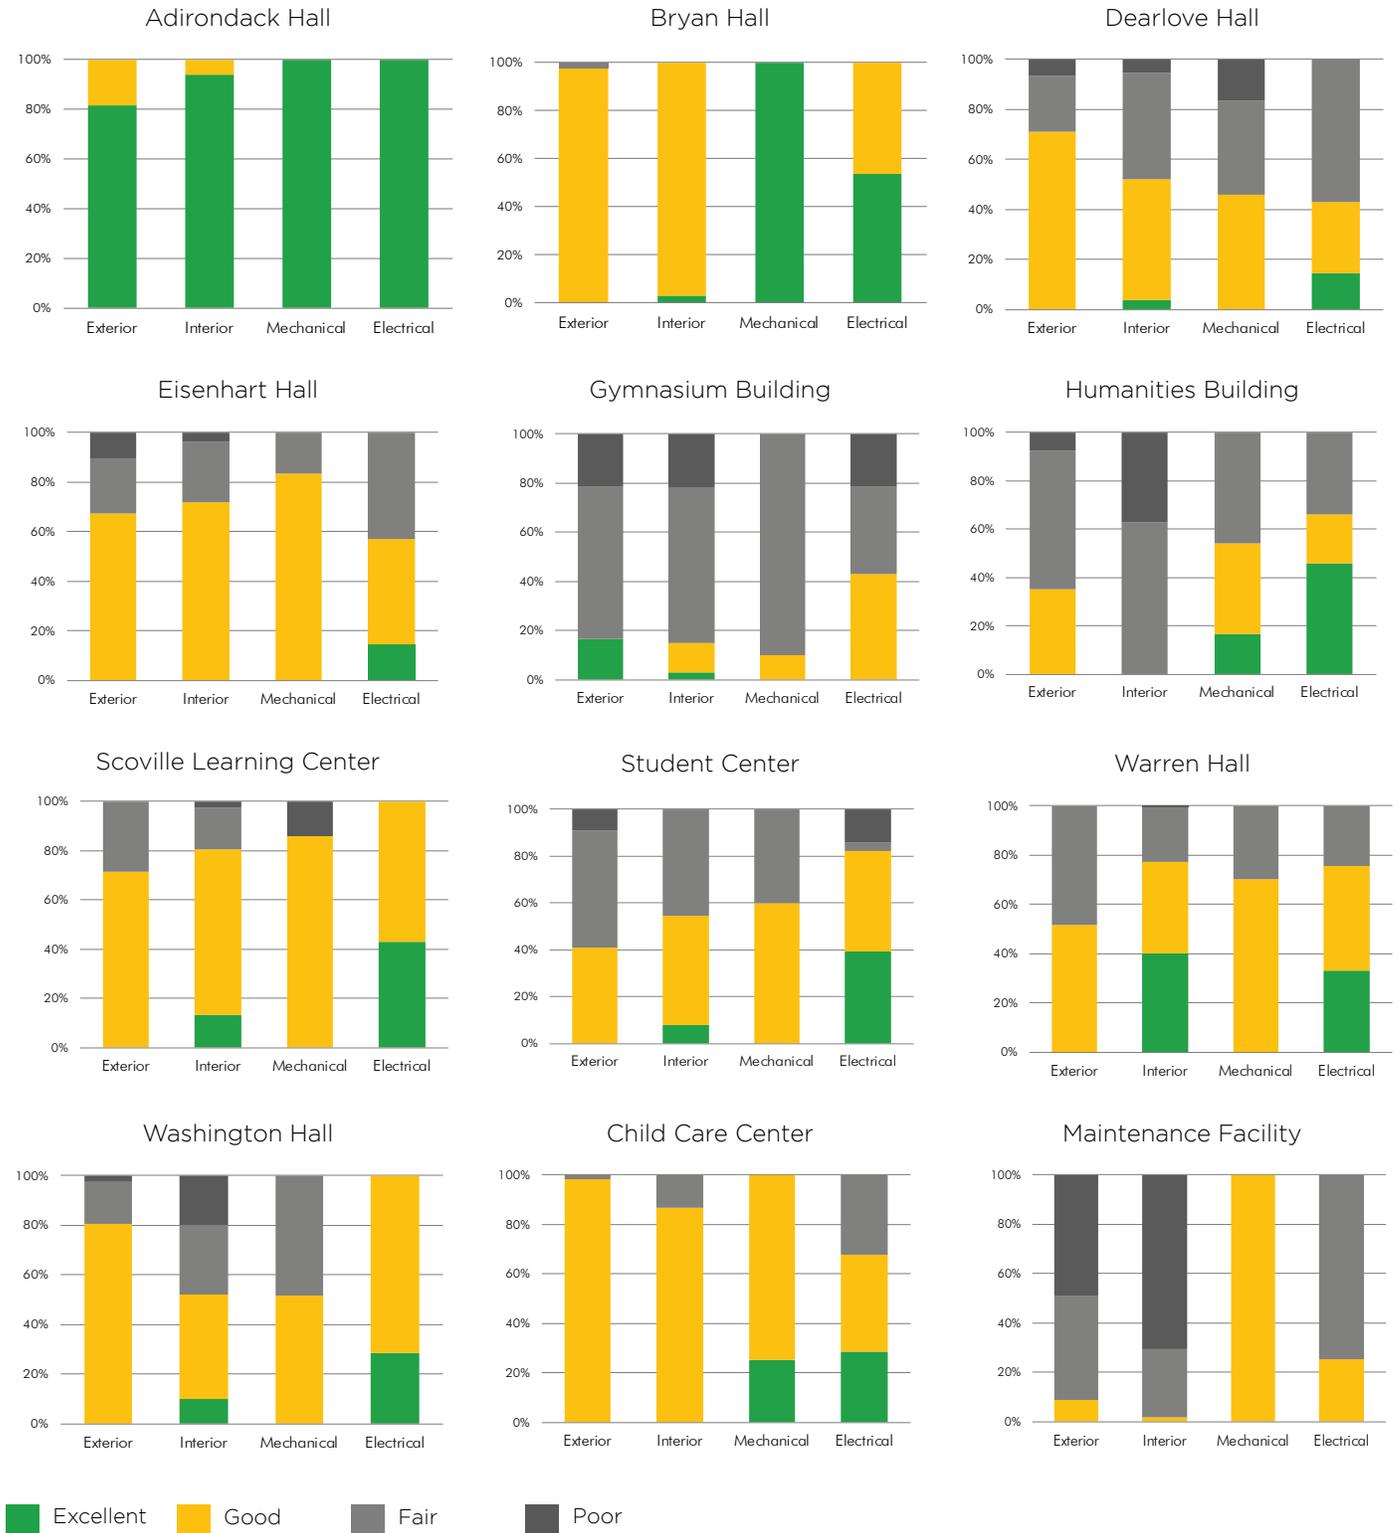
Figure 8 - Building Condition Charts

A summary of the findings is shown in Figure 8 (below). Supporting narrative and photographs for each building can be found in Appendix A.

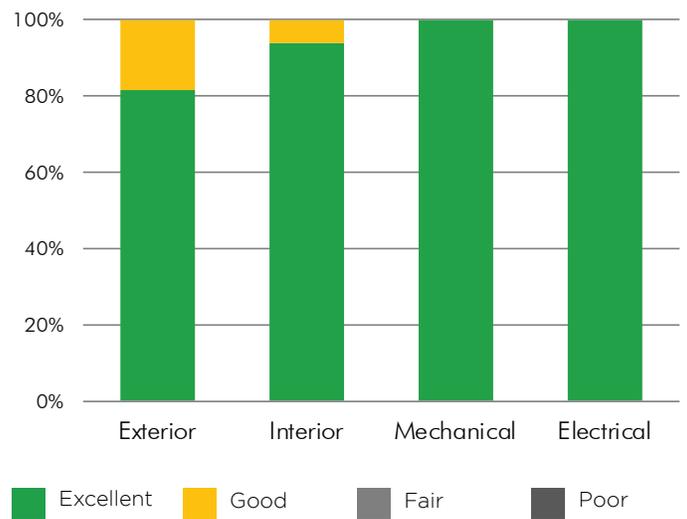
Adirondack Hall

- The adhesive on felt acoustical panels/tack surfaces has failed. In some locations, the felt trims are completely missing.

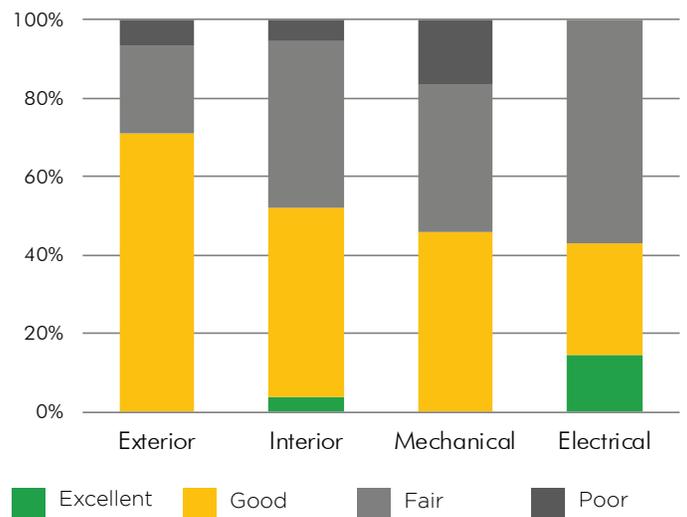
Dearlove Hall

- There are areas around the building and on the roof where sealant is cracked and deteriorated (2).
- There are several areas where mortar is cracked, which could introduce water into the wall system and affect structural integrity over time (3).

- Comprehensive accessibility improvements
- Updates to finishes and lighting
- Addition of room-darkening shades to reduce glare
- Strategic upgrades of aging mechanical and electrical systems to improve operating efficiency
- Repair superficial cracks in masonry to prevent further deterioration. Areas of severe through-wall cracks in masonry should be remediated professionally under guidance of an architect and engineer.

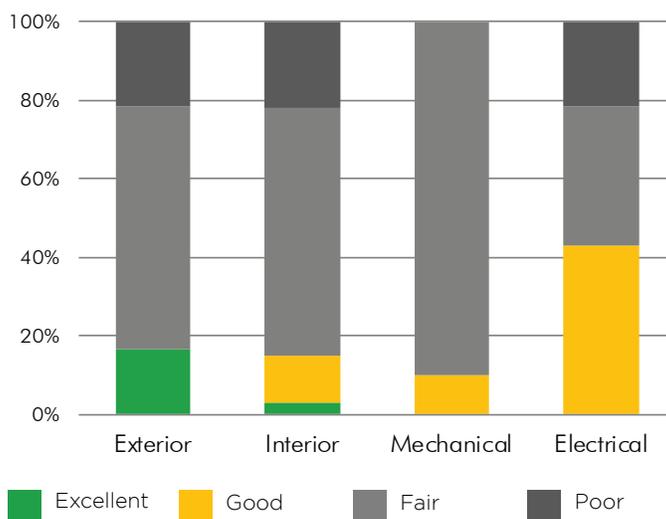
Gymnasium Building

With the exception of the roof, gymnasium floor, and two recently-updated offices, the building is in fair to poor condition. Many building systems and components, while functional, are near the end of their useful lives.

- Inspect roofs, copings, flashings, and plumbing for potential sources of moisture within wall cavities that could lead to efflorescence. Remedy leaks, if any are discovered.
- Clean the walls where algae is present and apply a suppressant to prevent future accumulation. If comprehensive renovations take place, re-grade around the building to provide better drainage away from the foundation.
- Repair superficial cracks in concrete and masonry to prevent further deterioration. Areas of severe through-wall cracks in masonry and areas of spalling where structural steel is exposed should be remediated professionally under guidance of an architect and engineer.
- A comprehensive renovation, including addition of an elevator and complete renovation of the lower level, is required.
- Provide air conditioning.
- Due to assembly occupancy, consider adding sprinklers as a safety measure.

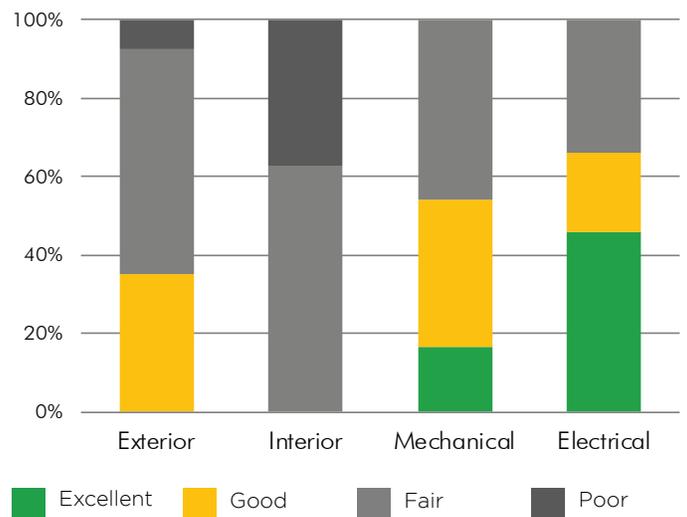
The Humanities Building is in fair to poor condition. Access to the building is directly through Adirondack Hall, the newest building on campus. The distinct difference in building condition amplifies the cosmetic and functional deficiencies of the Humanities Building. During the Adirondack Hall renovation, portions of the Humanities Building electrical and mechanical service were replaced and are in excellent condition.

Repair superficial cracks in concrete and masonry to prevent further deterioration. Areas of severe through-wall cracks in masonry and areas of spalling where structural steel is exposed should be remediated professionally under guidance of an architect and engineer.

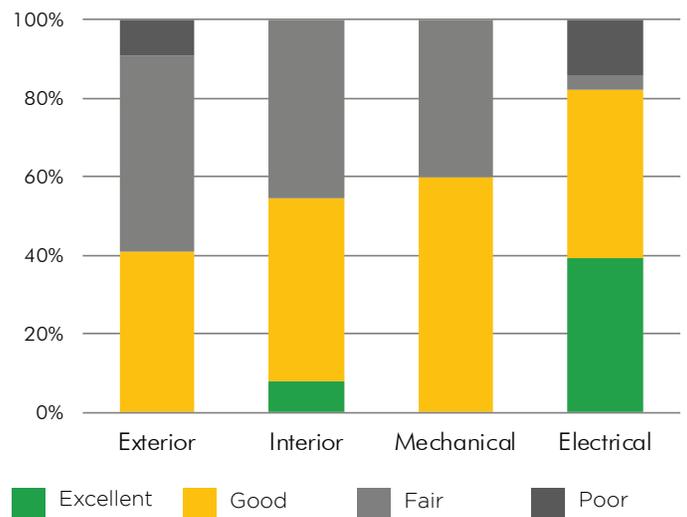
Student Center

- Areas of efflorescence on exterior masonry suggest persistent moisture within wall cavities. Moist air is being forced through the north wall due to high humidity and temperature variation from the kitchen and dishroom (1).
- Exterior concrete structural elements and overhangs are cracked, which has allowed moisture into the structural system. As a consequence, spalling has occurred. Exposed steel reinforcing is present in many locations. Weakened concrete can fall from the building, which is a safety concern (2).
- Gutters along the roof edge are damaged and have been temporarily patched in certain locations (3).
- The building envelope exhibits signs of leaks which could become more frequent or cause permanent damage if not addressed:
- Water damage at exterior soffit.
- Ponding on roof and persistent reported leaks at roof penetrations.

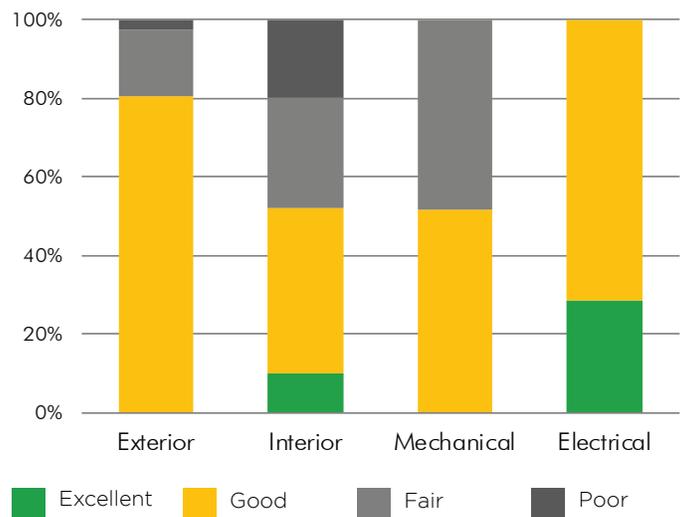
Most major building systems in Washington Hall are in good operating condition. Areas of high traffic exhibit worn and damaged finishes. The aging building envelope will require repair to restore it to good condition.

- Repair superficial cracks in concrete and masonry to prevent further deterioration. Areas of severe through-wall cracks in masonry and areas of spalling where structural steel is exposed should be remediated professionally under guidance of an architect and engineer.
- Windows and spandrel panels should be replaced with modern energy efficient units with thermal breaks.
- Update finishes, furnishings and lighting, except in recently renovated areas.
- Replace drinking fountains with modern units in accessible locations. Building users have requested bottle fillers.
- Toilet rooms should be renovated to include clear floor space, vertical grab bars, and sink pipe insulation.
- Replace non-compliant handrails in certain stairwells.
- Update signage.
- Replace remaining knob door hardware.
