JOINT MEETING of the  
WARREN COUNTY ECONOMIC  
GROWTH & DEVELOPMENT and  
HIGHER EDUCATION and  
FINANCE COMMITTEES and  
WASHINGTON COUNTY  
COMMUNITY COLLEGE and  
FINANCE COMMITTEES

## Facilities Master Plan

# SUNY Adirondack

640 Bay Road  
Queensbury, NY 12804

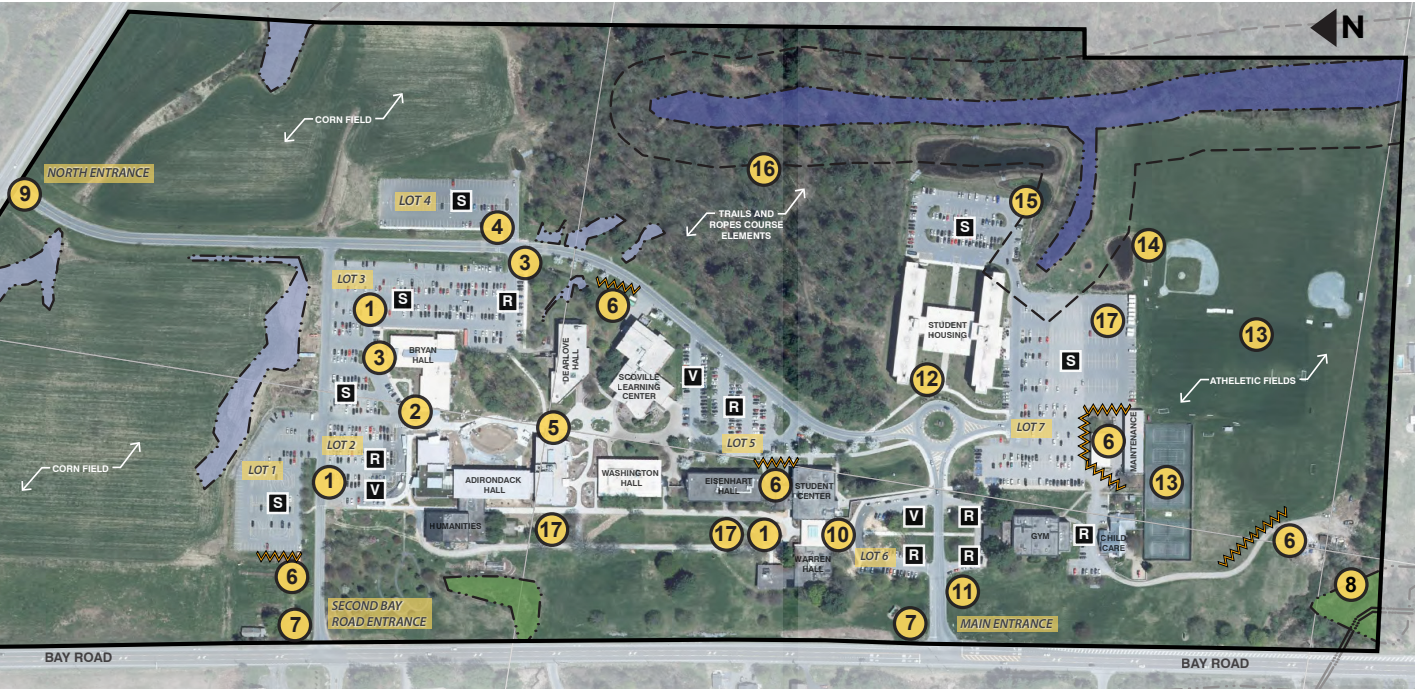
Site Analysis Diagram

| 1 | Light Fixtures Do Not Match in this Vicinity (At Least 2 Varieties) | 7 | Sign and Plantings in Good Condition |
| 2 | Minimal Benches and Trash Cans in Vicinity | 8 | Concrete Headwall in Poor Condition |
| 3 | Detectable Warning Strip in Poor Condition | 9 | Haviland Road Entrance Lacks Sense of Announcement |
| 4 | Lack of Signage | 10 | New Decorative Stone Wall and Plantings in Good Condition |
| 5 | Plaza Areas Are in Good Condition | 11 | Large Tree in Decline / Moderate Risk of Falling |
| 6 | View of Dumpsters, Storage, and/or Maintenance | 12 | Lawn in Need of Repair; Damage from Maintenance / Plow Vehicles |
| 13 | Fields and Tennis Courts in Fair Condition | 14 | Baseball Facilities Needs Maintenance |
| 15 | Garbage and Debris in Drainage Swale | 16 | Trails and Ropes Course Elements in Good Condition |

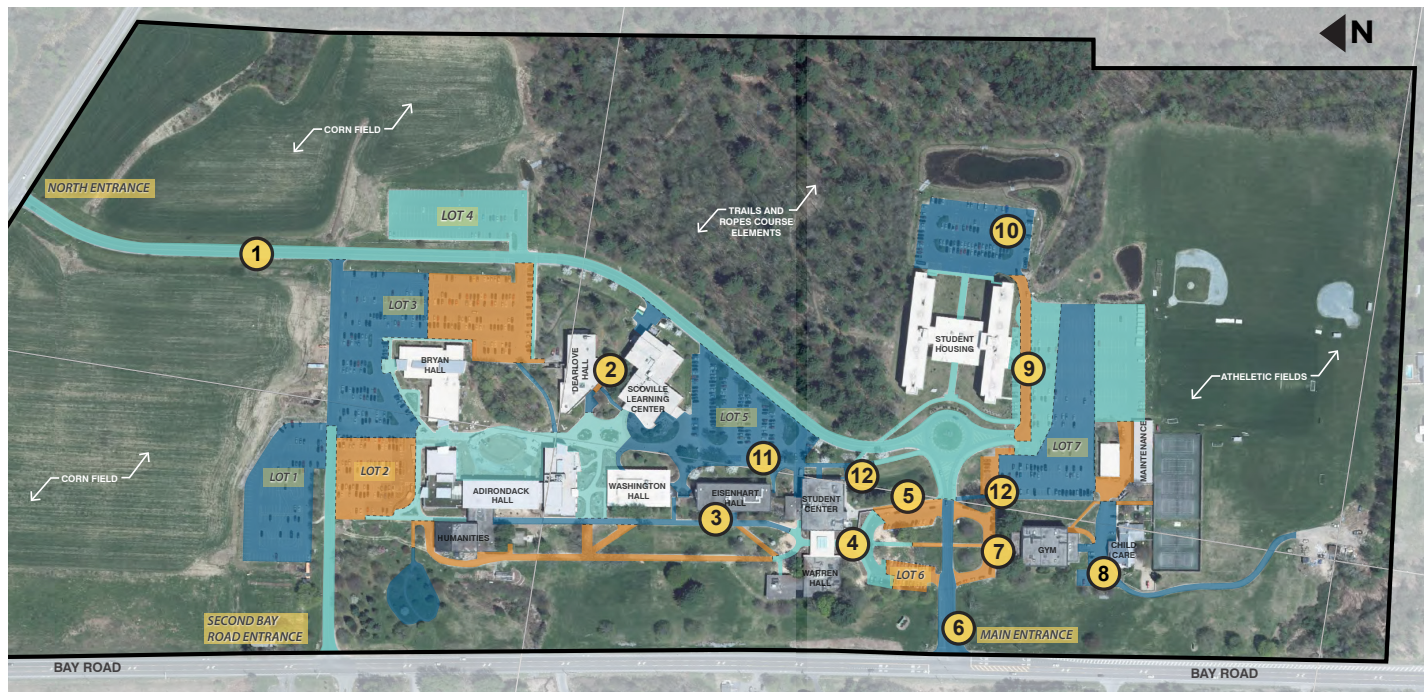
Figure 7 - Pavement Condition Diagram

- All of Lot 6 is in poor condition (1).
- A portion of Lots 2, 3, and 7 are in poor condition. A portion of Lot 2 is deteriorating with upheaval, potholes, and large cracks in the asphalt (2).
- ADA parking spaces in Lot 5 exceed allowable cross slopes and there is no reserved parking signage (3).

- The steep walk in front of the Gymnasium from parking lot 6 exceeds ADA maximum recommended slope (4).
- Ramp at the west entrance of Eisenhart Hall does not meet ADA requirements for rail configuration (5).
- The asphalt walks, site walls, and gravel road north of the Student Center are in poor condition.
- Stairs located outside Dearlove are in poor condition.
- Hardscape is used for maintenance vehicle access campus-wide. In areas where walks are too narrow to accommodate the College's full-sized pickup trucks, the edges of the walks are rutted and muddy (6).
- Walks on the north end of campus are in excellent condition.
- Areas of insufficient sight lighting were noted in a campus security study conducted by others (marked 17 on site analysis diagram).

| <p>① Campus Drive in Good Condition; Some Large Cracks Need to Be Sealed</p> <p>② Stairs Next to Dearlove Hall in Poor Condition</p> <p>③ Ramp Exceeds ADA Slope; Handrails Are Not Continuous and Don't Meet Shape Requirements</p> <p>④ New Walk and Crosswalk in Good Condition</p> | <p>⑤ Retaining Wall, Curb, and Concrete Walk in Poor Condition</p> <p>⑥ Entry Drive Asphalt in Fair Condition; Some Cracking and Potholes</p> <p>⑦ All Concrete Walk, Curb, and Asphalt Drive in Poor Condition</p> <p>⑧ Swale in Asphalt Pavement; Erosion Problems Occurring</p> | <p>⑨ Travel Lane in Poor Condition</p> <p>⑩ Asphalt Parking Lot in Fair Condition; Wing Swale Gutter in Poor Condition in Some Spots</p> <p>⑪ Entire Row of ADA Parking Lacking Signage; Slope Exceeds Requirements</p> <p>⑫ Accessible Route Does Not Meet ADA Slope and/or Surface Requirements</p> | <p>● Pavement in Good Condition</p> <p>● Pavement in Fair Condition</p> <p>● Pavement in Poor Condition</p> |

- Install removable bollards to prevent unauthorized vehicular use of walks.
- Remedy erosion at the sanitary manhole adjacent to the maintenance yard.
- Repair or replace damaged asphalt campus wide.

- Where possible, adjust slopes at walks and parking areas where ADA-recommended maximum slopes are exceeded.
- Continue to update exterior signage.
- Continue to upgrade landscape seating, lighting, and trash receptacles.

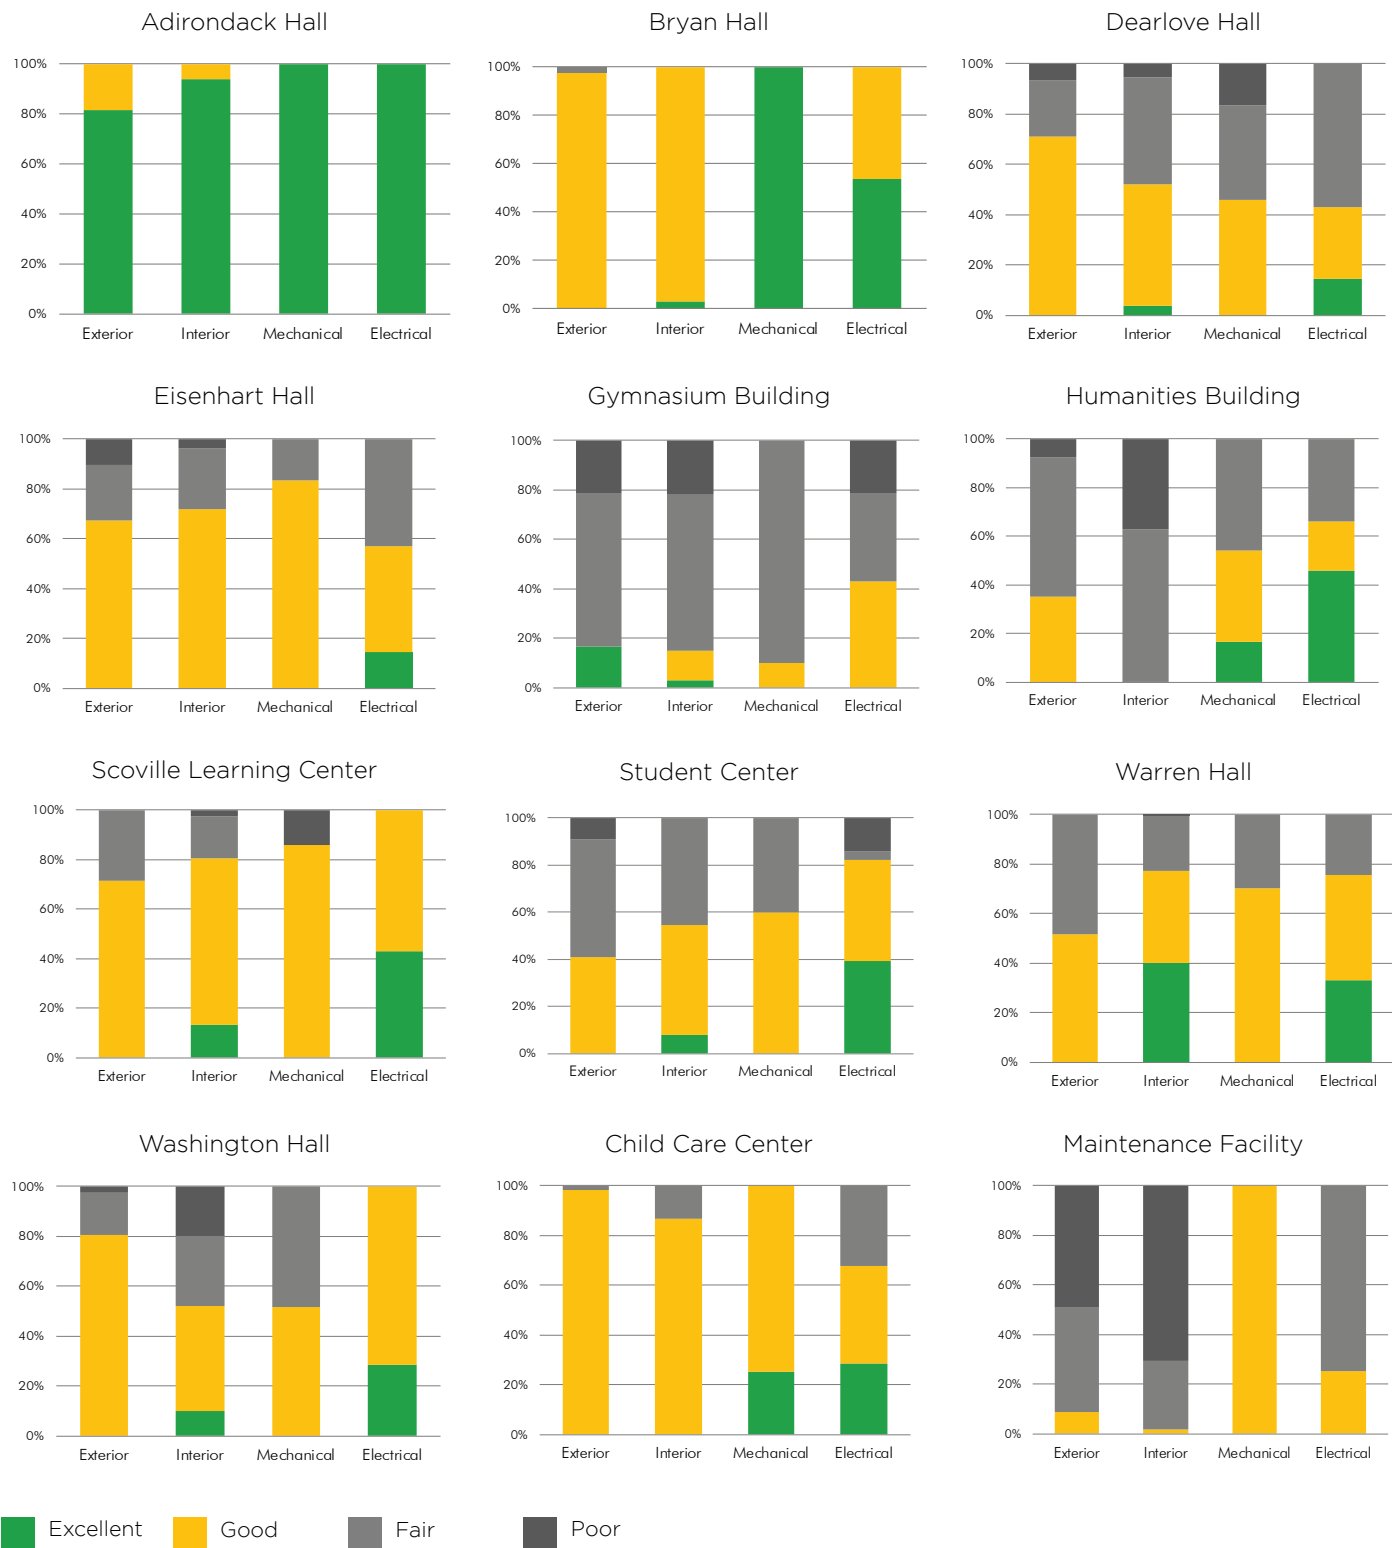
Figure 8 - Building Condition Charts

A summary of the findings is shown in Figure 8 (below). Supporting narrative and photographs for each building can be found in Appendix A.

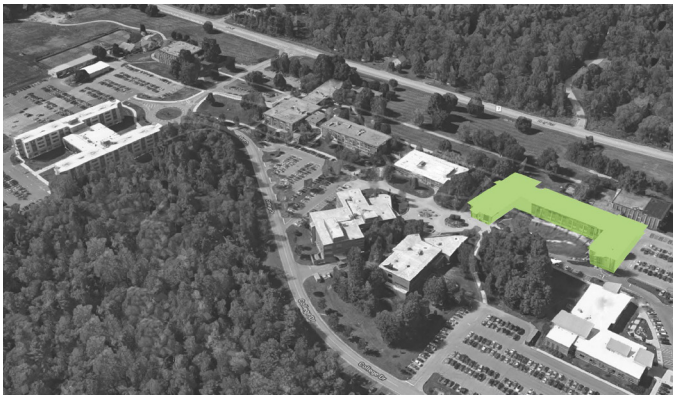
Adirondack Hall

- Grout joints at floor bases are cracked in a few corridor locations (3).
- Portions of corridor walls and floors in high traffic areas have been scuffed and scraped (4).
- A single cracked stair riser in the main lobby (5) and a bent floor grate at the eastern stair vestibule could be tripping hazards (6).

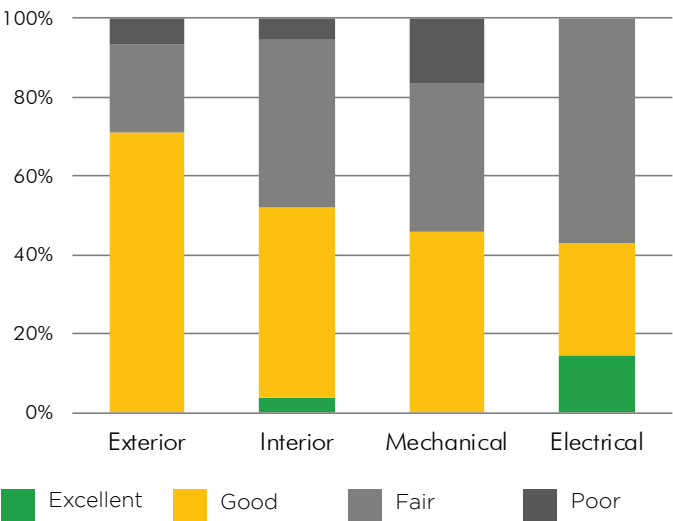
Dearlove Hall

- There are areas around the building and on the roof where sealant is cracked and deteriorated (2).
- There are several areas where mortar is cracked, which could introduce water into the wall system and affect structural integrity over time (3).

- Comprehensive accessibility improvements
- Updates to finishes and lighting
- Addition of room-darkening shades to reduce glare
- Strategic upgrades of aging mechanical and electrical systems to improve operating efficiency
- Repair superficial cracks in masonry to prevent further deterioration. Areas of severe through-wall cracks in masonry should be remediated professionally under guidance of an architect and engineer.

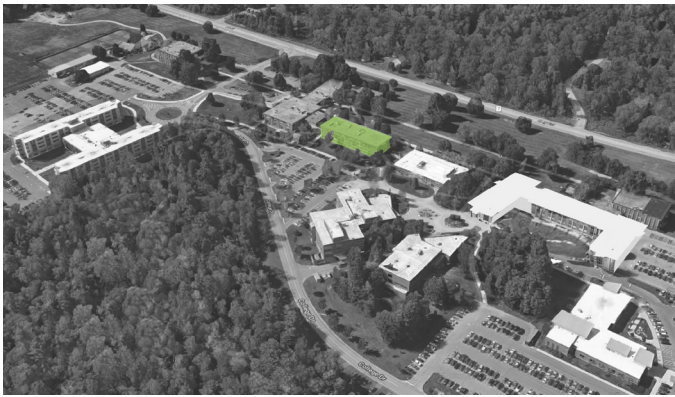
Eisenhart Hall

- Exterior concrete structural elements and overhangs are cracked, which has allowed moisture into the structural system. As a consequence, spalling has occurred. Exposed steel reinforcing is present in many locations. Weakened concrete can fall from the building, which is a safety concern (1, 2).
- Black mildew stains are present on exterior masonry walls. Sometimes, such stains are merely cosmetic. However, their location at the bottoms of wall cavities at Eisenhart suggest possible persistent moisture within the wall system (3).
- Windows and spandrel panels are original to the building, are dated in appearance, and are not energy efficient.

- Windows and spandrel panels should be replaced with modern energy efficient units with thermal breaks.

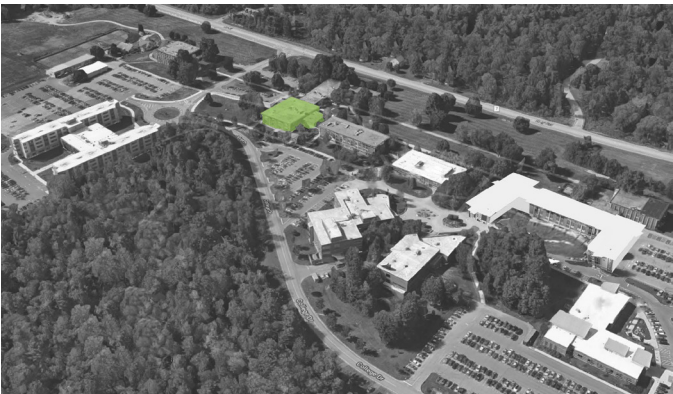
Student Center

- Areas of efflorescence on exterior masonry suggest persistent moisture within wall cavities. Moist air is being forced through the north wall due to high humidity and temperature variation from the kitchen and dishroom (1).
- Exterior concrete structural elements and overhangs are cracked, which has allowed moisture into the structural system. As a consequence, spalling has occurred. Exposed steel reinforcing is present in many locations. Weakened concrete can fall from the building, which is a safety concern (2).
- Gutters along the roof edge are damaged and have been temporarily patched in certain locations (3).
- The building envelope exhibits signs of leaks which could become more frequent or cause permanent damage if not addressed:
- Water damage at exterior soffit.
- Ponding on roof and persistent reported leaks at roof penetrations.
