## Lake George Basin Reservoir and Sediment Basin Cleanout Program

# 2007

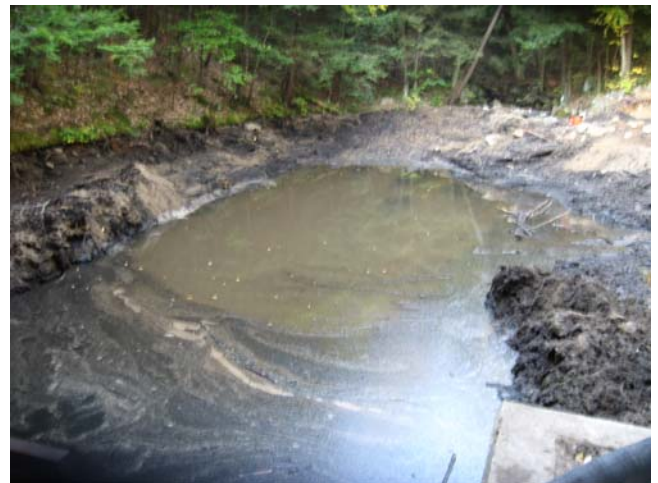
*Hubble Reservoir, Town of Lake George - English Brook*

This reservoir was last maintained in 2001 and has effectively captured sediment that would otherwise have accumulated in Lake George. Because of the geographic location this reservoir is difficult to dewater. Therefore Town of Lake George installed a temporary piping system to route the stream around the reservoir during excavation. Following dewatering activities, the sediment was then excavated and removed.

This was a cooperative effort between the Warren County SWCD and the Town of Lake George, and funded through the Lake George Watershed Conference. By excavating as much sediment and material as possible from this basin (approximately 1400 cubic yards), it once again had the capability of slowing flow and collecting in-stream sediment.

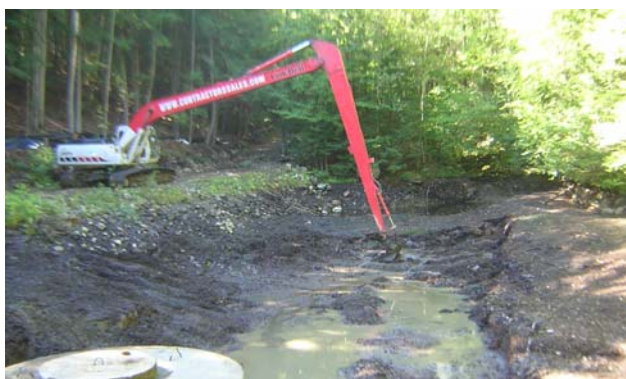
*Ore Bed Reservoir, Town of Lake George - West Brook*

Ore Bed Reservoir is located within the West Brook watershed above the location of the Lake George transfer station, and is owned by the Village of Lake George. Ore Bed is dewatered with the use of an off-line ditch adjacent to the reservoir. This ditch is lined with stabilization fabric or plastic liner in order to support the stream flow, which is then blocked and diverted into this ditch; eventually outleting back into West Brook below the reservoir.

Once the stream is diverted, the water in the reservoir is either pumped out or released with the sluice gate at the bottom of the dam.

Following dewatering, a long-reach excavator excavated the material directly into trucks which haul the material away. As the reservoir is adjacent to the landfill and transfer station, the excavated material was deposited there. Approximately 200 cubic yards sediment was removed from this basin in 2007.

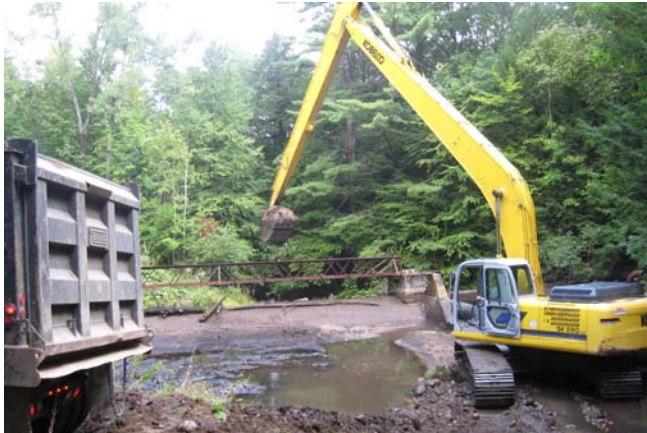
**Gage Brook Reservoir, Town of Lake George  
- West Brook**

This reservoir is located on West Brook at the confluence of West Brook and Gage Brook, just upstream of the Northway. It is located approximately three quarters of a mile downstream of Ore Bed Reservoir, on the same stream. Even with this large reservoir upstream, Gage Brook Reservoir still captures a significant amount of sediment and debris on an annual basis. This reservoir has been the most consistently maintained under this sediment basin program, due to the speed at which it fills with sediment and the relative ease of cleaning it out. This year alone approximately 450 cubic yards of sediment that would have made its way to Lake George were removed.

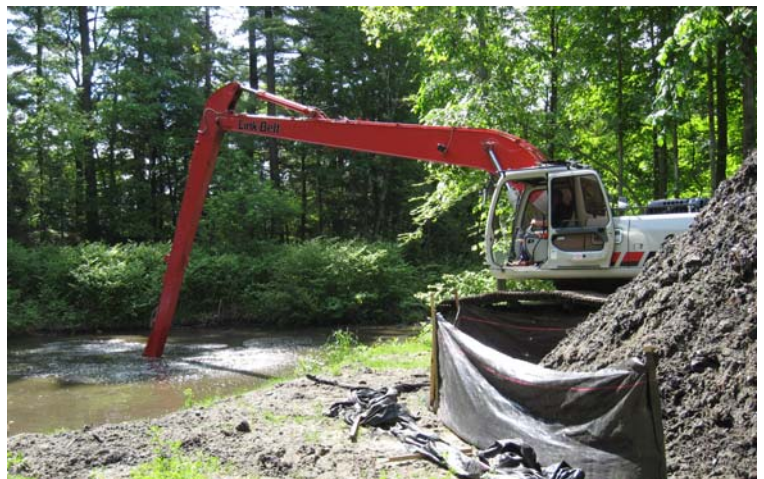
**Artist Falls Reservoir 2007, Town of Bolton  
- Finkle Brook**

For this cleanout, the stream is routed around the basin back into the old stream channel during excavation. This minimizes impacts to the stream from turbidity and potential erosion during cleanout activities.

The in-stream sediment basin collected approximately 100 cubic yards of sediment since its last cleanout in 2005.

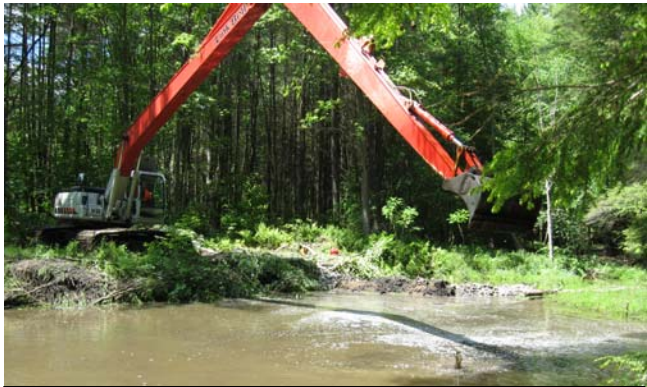
*Woodshire Estates Sediment Pond 2007, Town of Bolton - Finkle Brook*

The water flowing into the basin was diverted with a large capacity pump supplied by the town and by passed through a small rock-lined settling basin. The culvert pipes were also secured with filter fabric to filter any excess water and sediment that was remaining before it reentered the stream.

Approximately 50 cubic yards of sediment was excavated from this basin in 2007. The last cleanout of this pond was in 2005.

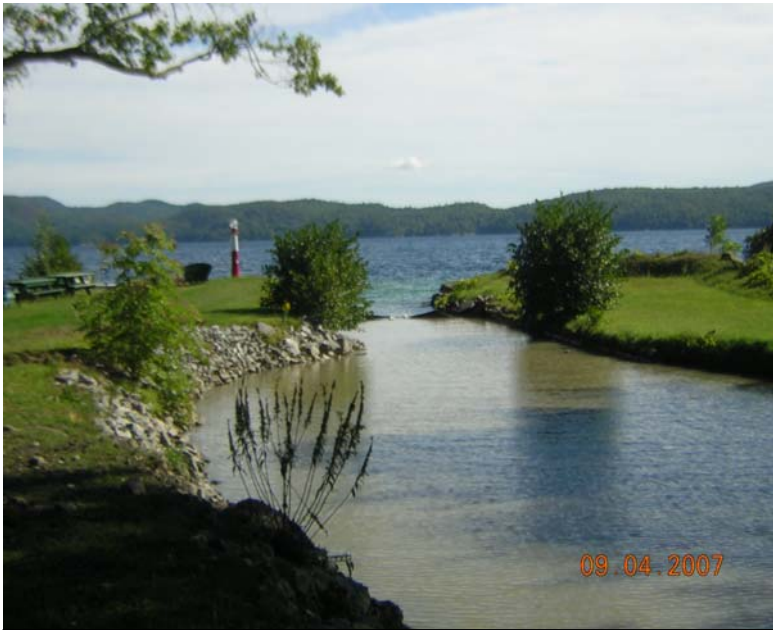
*Jenkin's Brook Sediment Basin 2007, Town of Hague*

The Jenkins Brook Basin, located on property owned by the Cape Cod Village Association, was constructed in 2004 and maintained in 2005 and again in 2007.

The total volume of the basin is approximately 400 cubic yards, of which approximately 200 cubic yards of sediment was excavated in 2007. After excavation was completed the entire area was hydroseeded by the Warren County SWCD.

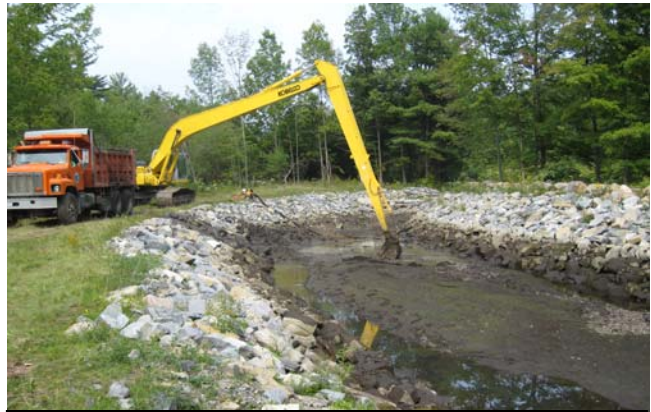
*West Hague Road Sediment Basin 2007, Hague Brook  
Town of Hague*

Much like the Artist Falls design, this basin is designed "off line", meaning that the basin is located next to the original stream channel and flow is routed into it. The streamflow is split between the original channel and the new channel, capturing approximately 50% of the flow. During dewatering the stream is diverted back into its original channel through the use of temporary dewatering devices that were installed when the basin was created. After the water was diverted the Town utilized two large pumps to draw down the remainder of the water until the basin was dry.

A 60-foot long reach excavator was utilized to dig the channel when the basin after the water was drawn down. When completed the channel was rerouted back to continue capturing the sediment again. Approximately 100 cubic yards of sediment were removed from this basin in 2007.

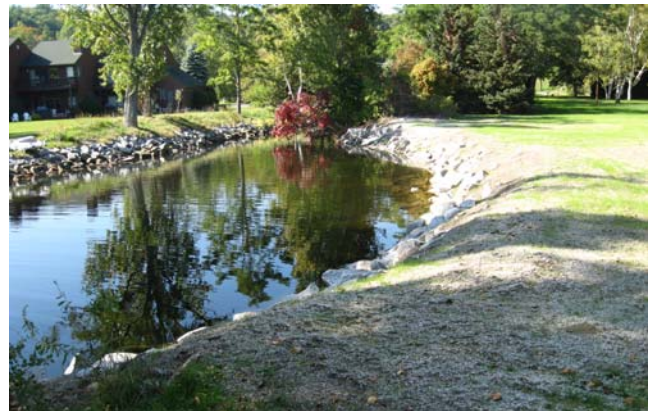
*Land Conservancy Sediment Basin 2007, Hague  
Brook, Town of Hague*

Given the volume of sediment carried within Hague Brook, a new sediment pond was designed and installed adjacent to the outlet of the Brook into Lake George on LG Land Conservancy property. Land Conservancy permitted use of their land to build this 100' x 50' approximately 7-foot deep sediment basin. The basin was designed and overseen by Warren County SWCD, constructed by the Town of Hague highway department, and funded jointly by the Lake George Association and the LG Watershed Conference. It has the capacity to capture and store about 400 cubic yards of sediment that would otherwise reach the Lake. The cost of designing and constructing this new basin was approximately \$15,000.

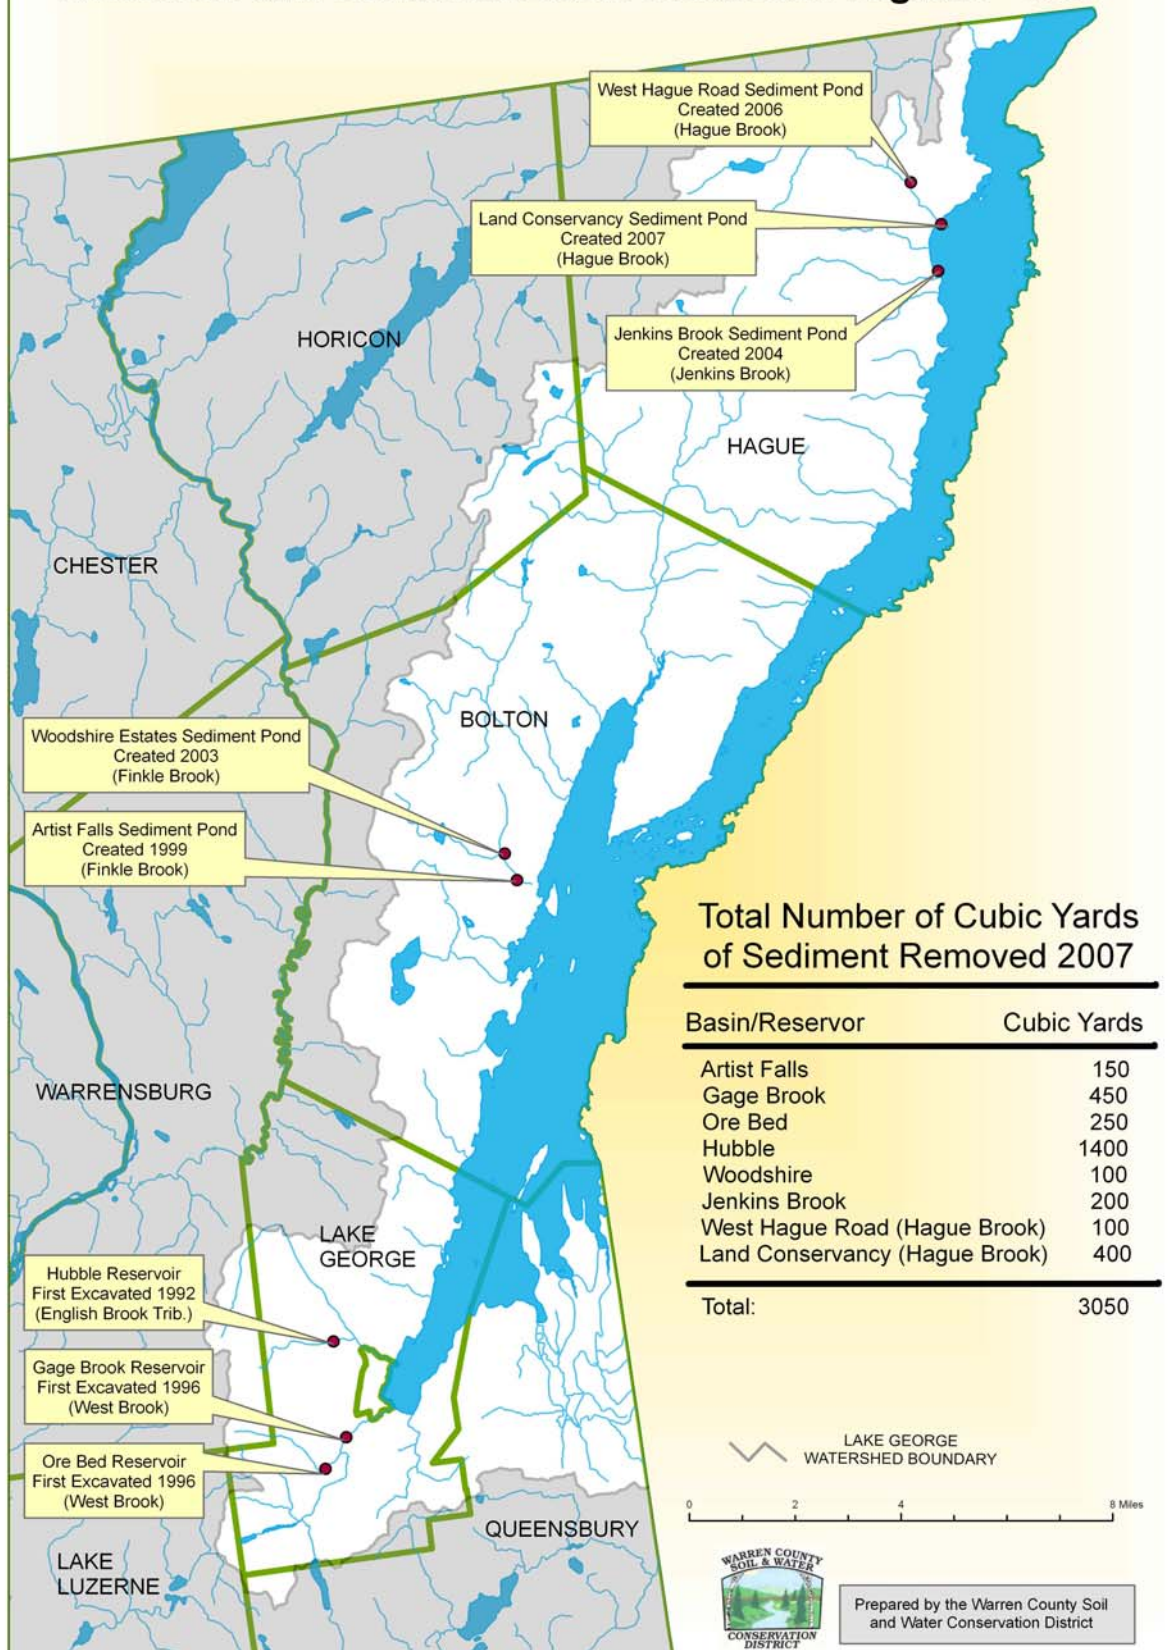
# Lake George Basin Reservoir and Sediment Basin Cleanout Program - 2007

This report provides a brief narrative of each reservoir and sediment pond cleaned out in 2007. A Geographic Information System (GIS) map showing the location of each basin and the amount of sediment removed in 2007 is attached to this summary.
