NYSDOT Network Level
Pavement Condition Assessment
V2.0w
March 2010

Appendix F & G

Appendix F: Photographic Examples of Pavement Ratings

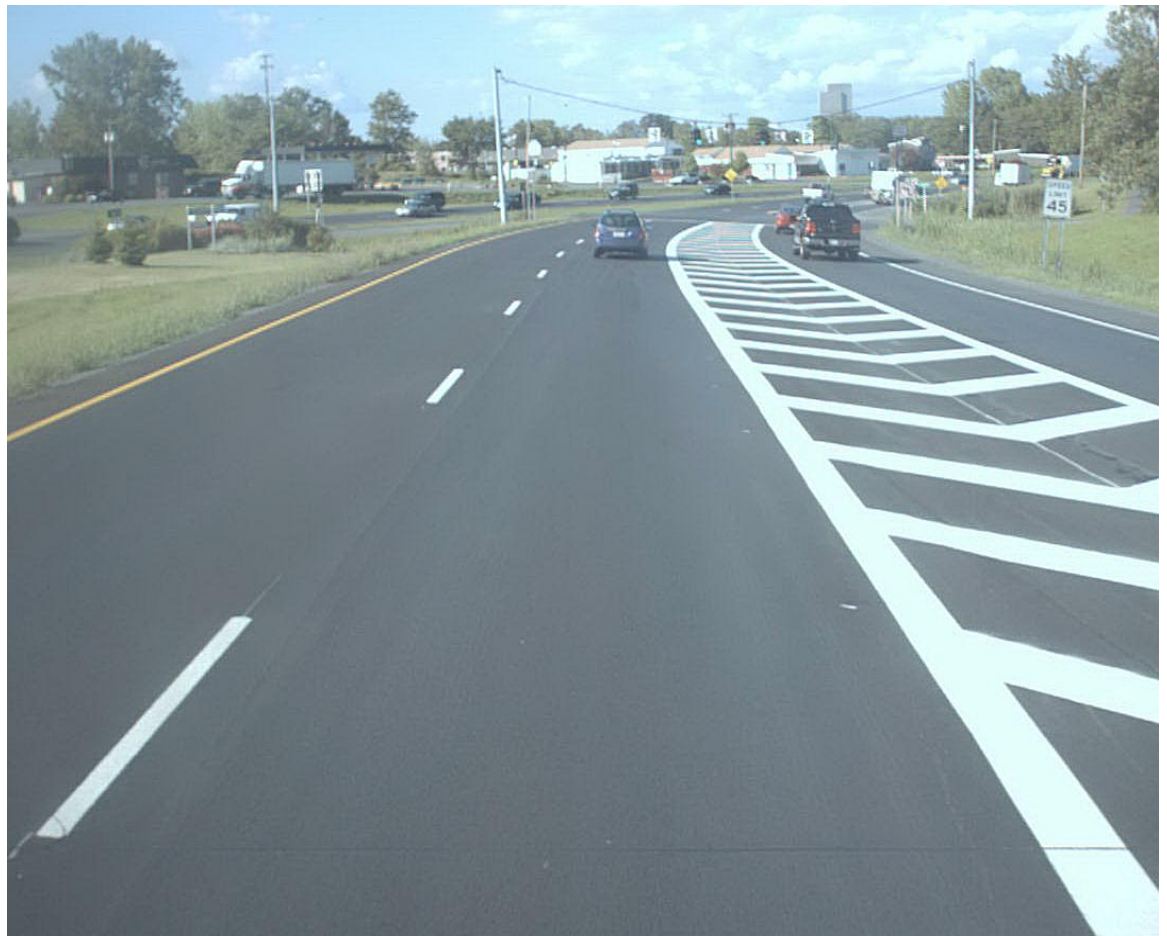
10
Excellent

New
Pavement

No
Distress

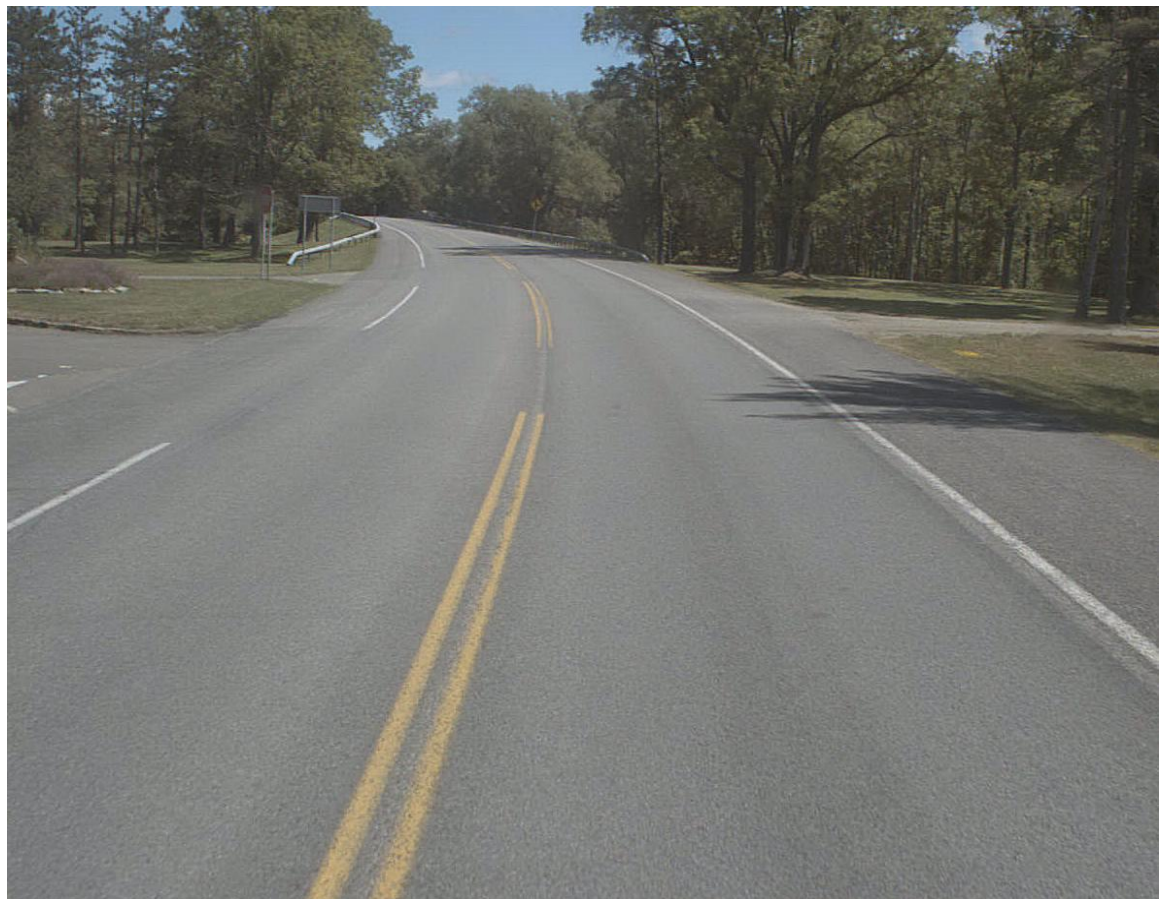
9
Excellent

No
Distress

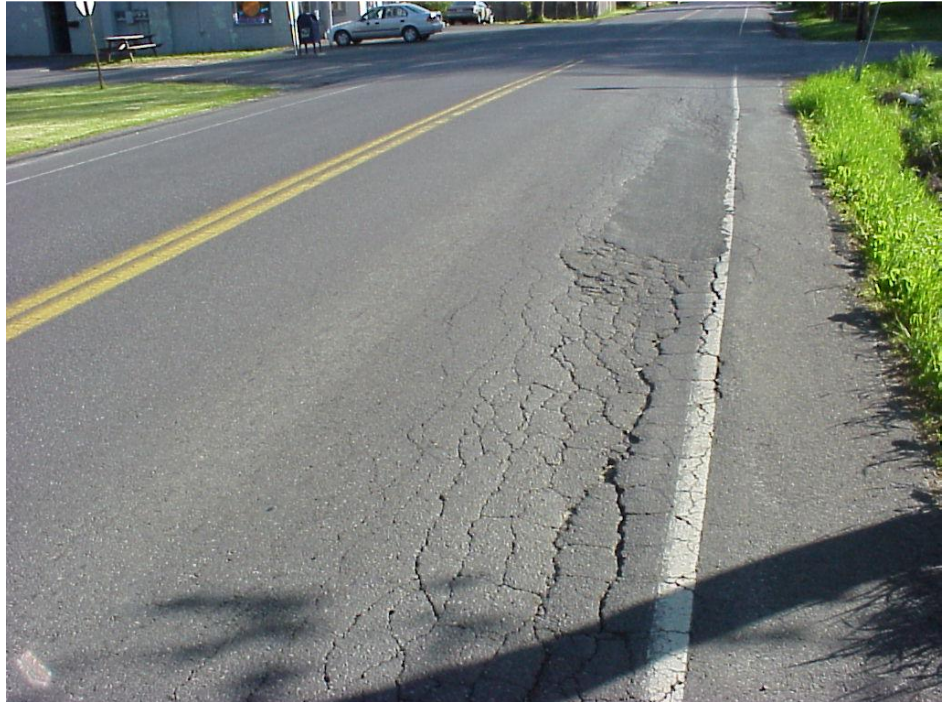
Alligator Cracking

Typical alligator cracking is composed of frequent interconnected cracks. The distress is load-related, so it is identified only when present in the wheelpath of a full-depth asphalt pavement.

Alligator cracking is identified as “isolated” when it occurs over less than 20% of the length of the segment, and “general” when it occurs over more than 20% of the segment.

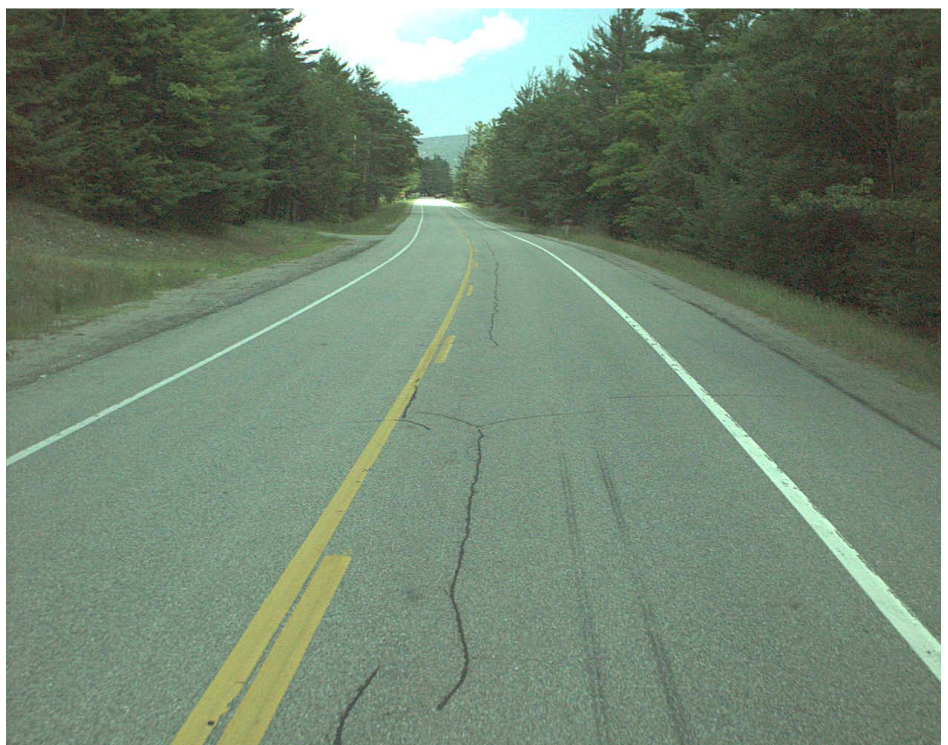
The longitudinal crack in this photo qualifies as alligator cracking even though it lacks the interconnected cracking. The crack is in the early stages of development, but still represents a load-related distress because it occurs in the wheelpath.

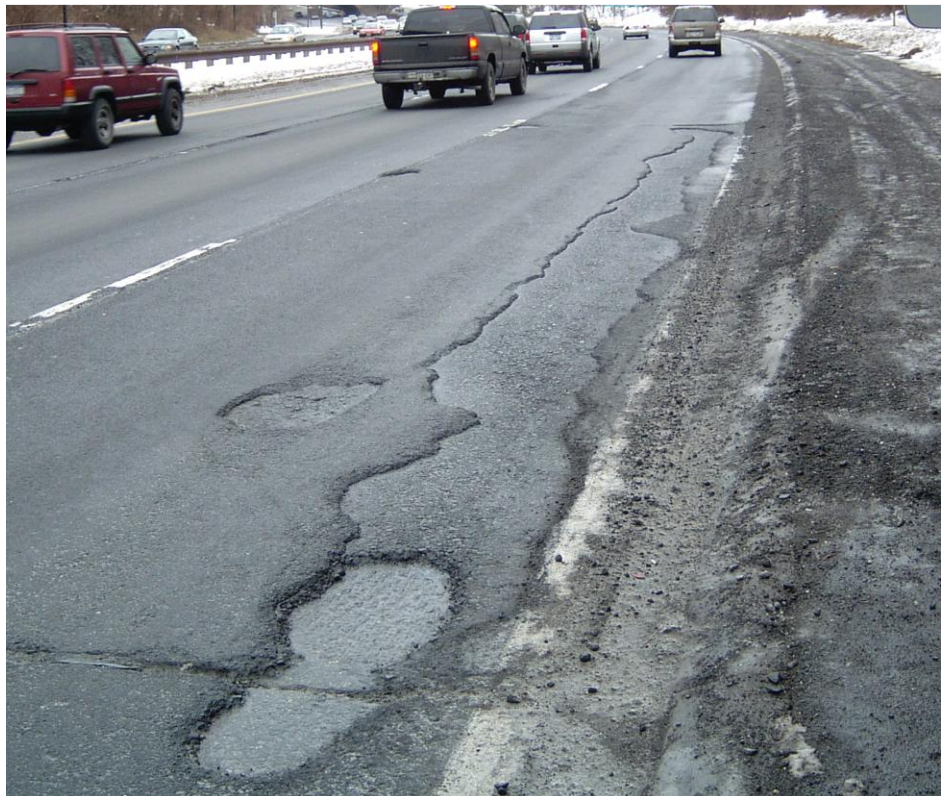
Delamination occurs when an overlaid pavement loses the bond to the underlying layers and becomes dislodged. This distress is not identified directly in the NYSDOT survey, so when it is observed, the delaminated areas should be considered the same as cracking distress.

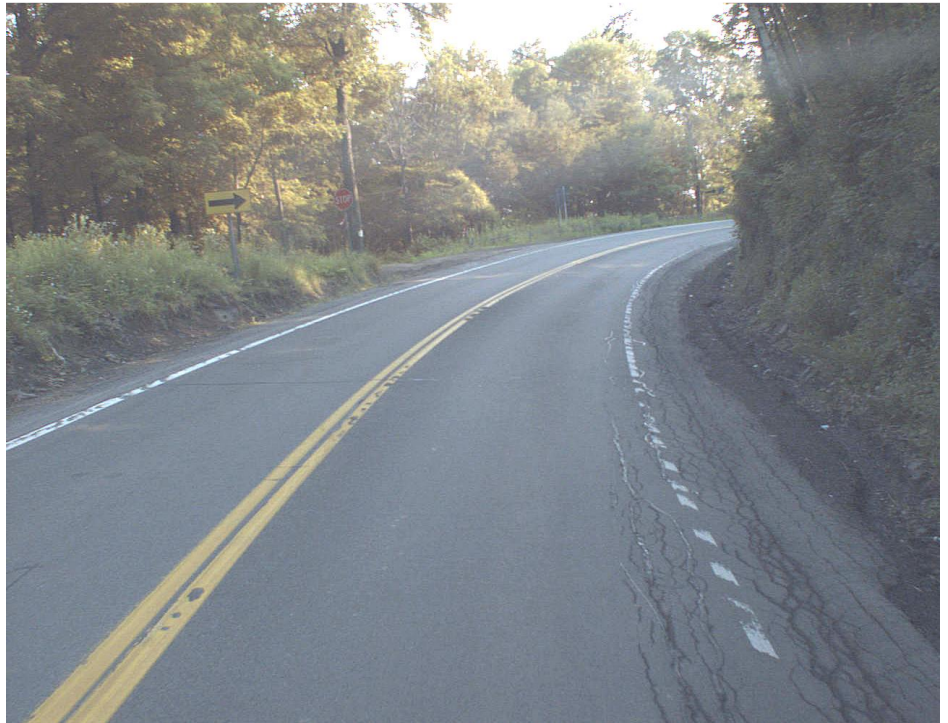
Widening Dropoff

Widening dropoff occurs when an old concrete pavement is widened with an asphalt overlay. The dissimilar base materials settle relative to each other, causing a dropoff at the edge of the underlying slab.

The widening dropoff dominant distress is identified as “low” severity (photo at right) when the cracking at the drop becomes well developed.

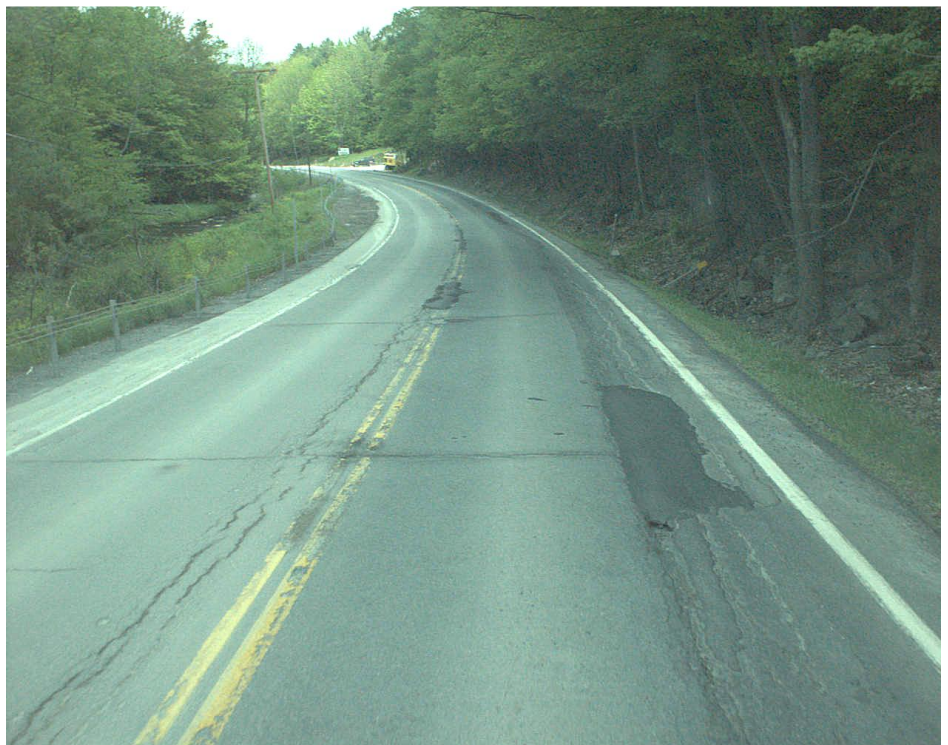
The distress is identified as “high” severity (photo at right) when the effect of the height difference can be detected when driving across the drop, or has the potential to influence the track of a vehicle.

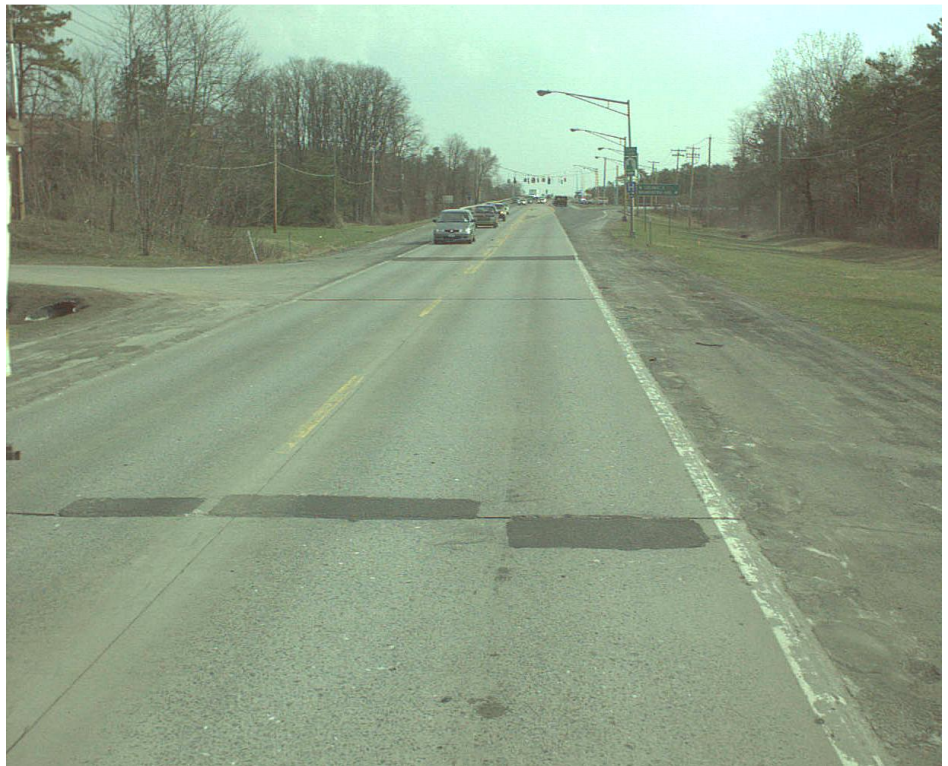
Permanent Patching

Patches with straight, saw-cut edges are assumed to be permanent repairs to the pavement and are expected to perform as original pavement. These areas are not counted as distress until the patch itself begins to show signs of distress.

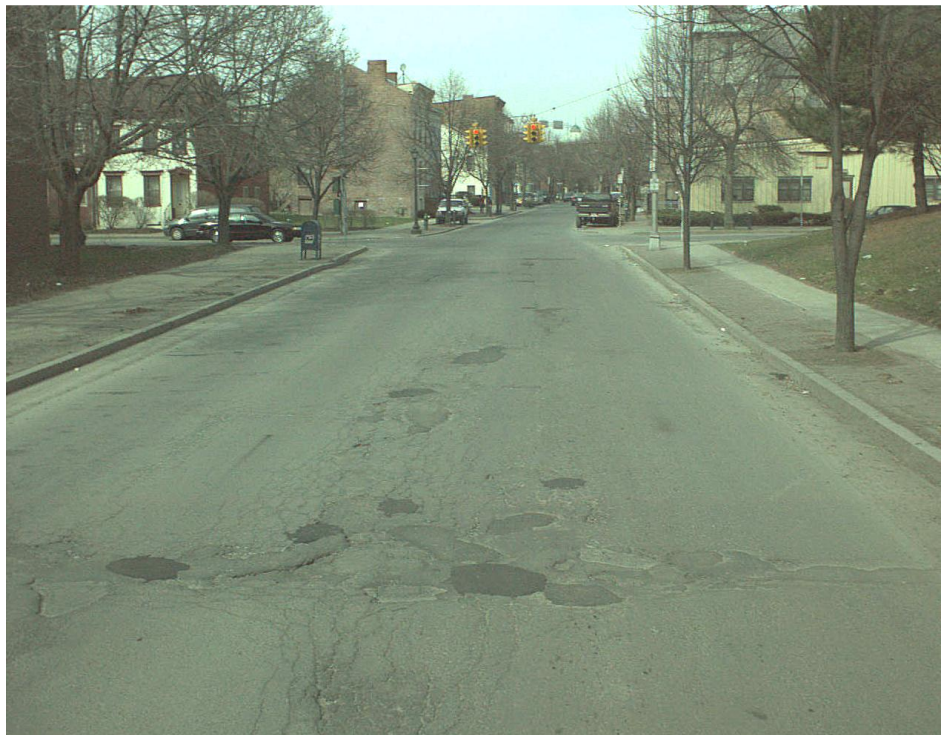
Temporary Patching

Temporary patching, such as “throw and go” patches, do not repair the structural damage in the pavement and therefore are counted as distress. These patches can be identified by their rounded, random shapes.

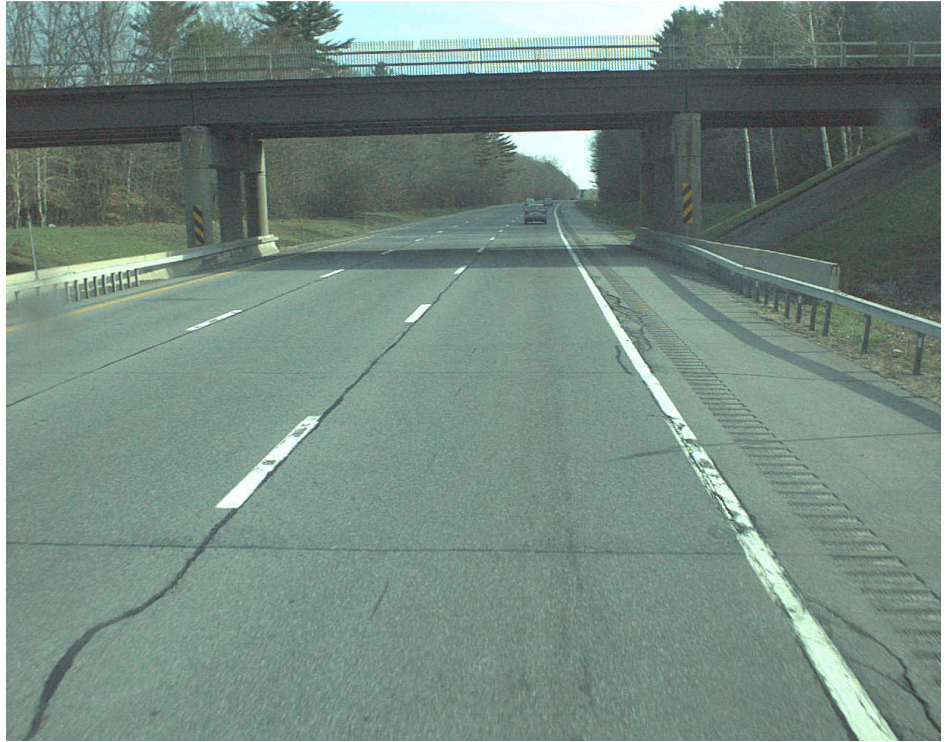
Crack Seal

Crack seal is an effective preventive maintenance activity that helps keep water out of the pavement structure. When a pavement is crack sealed, the sealant tends to highlight the cracks, which could make the pavement look worse and cause a decrease in the rating. Roads that are crack sealed should be given the same rating as the prior year until the continued development of the cracking extends beyond the sealed areas.

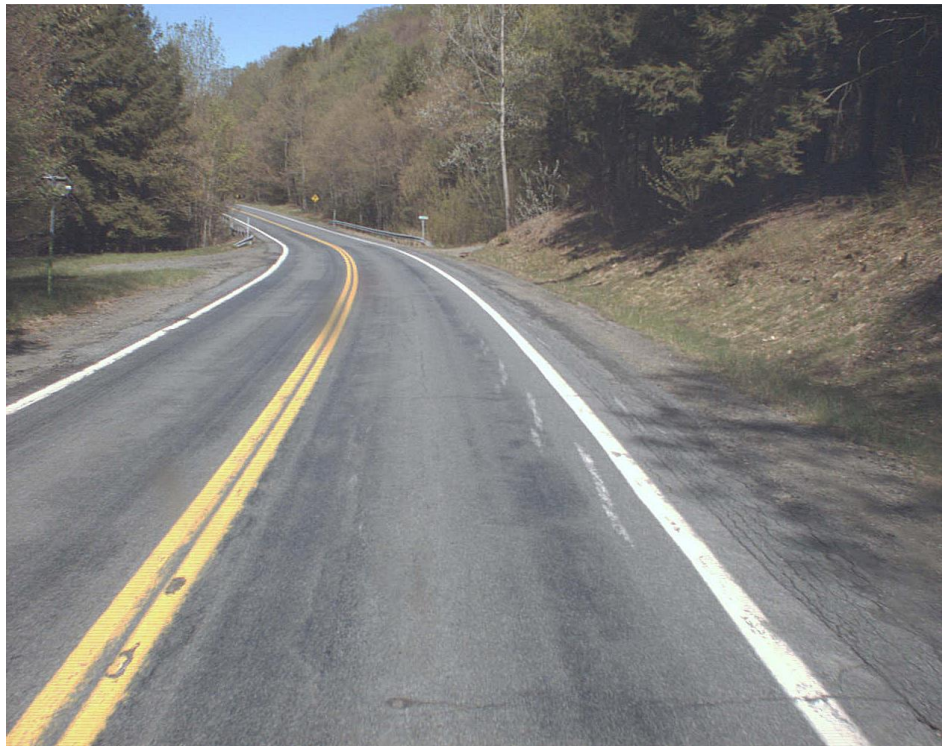
Flushing occurs when excess liquid asphalt material rises to the surface of the pavement. This distress is not identified directly in the NYSDOT survey, but should be reported separately to the Resident Engineer and/or the Regional Materials Engineer, as it may present an urgent safety condition.
