AE Commercial Diving Services 2019 Lake George Eurasian Milfoil Management Report

**Lake George
Park Commission**

PART I: AECDS 2018 Harvesting Site Totals Comparison

Part II: Location Analysis

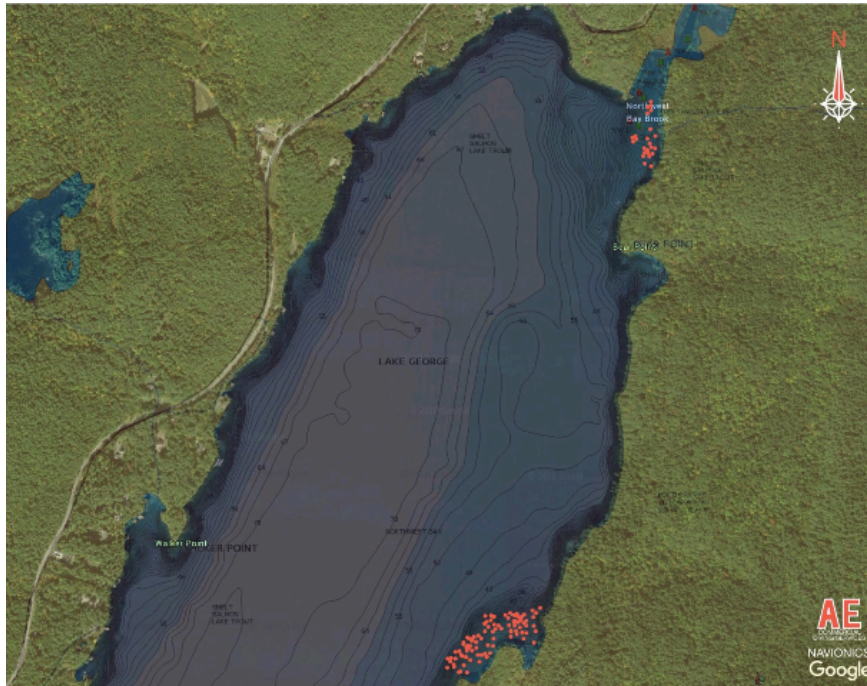
- **Northwest Bay**

The areas worked furthest north in NWB, near the outlet, have had the best success. The bottom is much softer, comprised mostly of mud and native vegetation.

As you head down the east shoreline to the southern sectors of NWB the bottom composition becomes less optimal. The lake bottom becomes rockier and the soft sediment seems to shift to more of a clay base. This can cause poor visibility due to the nature of agitated clay in the water column. These southern sectors are comprised of dense beds located on large rock deposits. Therefore, the invasive plants are harder to eradicate due to the difficulty of digging roots from the rocky bottom.

It is imperative that we continue to remove the invasive plants in this site, however; it is important to recognize how the changes in bottom composition from the northern sector to the southern sector of this site affect productivity. The increase in pounds of invasive Eurasian Watermilfoil removed this year as compared to last year from this site is a clear indication that progress can be made with more time on site, as the days on site increased by five. It also suggests that many contextual factors must be considered when evaluating productivity. Site to site comparison is less informative than annual data from a site contrasted against that same site's past annual data.

Additionally, there are many fishermen who frequent these areas; continued efforts to educate fishermen on how they can help to reduce fragmentation is essential, as our observations of the southern sectors of this site demonstrate a 'moving' of the main beds south-ward, which is consistent with observed fishing patterns for boaters in the areas. We also recommend that education regarding safety standards and marine/boaters safety rules for boating in the vicinity of divers continue as this site proves to be hazardous for our crews.

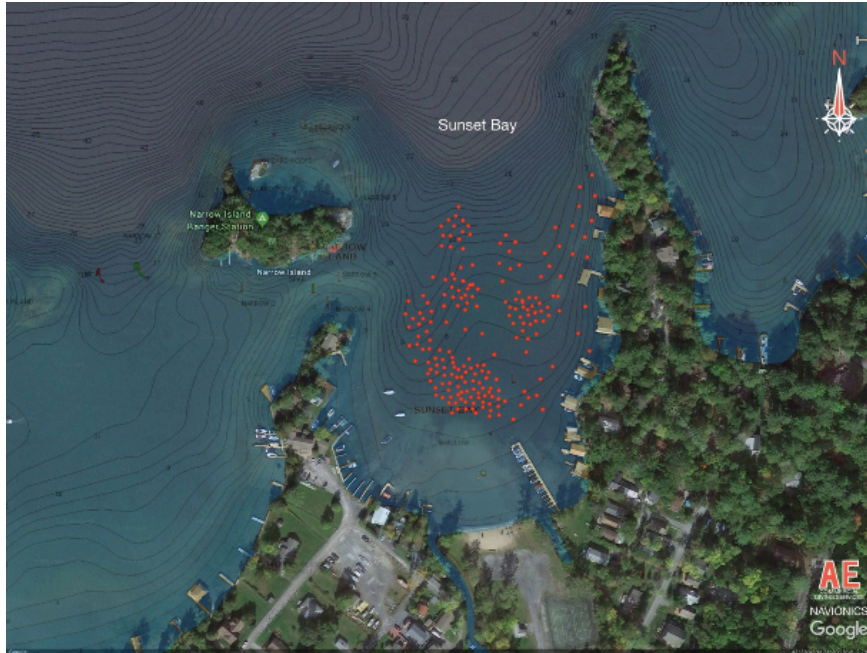
- **Sunset Bay**

Two harvesters and an occasional hand pulling crew worked in Sunset Bay in the 2019 season. We put a good deal of time and effort into the bay in 2018 and made a good deal of progress. We increased our efforts in 2019, which pushed progress along. The bottom composition is ideal for the removal of root systems and there is an abundance of native vegetation that can, (and often will), take over once invasive Eurasian Watermilfoil is removed. Because of these conditions, we expected to see additional progress in the 2020 season.

There is a good chance that there is a dense bed of Eurasian Watermilfoil located north of Sunset Bay that is seeding further infestation. We recommend a survey of the area early in the season to determine if this is indeed contributing to the sparse to moderate growth we observed in roughly 50% of the bay.

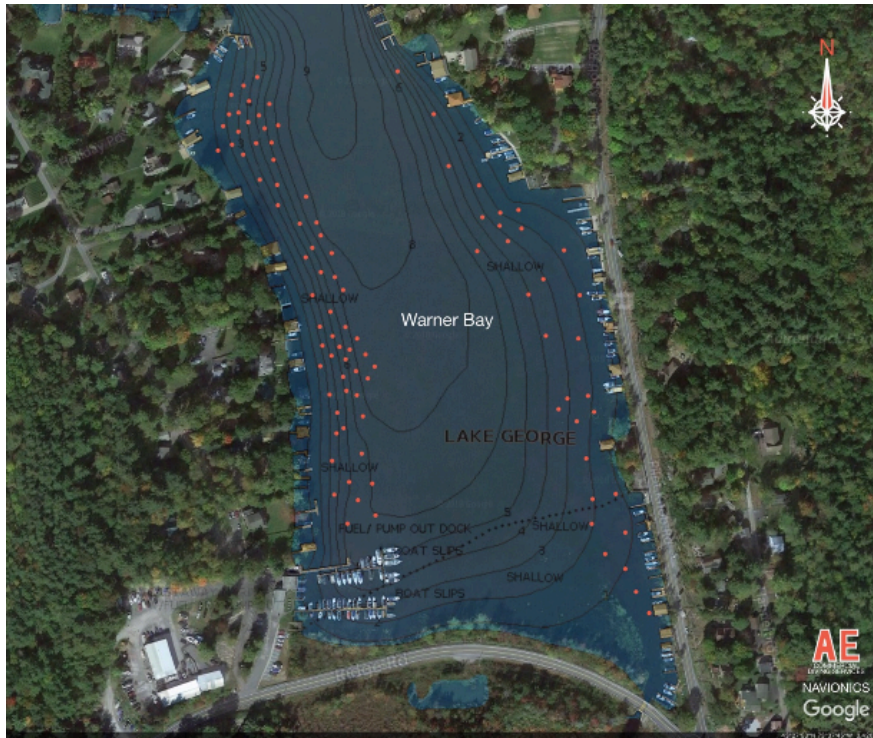
- **Warner Bay**

Warner Bay has sporadic growth down both the east and west shorelines. The middle of the bay, when surveyed, appeared to be free of Eurasian Watermilfoil, as it has in past years. We visited Warner Bay throughout the summer with a hand pulling crew, and a harvester was brought in to help remove areas that would have been too time consuming for hand pulling crews a couple of times. The inlet into Warner Bay creates a low visibility situation for the dive crews.

While sporadic growth can often be best addressed through hand pulling, the large, spread-out nature of the bay, coupled with visibility concerns and boat traffic, have led us to believe that suction harvesting would be a more effective control method.

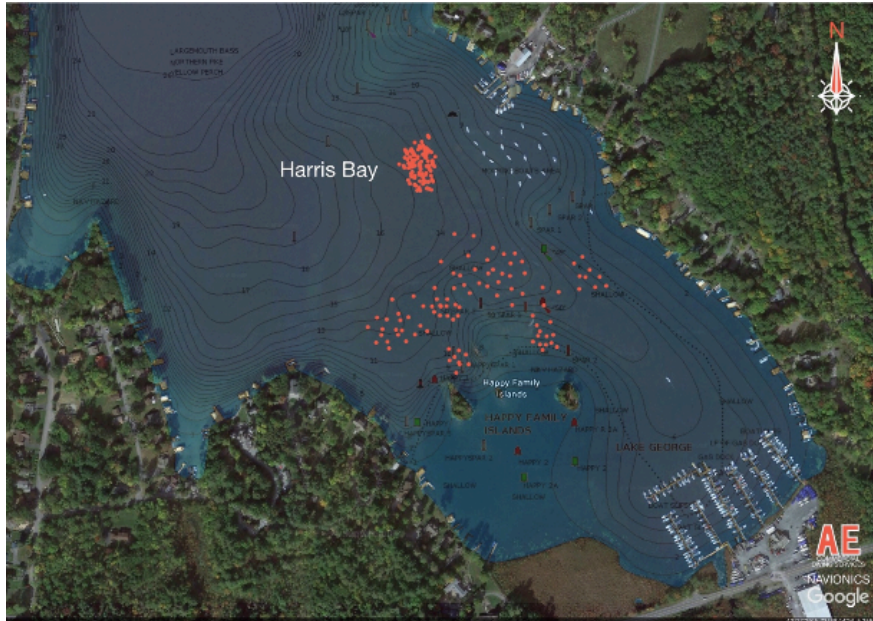
- **Harris Bay**

Harris Bay has proven to be a tricky site to the wide variety of bottom composition, topography, and sediment. The area surrounding the islands consists of boulders and rocks, making it difficult to remove plants *and* their entire root systems. As a result, the risk for regrowth is high, and will require monitoring.

As you move away from the islands, some sectors of Harris Bay shift dramatically to soft sediment with clusters of native vegetation. These areas are showing the most improvement and are more easily controlled.

Farther still from the islands, however, large flat sectors open-up with a depth ideal for invasive Eurasian Watermilfoil to proliferate. These open ‘plane-like’ sections make conditions ideal for the invasive plants to take over quickly in large, dense beds if left unchecked.

Progress is being made but at a much slower pace than was hoped. Areas worked in 2018 remained open in 2019 but new spots continue to pop up due to the conditions described above.

Harris Bay is complex and requires vigilance. Ongoing discussion regarding the site is recommended to ensure progress is not undone.

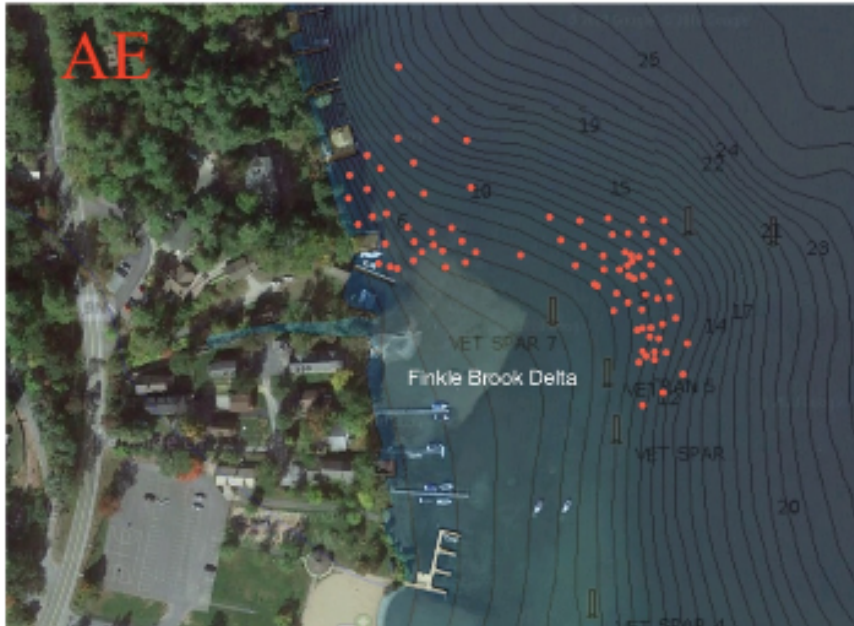
- **Finkle Brook/Finkle Brook Delta**

The Finkle Brook Site is broken into two distinct sectors: the delta and the off-shore sector adjacent to the beach park. Work completed in the delta in 2018 has proven to have a positive effect on the reduction of invasive Eurasian Watermilfoil. Very little regrowth was found near the inlet of Finkle Brook or the immediate area of the delta in 2019.

The offshore sector had slightly more new growth than the inlet, but still showed a reduction due to work completed in 2018.

We believe growth in the offshore sector of Finkle Brook may be related to regrowth in part, however; a patch discovered a few hundred meters southeast is suspected to be contributing to regrowth in the area due to fragmentation.

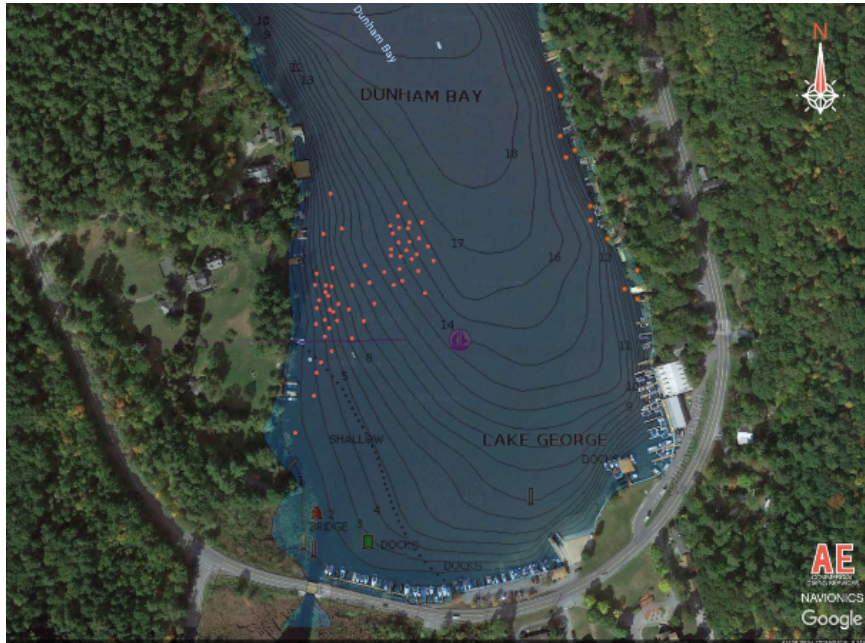
- **Dunham's Bay**

Overall, Dunham's Bay looked very good. There was a sporadic vein of milfoil along roughly 60% of the eastern shore. The western shore revealed very little growth of Eurasian Watermilfoil, with only a few plants along its entirety. The bulk of harvesting efforts in Dunham's Bay was in the center of the bay in roughly 20 - 25 feet of water. The bed was small but dense. It was located at an old bottom barrier site.

In the coming season, it will be very important to monitor Dunham's Bay, as there is a very busy marina on site. Though most of the dense growth was away from the marina, boat traffic could lead to fragmentation and spread of Eurasian Watermilfoil quickly. Continued DASH and frequent surveys are essential to keeping Dunham's Bay on a trajectory towards optimum containment and control.

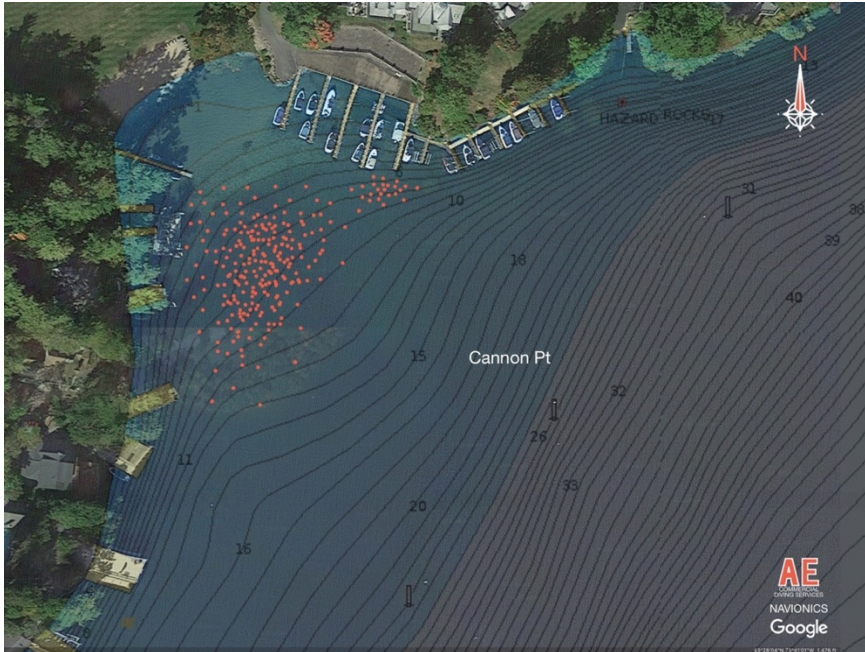
- **Cannon Point/ Bay SW of Cannon Point**

When we began work at Cannon Point in 2019, we found that it resembled how it had looked before commencing work in 2018: a dense bed of invasive Eurasian Watermilfoil was located southwest of the point, in roughly the same place as 2018, though the bed had shifted slightly to the east.

There are several contributing factors to why work in this area has only held the advancement of the Eurasian Watermilfoil at bay rather than reduce it. First, the lake bottom at this site is a dense sandy base that encourages deep root growth. Removing the entire root ball of the invasive Eurasian Watermilfoil plants that grows here is time consuming and difficult, though clearly imperative.

Next, this site is thick with native plant life that is punctuated with Eurasian Watermilfoil. Removing the invasive plant without damage or destruction of these native plants is very difficult and leads to a situation where divers are sorting through stems at the bottom of the lake in poor visibility conditions.

Finally, Cannon Point is rife with boat traffic and we suspect the perpetual traffic is leading to a rapid regrowth potential through fragmentation.

It is crucial that the dense bed of Eurasian Watermilfoil be held in check to reduce movement of the bed into areas south of Cannon Point, as was observed occurring between 2018 and 2019, or beyond. The increase of days allotted to this site, (5 in 2018 to 13 in 2019), allowed for a more robust removal of invasive Eurasian Watermilfoil and must continue in order to control this site's infestation. With a continued aggressive approach to Cannon Point, we are hopeful that the natural complicating factors of the site will be eventually be overwhelmed by effort and a reduction will be seen in Eurasian Watermilfoil.

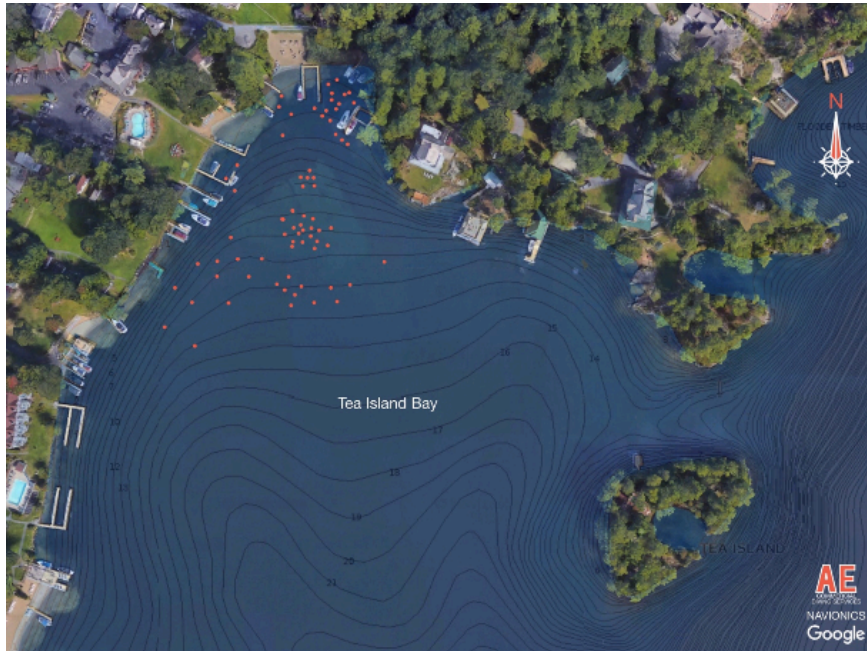
- **N. Tea Island Bay/Tea Island**

The initial survey prior to the commencement of work in 2019 revealed that work in 2018 on the Tea Island site was successful in significantly reducing the infestation of Eurasian Watermilfoil. This made for quick work at the site. However, the shallow areas of the site, especially in the areas around the resorts and their docks, revealed new growth that was more complicated to remove.

New growth at this site, (most likely due to fragmentation caused by a high tempo of boat traffic), is in areas where DASH work is much harder to conduct, such as under and around docks and moorings. We recommend that close attention be paid to the trend of regrowth at this site in order to prevent a relapse into a denser area of infestation, especially in shallow areas.

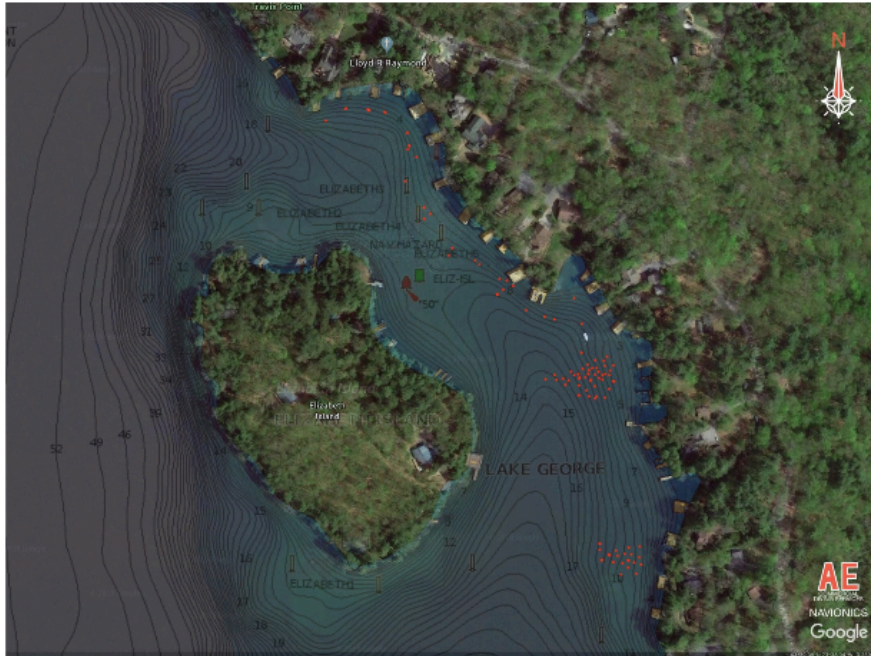
- **Elizabeth Island**

The Elizabeth Island site, (new to us in 2019), was completed faster than anticipated. There were only a few small dense beds in areas of shallow water, and the crews had no problem finding them and removing them.

Though the work was fast and straightforward at this site, the dense beds were located on rocky deposits which make for a difficult removal of the Eurasian Milfoil root ball. Because of this, we recommend a site survey of the area in 2020 to ensure the beds have not moved or become larger.

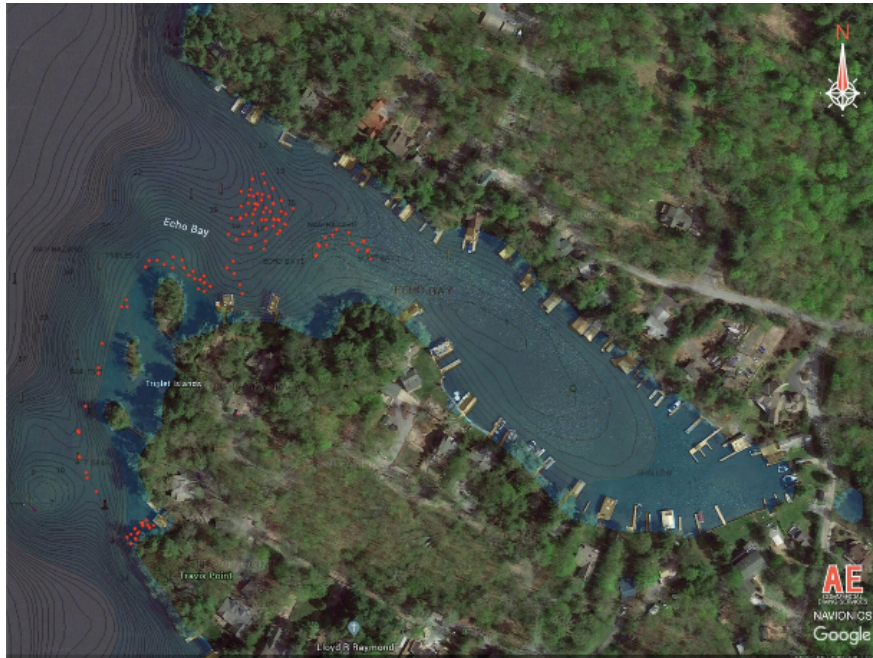
- **Echo Bay**

Usually combined with Elizabeth Island, this site was separated out this year due to its contextual challenges. The site was moderate infested with Eurasian Watermilfoil at the mouth of the bay that spread southward around the point and islands. This created challenges for our crews to anchor, dive, and transit safely given the high boat traffic in an out of work zone. Transiting and working around the point southward was also hazardous for these reasons. The bottom composition was also challenging; a rocky bottom layered upon with mud made it challenging to remove the root balls of the Eurasian Watermilfoil. A steady current around the point and islands stirred up the mud and made visibility tricky.

It is imperative that boater education continue, regarding both how to reduce the spread of Eurasian Watermilfoil as well as how to maintain boater safety regulations while transiting in the vicinity of divers. Going forward, it will also be important for geography of the site to be recognized as a formidable challenge for the safety and productivity of our crews; even the safest boaters following the strictest guidelines for diver safety create a potential danger to crews because of the small mouth of the bay and depth.

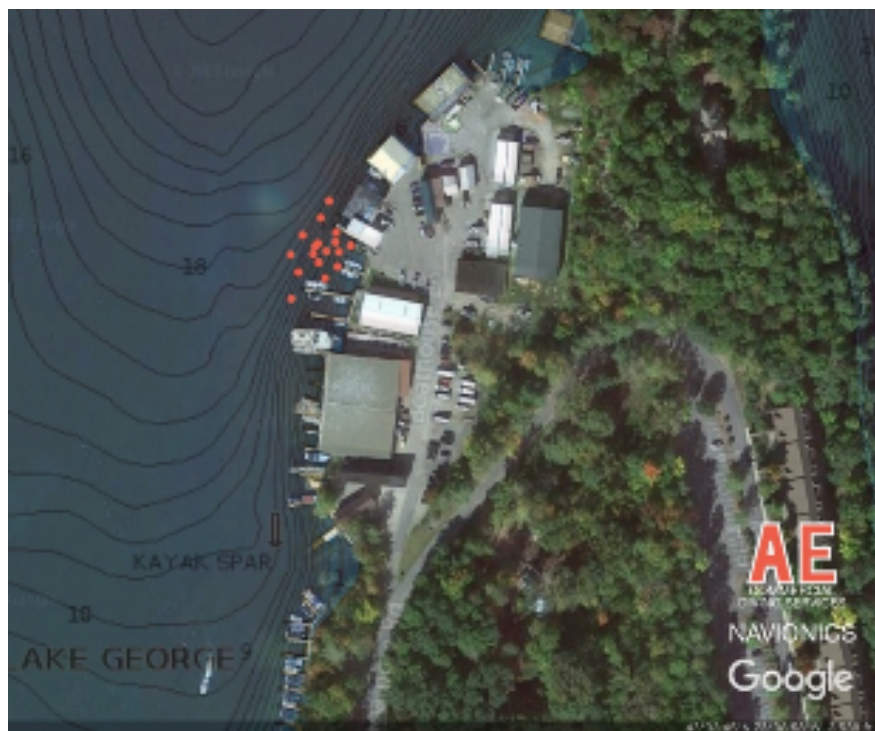
- **DEC Facility:**

The DEC site was completed quickly. The 2019 season was the first time AED harvested the area and we only found sporadic growth with a couple small clusters of medium sized plants.

This area should be monitored due to a new patch discovered in the channel, however, we believe it will continue to prove to be one of the less-challenging sites in 2020.

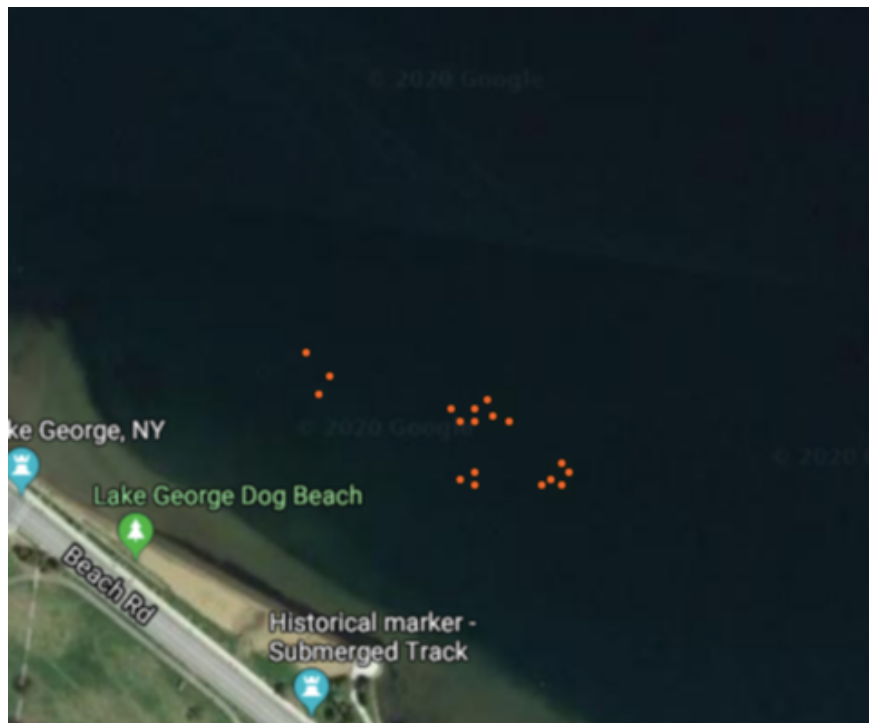
- **Dog Beach/SE Boat Launch**

This site proved to be a very challenging area to perform DASH at. The bottom composition was mostly loose sediment on a steep grade, which made it difficult to anchor properly at the site. Wind was also a factor in keeping anchored. While visibility was good most of the time, it was very difficult for crews to work into the good visibility due to the above-mentioned anchoring issues.

This site will continue to prove challenging to work, but is an essential area of infestation to work away at given its location in a high traffic area.

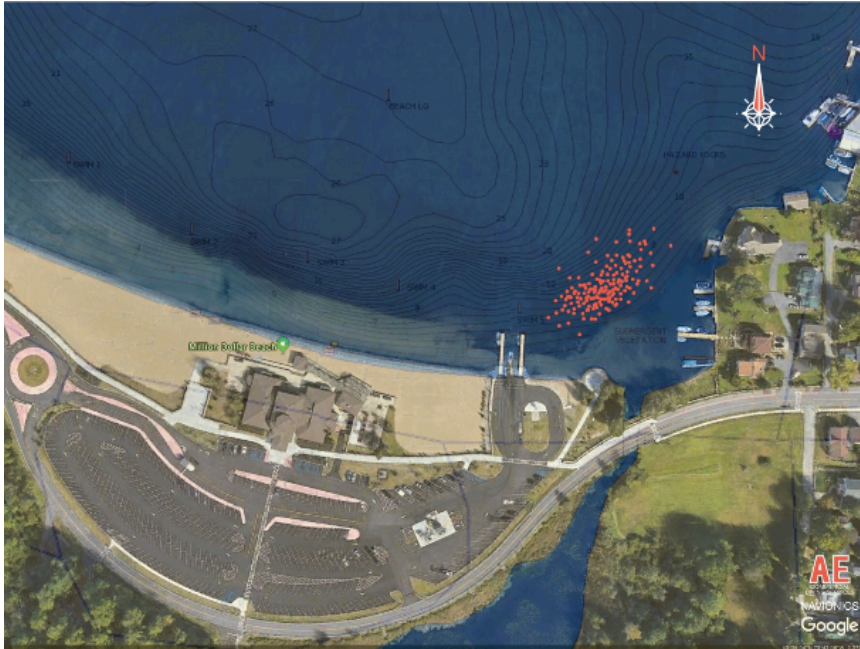
- **Million Dollar Beach/Boat Launch**

The boat launch at Million Dollar Beach harbored a large dense patch of Eurasian Watermilfoil. The patch began to east of the launch and extended norward up the shore. The bottom composition at this site was ideal for harvesting, consisting of a soft sediment. Because of the almost complete removal of the Eurasian Watermilfoil, (seeds and roots may be still present in the bottom), we expect that the site to be greatly improved for the beginning of the 2020 boating season. However, due to the nature of it being a boat launch where sediment is stirred by launching vessels, vessels possibly bringing Eurasian Milfoil back from other parts of the lake to the site when preparing to exit, and strong winds naturally pushing any fragmentation towards that corner of the lake, we fully anticipate a flare up of infestation after the season has begun.

Additionally, this site proved challenging to our divers' safety as many boaters seem unaware of how to behave in the vicinity of diver flags and buoys.

It is imperative that boater education continue, regarding both how to reduce the spread of Eurasian Watermilfoil as well as how to maintain boater safety regulations while transiting in the vicinity of divers. We are grateful for the efforts of the boat launch monitors and know that their job is already a difficult one, especially in the peak of the season. We would be happy to provide a reproducible information flyer to be given to boaters or to create a sign that would be posted at the launch reminding boaters of the proper precautions and boater safety responsibilities for those transiting near divers and their boats.

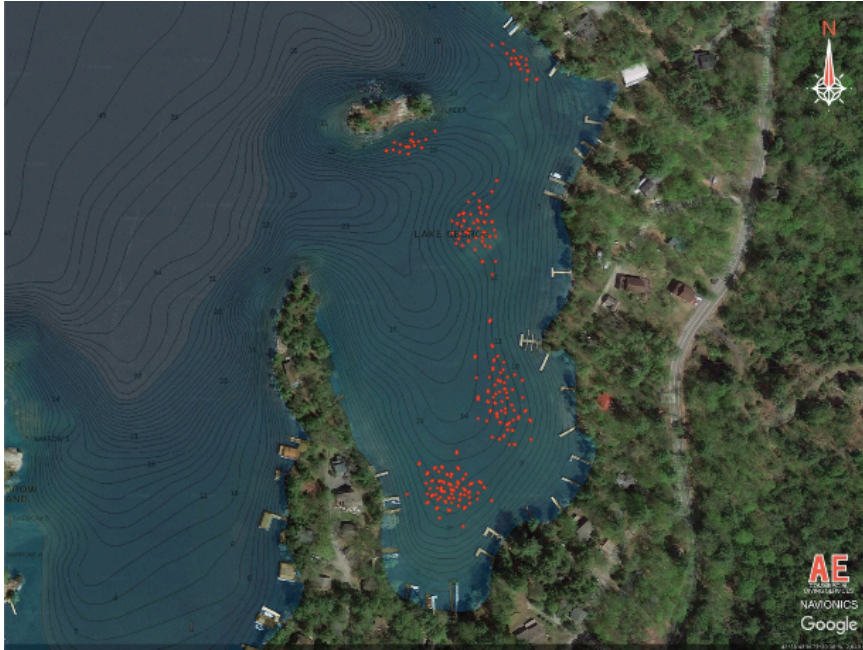
- **Indian Bay**

Indian Bay contained several isolated dense beds of Eurasian Watermilfoil, with sporadic growth throughout the shallows. The sandy bottom composition made harvesting easier for the two DASH crews and the hand pulling team. However, this site was worked last in the season and was not completely harvested before the season ended.

We recommend that Indian Bay be revisited earlier in the 2020 season in order to eliminate the potential for fragmentation out of *and* inside of this site that is probable due to the high-traffic nature of the bay.

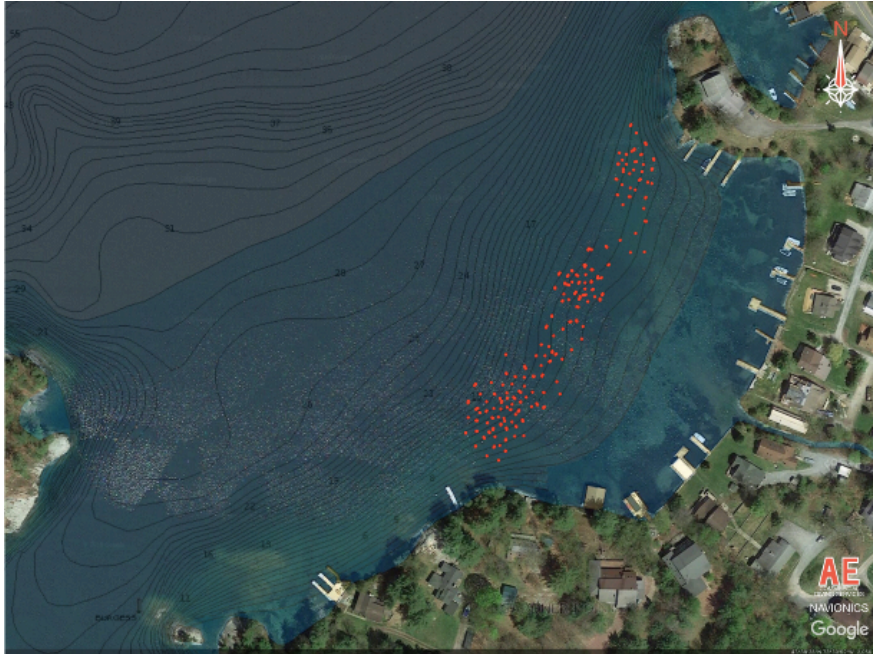
- **Eichlerville Bay**

Eichlerville Bay revealed two dense beds of Eurasian Watermilfoil connected by a smaller line of moderate growth. Two DASH crews worked the large patches towards each other and through to each other in the areas of moderate growth. Harvesting was completed in this area; however, the varied bottom composition causes concerns to potential regrowth. Because the site was done late in the season, it was not possible to check for regrowth after harvesting in 2019. A rocky bottom composition layered with mud on top, Eichlerville Bay was a complex site to remove invasive Eurasian Watermilfoil from, with a great deal of uncertainty if complete root removal was accomplished.

Because this site was completed at the end of the DASH season in 2019, we recommend that it be revisited earlier in the 2020 season in order to check regrowth and eliminate the potential for fragmentation into other areas, (which is possible in this high traffic site).

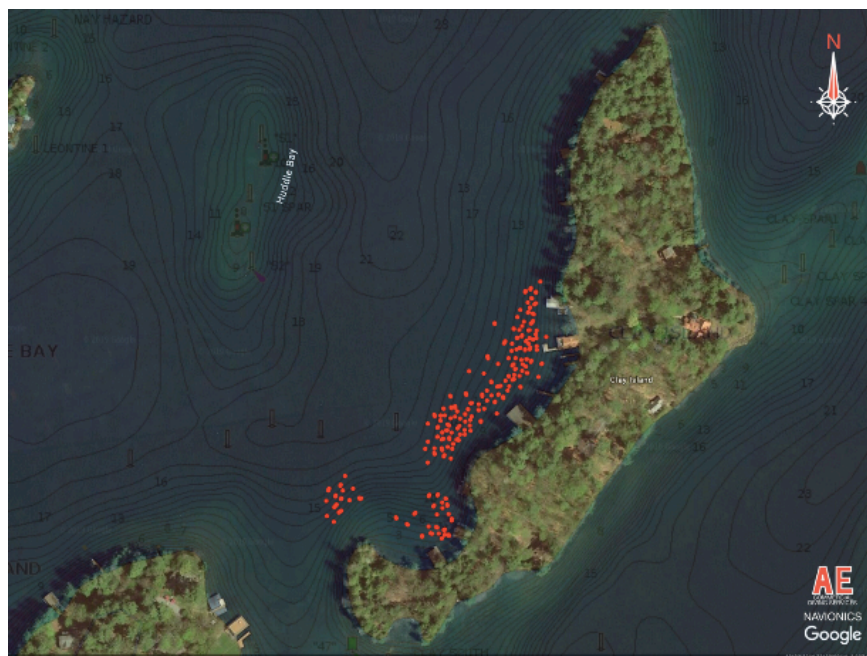
- **Clay Island**

The Clay Island site consisted of a large dense bed on the western shore of Clay Island. The site was worked with two harvesters and occasionally a hand pulling crew. The harvesters started on opposite ends of the dense bed and worked to reach each other in the center. After completion, the site seemed to hold for the remainder of the summer. However, the bottom composition consisted of sand and clay. This makes eradicating root systems more troublesome.

This site should be revisited earlier in 2020 to survey potential regrowth and ensure its removal as quickly as possible. The clay/sand bottom composition will continue to make this site a priority each year.
