**West Brook Conservation Initiative Stormwater Improvement Ponds Wetland Complex -  
The Results of a Monitoring Program to Evaluate Current Treatment Efficiencies**

December 2018

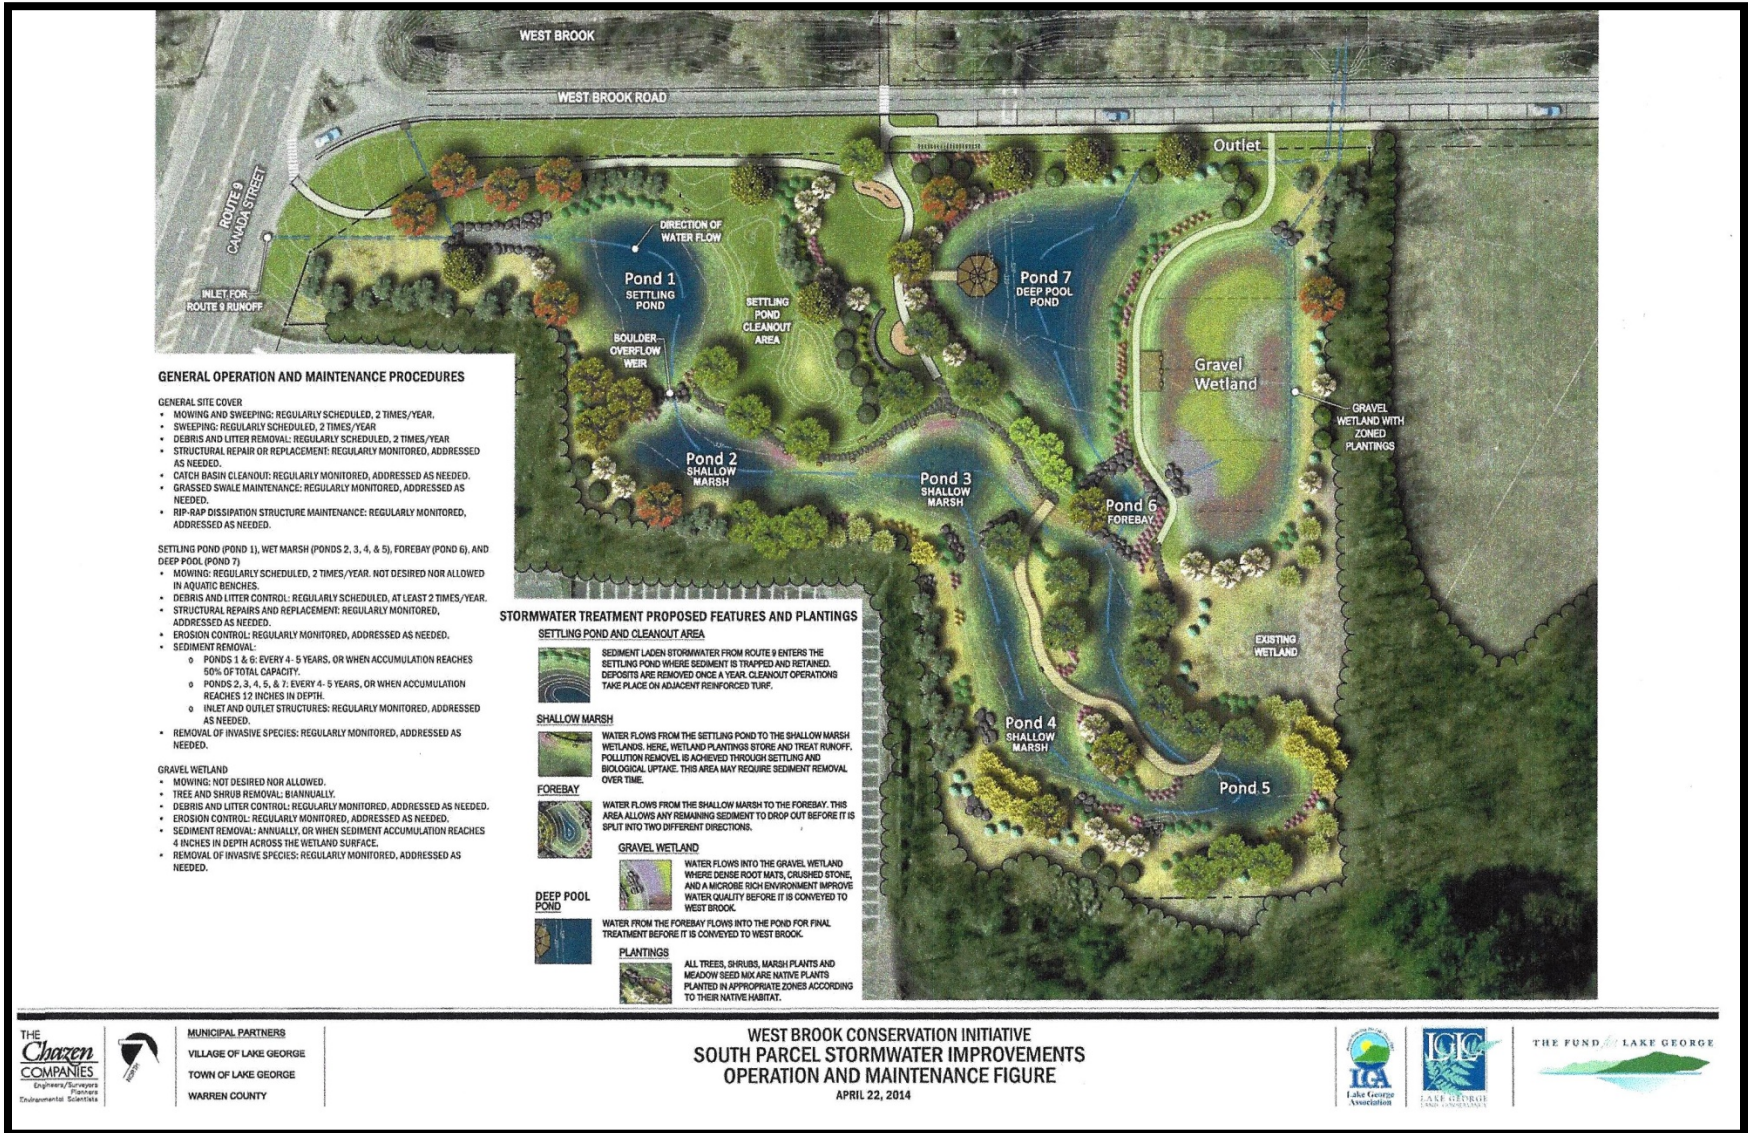
Figure 3-2

WEST BROOK CONSERVATION INITIATIVE  
SOUTH PARCEL STORMWATER IMPROVEMENTS  
OPERATION AND MAINTENANCE FIGURE

Multiple cell systems such as pond/wetland systems utilize at least one pond component in conjunction with a shallow marsh component. The first cell typically is a wet pond or forebay (**Pond 1** on Figure 3-2) which provides pretreatment of runoff by removing particulate materials. When properly designed, the permanent pool reduces the velocity of incoming water to prevent resuspension of particles and promote settling of recently introduced suspended solids. The energy-dissipating and treatment properties of the permanent pool are enhanced by aquatic vegetation which is an essential part of the stormwater design. The additional vertical storage volume also provides extra runoff detention above the normal pool elevations.

The shallow marsh wetland system (**Pond 2** through **Pond 5** Shallow Marsh on Figure 3-2) receives runoff from the forebay and then filters the runoff, particularly for soluble pollutants, prior to discharge. Shallow marsh wetlands consist of aquatic vegetation with a permanent pool ranging from six to eighteen inches during normal conditions. The growing area in shallow wetlands extends from the normal pool elevation to the maximum water surface elevation. Wetland plants that tolerate intermittent flooding and dry periods have been selected for the extended detention area above the shallow marsh elevations.

The gravel wetland system consists of one or more flow-through constructed wetland cells, preceded by a forebay (**Pond 6** and **Gravel Wetland** on Figure 3-2). The cells are filled with crushed rock or gravel, covered with an organic soil layer, and planted with wetland vegetation. During low-flow storm events, the system is designed to promote subsurface horizontal flow through the gravel media, allowing contact with the root zone of the wetland vegetation. The gravel and planting media support a community of soil microorganisms. Water quality treatment occurs through microbial, chemical, and physical processes within this media, as well as direct vegetative uptake. To accommodate higher flows, the system is designed to permit inundation of the wetland surface, and the system would function similar to other constructed wetland systems. Overflow from the wetland is provided by an outlet structure designed to keep the gravel media submerged. Following an event, remaining water on the surface of the wetland would infiltrate into the gravel media, and flow horizontally through the media as in the low flow condition.

Water from the forebay enters this pond (**Pond 7** on Figure 3-2) which allows or final polishing before being discharged into West Brook.

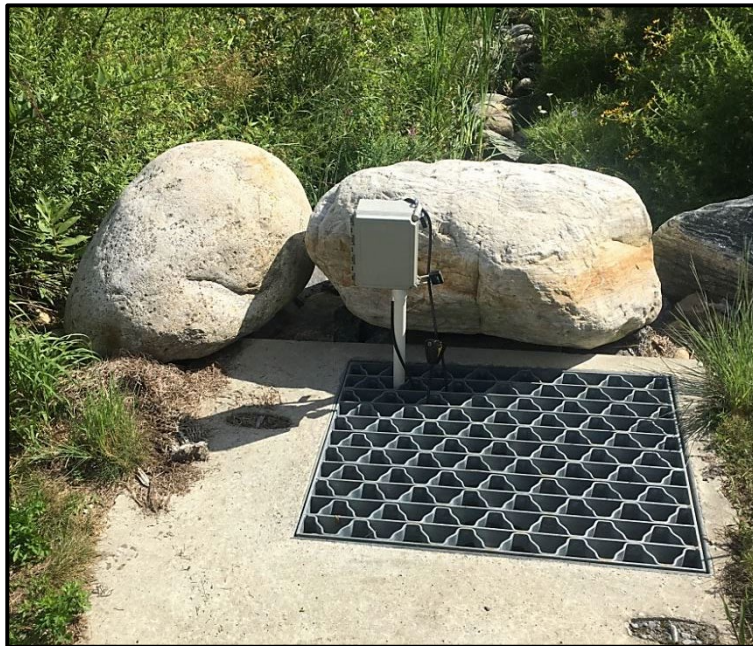
The Telog Inc. water level recorder system assembly was secured to the grate of the outlet chamber using a Master Python cable lock system.

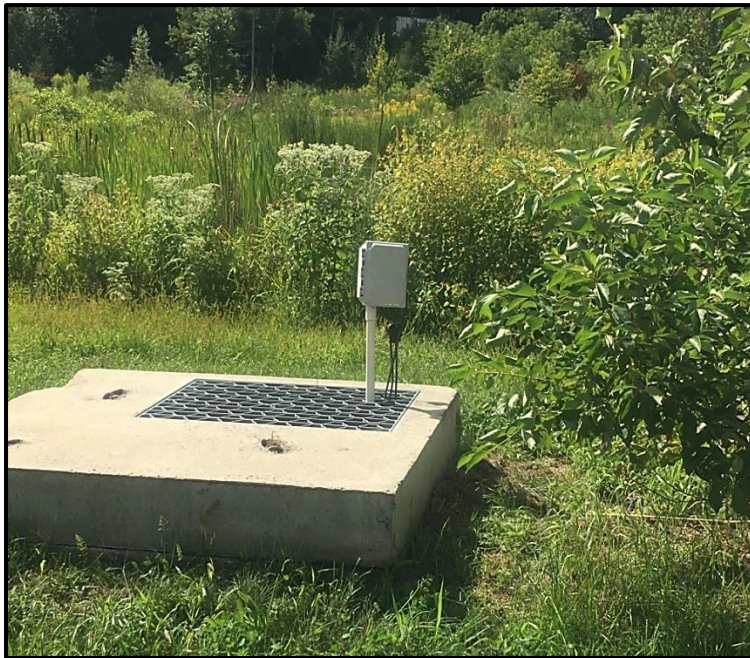
The Telog Inc. water level recorder system assembly was secured to the **Pond-7** outlet chamber grate using a Master Python cable lock system.

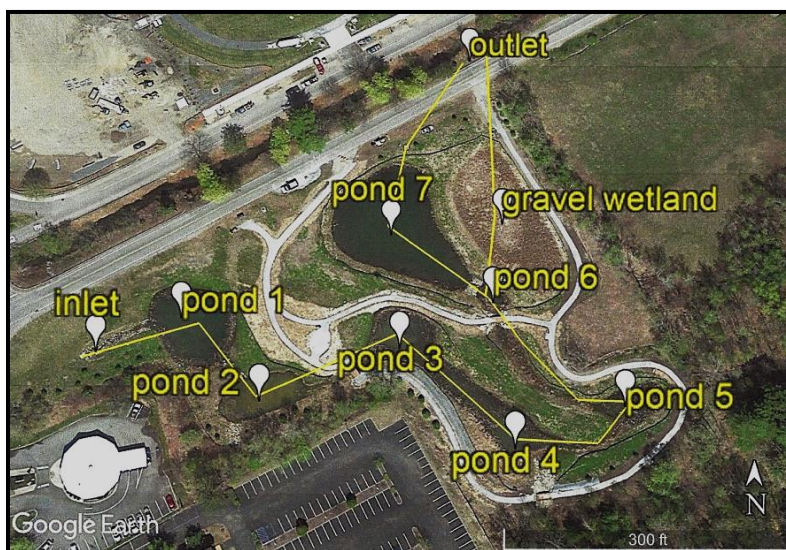
Figure 5-1 traces the sequence of the wetland treatment process for storm event discharge entering the system from the Inlet to **Pond 1** and then through the series of succeeding ponds, with water finally discharging either to **Pond 7** or to the **Gravel Wetland**, depending upon the level of water in the area of the **Pond 6** weir. During dry (base-flow) conditions, however, water movement through the system is entirely dependent upon ground water flow which moves from higher elevation to the south (bottom of Figure 5-1) toward West Brook (top of Figure 5-1).

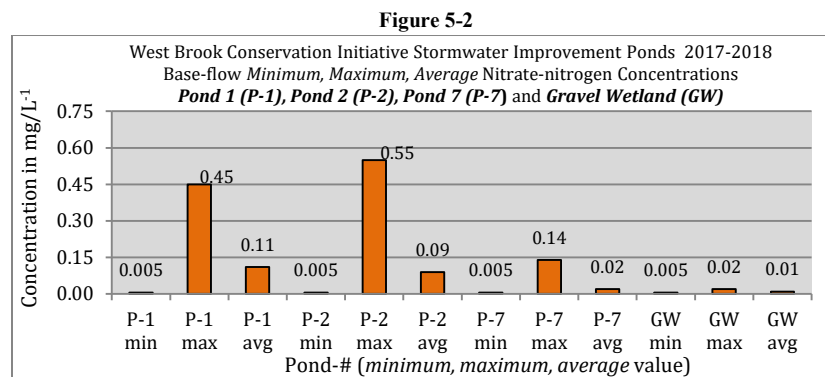
The difference between *average nitrate-nitrogen* values at the beginning and end of the wetland treatment chain indicate that nutrient uptake was occurring to reduce this nitrogen component that is readily available uptake and metabolism by attached plants and algae in the system.

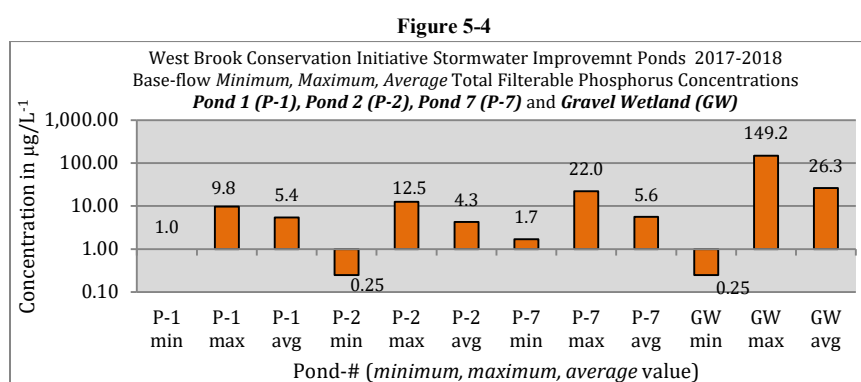
The y-axis in the above figure is formatted in logarithm scale due to the wide range of **TFP** concentrations and in order to properly demonstrate the relative concentration of each value with regard to all other values in the matrix.

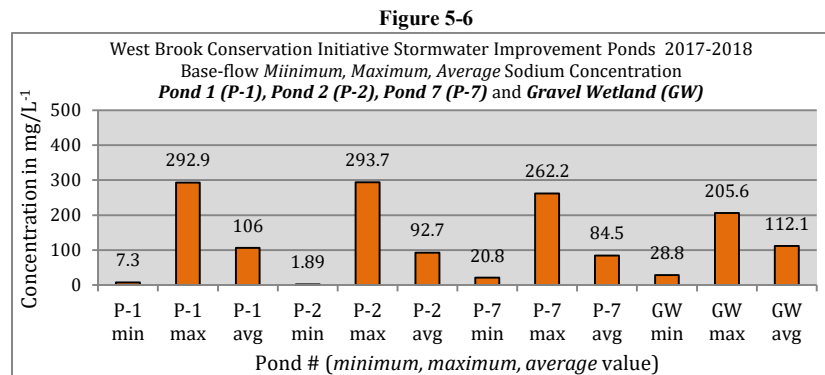
The *average* concentration of **Na** exiting the wetland complex via **Pond 7** (84.5 mg **Na**·L<sup>-1</sup>) is below the *average* values measured in **Pond 1** (106 mg **Na**·L<sup>-1</sup>) and **Pond 2** (92.7 mg **Na**·L<sup>-1</sup>) and indicate some minor processing of **Na** within the treatment chain, while the *average* concentration discharged from the **Gravel Wetland** (112.1 mg **Na**·L<sup>-1</sup>) is the highest measured. All of these *average* concentrations being discharged are considerably above 20 mg L<sup>-1</sup> which is the upper limit for **Na** concentrations considered safe for drinking water.

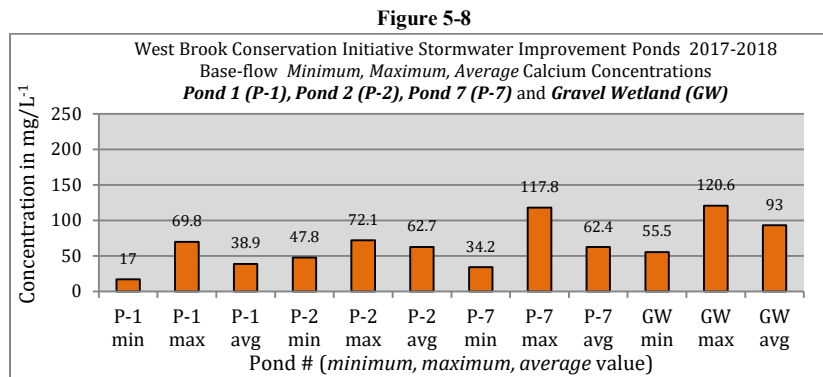
The wide range of *minimum* and *maximum* concentrations exhibited by **sodium** and **chloride** discussed above is not apparent with **calcium**, although there does appear to be a trend of increased *maximum* values in **Pond 7** and the **Gravel Wetland** at the end of the treatment chain.

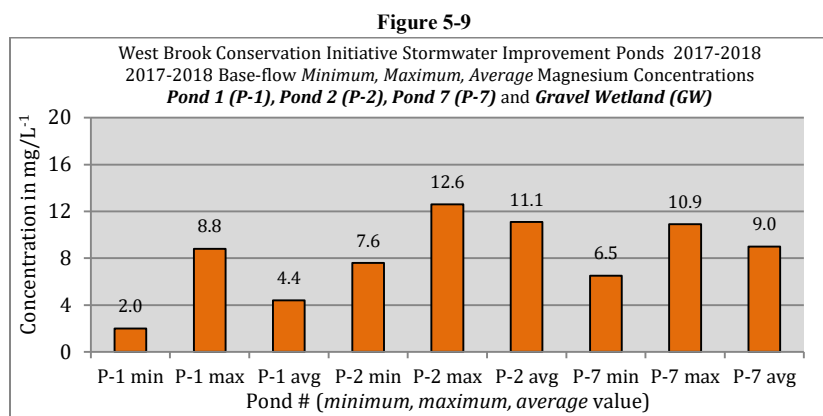
There is no distinct pattern of **magnesium** concentration among the 3 ponds when viewing the *minimum*, *maximum* and *average* values in Figure 5-9. The fact that all of the wetland ponds were sampled for highway runoff constituents beginning in May 2018 probably had some effect on the concentrations exhibited in the figure above because runoff from the winter 2017-2018 snowpack and snow-melt would accumulate in the ponds resulting in the high concentrations exhibited. It is likely that further dilution of **magnesium** would have been demonstrated if sampling of the wetland system had continued beyond September 2018.

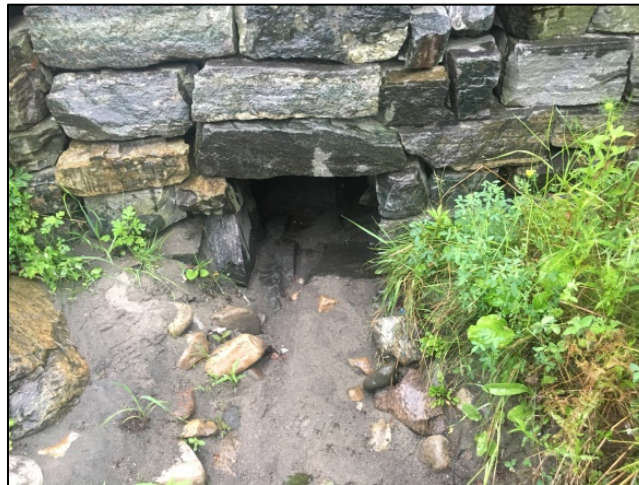
The outlet chamber consisted of a defined structure and solid stone bottom which provided good conditions for the manual collection of grab samples for chemistry and field measurements and manual gaging of event discharge.

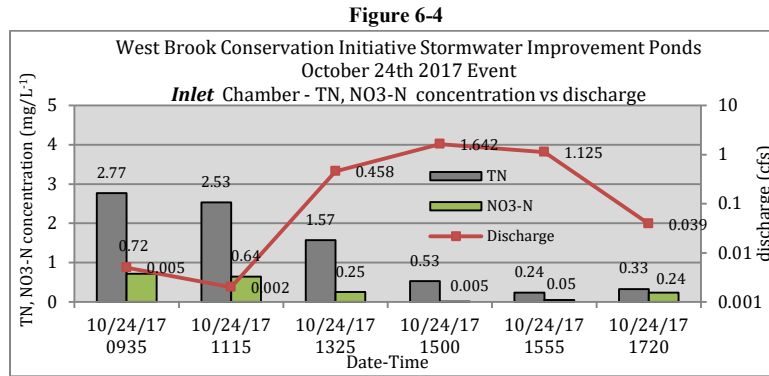
Discharge at the beginning of the runoff event was very low (0.005 and 0.002 cfs), so the first two samples collected represent the ‘first flush’ from the subcatchment when the highest concentration of **total nitrogen** and **nitrate-nitrogen** occurred. The same pattern occurred with **total phosphorus** and **total filterable phosphorus** as shown in Figure 6-5 below.

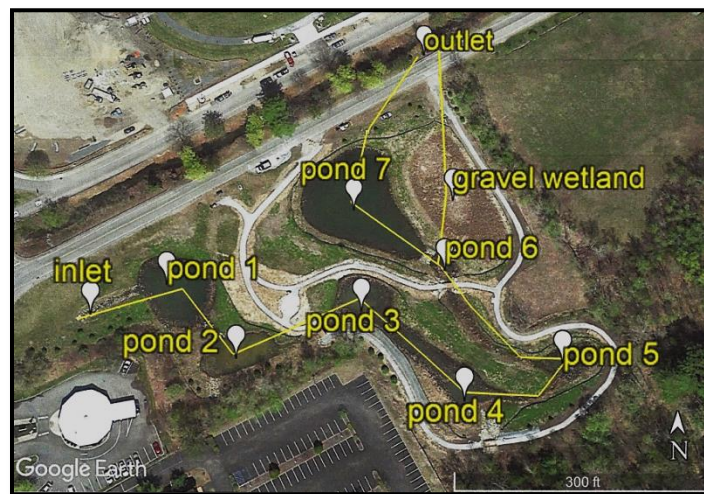
Figure 8-1

An aerial view of the West Brook Conservation Initiative Stormwater Improvement Ponds taken from Google™ Earth is shown in Figure 8-1.

The figure above traces the sequence of the wetland runoff treatment process from **Pond 1** through the series of succeeding ponds, with water finally discharging either to **Pond 7** or to the **Gravel Wetland**, depending upon the level of water in the area of the **Pond 6** weir.

The runoff from storm events enters the wetland complex via the *Inlet* chamber at the head of the treatment chain (see Figure 8-1), although there likely is a limited amount of sheet flow along the edges of the various ponds when the intensity of rainfall is high. The volume of water that enters the wetland system is a function of the amount of the precipitation event and/or the extent of snow-melt during winter warming periods or late spring. The volume of water entering *Pond 1* will mix with water in the pond to a certain extent and also will displace an equivalent volume of water to *Pond 2*, with a repeated effect down the treatment chain.

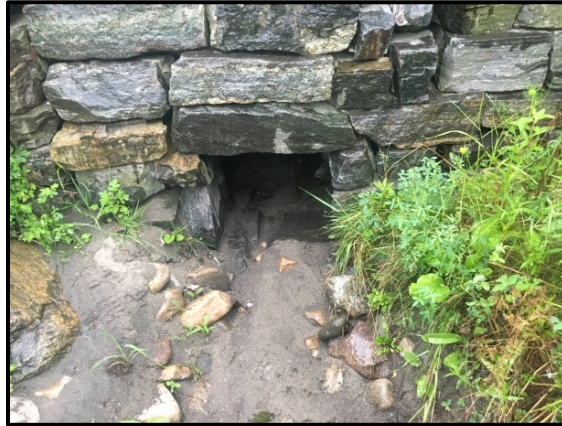
During dry, non-storm event periods, the *Inlet* chamber never exhibited any discharge to the outlet channel that conveys runoff to *Pond 1* in the wetland complex. Figure 8-2 shows the channel exiting the *Inlet* chamber during a non-storm event (dry) period.

This dry feature of the *Inlet* chamber during non-event periods confirms the fact that the subsurface drainage system that was constructed in the wetland subcatchment along Route 9 (Canada Street) to convey runoff to the wetland is a closed system that does not allow any infiltration of ground water in the immediate area.

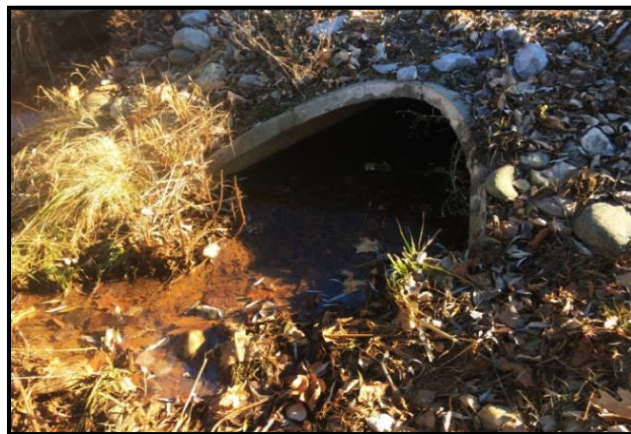
Figure 8-3

Efforts were made during the sampling Program to determine the amount of water continuously moving through the wetland complex as a result of ground water movement from higher elevations to the south. The *Pond 7* outlet culvert is shown in Figure 8-2.

The outlet channel was gaged 15 times during 2017; data collected during the manual gaging process were used to calculate discharge (in cfs and mgd) and these data were paired with the Telog recorder level data collected from the *Pond 7* outlet chamber for the same times that the gagings were performed to establish a rating curve that would define the discharge of water through this wetland component.

However, the outlet channel was poorly configured for manual gaging and 4 of the 15 channel gaging values were considered suspicious due to either very low discharge during the times that the gagings were performed or

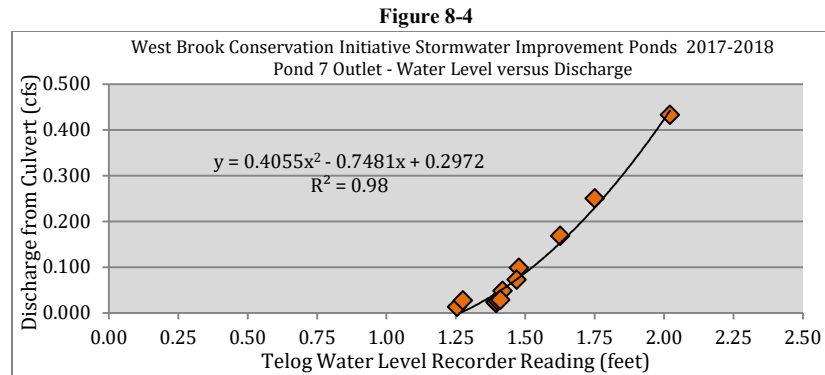
The relationship that links the **Pond 7** water level and discharge is a polynomial equation as follows:

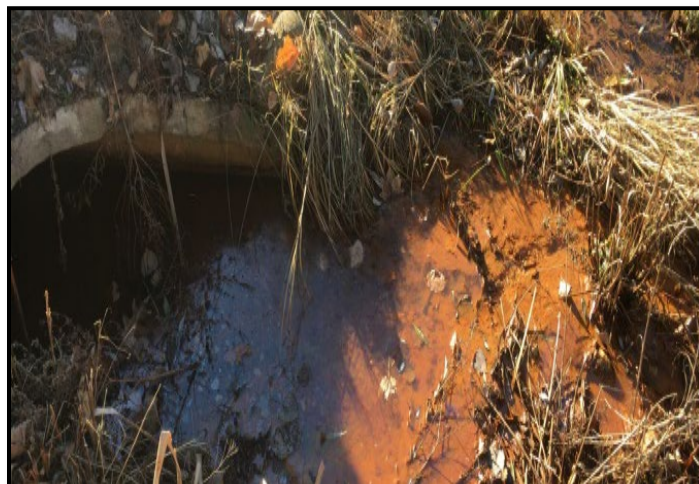
This device provides the second means for water to discharge from the wetland complex during base-flow conditions and during storm event periods when the water level in **Pond 6** rises above the level setting of the weir. Figure 8-5 shows the **Gravel Wetland** outlet culvert; note the abundance of oxidized iron precipitate in the channel.

This outlet channel was extremely difficult to gage manually because the channel constantly was choked with vegetation and oxidized iron precipitate (Figure 8-5), literally making accurate manual gaging very difficult to achieve and usually permanently staining any objects that came in contact with the oxidized material.

The *Gravel Wetland* outlet channel was gaged 8 times during 2017; data collected during the manual gaging process were used to calculate discharge (in cfs and mgd) and these data were paired with the Telog recorder level data collected from the *Gravel Wetland* outlet chamber for the same times that the gagings were performed to establish a rating curve that would define the discharge of water through this wetland component.

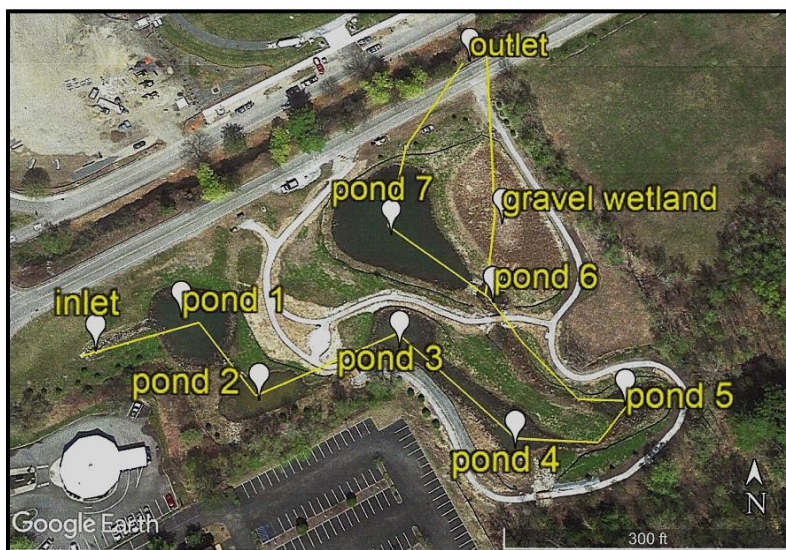
An aerial view of the West Brook CI SIP taken from Google™ Earth is shown in Figure 9-1. The view is looking from south to north and shows the different components of the wetland complex including **Pond 1**, **Pond 2** and the **Pond 7** and **Gravel Wetland** outlets which were sampled for base-flow chemistry during the Program. The **Inlet** chamber at the head of the wetland complex receives flow from the highly developed subcatchment that includes the Route 9 (Canada Street) corridor and was the location where storm events samples were collected during the 2017-2018 sampling program.

Figure 9-1 traces the sequence of the wetland treatment process for storm event discharge entering the system from the **Inlet** chamber to **Pond 1** and then through the series of succeeding ponds, with water finally discharging either to **Pond 7** or to the **Gravel Wetland**, depending upon the level of water in the area of the **Pond 6** weir. During dry (base-flow) conditions, however, water movement through the system is entirely dependent upon ground water flow which moves from higher elevation to the south (bottom of Figure 9-1) toward West Brook (top of Figure 9-1).
