SUNY
ADIRONDACK

Facilities Master Plan

February 2022

Site and Building Conditions Assessment

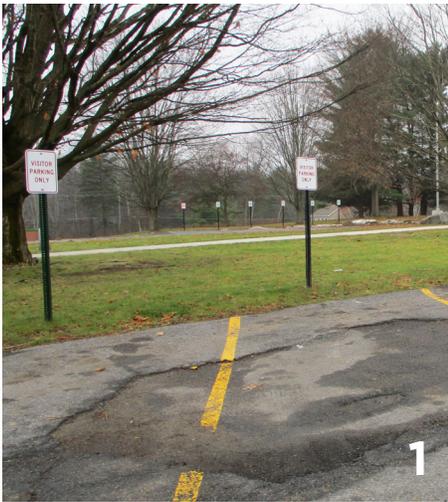
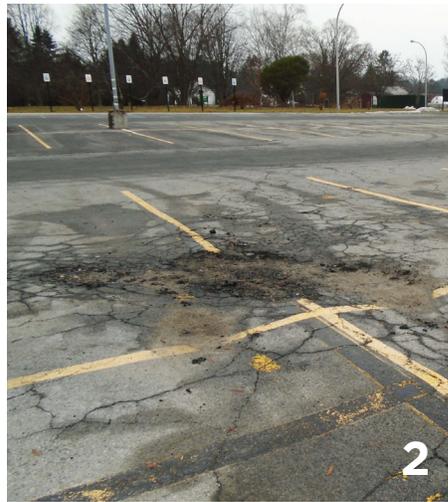
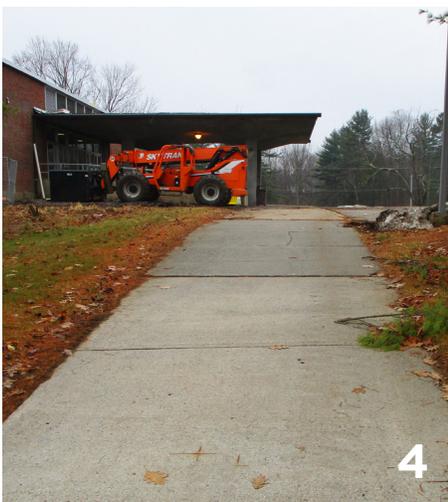
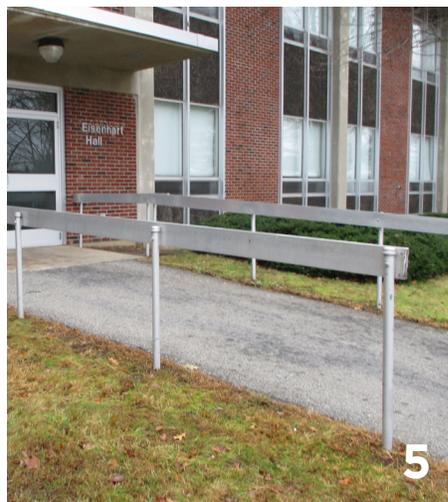
The asphalt drive at the main entrance and the asphalt loop at the gym are in poor condition with cracking and pitted surfaces. The asphalt surrounding the maintenance facilities is also in poor condition. On the south side of campus, there is reportedly a vehicular choke point at the access drive to the Maintenance Building and Child Care Center. In addition, it was reported that drivers occasionally drive along the north/south pedestrian pathway that connects academic buildings. There is an unimproved trail leading eastward from the athletic fields that appears to be an overgrown access drive, perhaps remaining from before the site was developed as a college.

Parking lots range from fair to poor condition. Limited areas are in good condition.

- All of Lot 6 is in poor condition (1).
- A portion of Lots 2, 3, and 7 are in poor condition. A portion of Lot 2 is deteriorating with upheaval, potholes, and large cracks in the asphalt (2).
- ADA parking spaces in Lot 5 exceed allowable cross slopes and there is no reserved parking signage (3).

- The steep walk in front of the Gymnasium from parking lot 6 exceeds ADA maximum recommended slope (4).
- Ramp at the west entrance of Eisenhart Hall does not meet ADA requirements for rail configuration (5).
- The asphalt walks, site walls, and gravel road north of the Student Center are in poor condition.
- Stairs located outside Dearlove are in poor condition.
- Hardscape is used for maintenance vehicle access campus-wide. In areas where walks are too narrow to accommodate the College's full-sized pickup trucks, the edges of the walks are rutted and muddy (6).
- Walks on the north end of campus are in excellent condition.
- Areas of insufficient sight lighting were noted in a campus security study conducted by others (marked 17 on site analysis diagram).

- Install removable bollards to prevent unauthorized vehicular use of walks.
- Remedy erosion at the sanitary manhole adjacent to the maintenance yard.
- Repair or replace damaged asphalt campus wide.

- Where possible, adjust slopes at walks and parking areas where ADA-recommended maximum slopes are exceeded.
- Continue to update exterior signage.
- Continue to upgrade landscape seating, lighting, and trash receptacles.

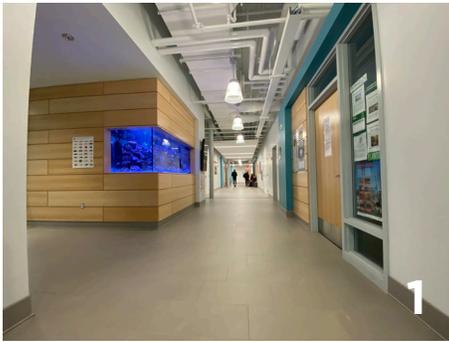
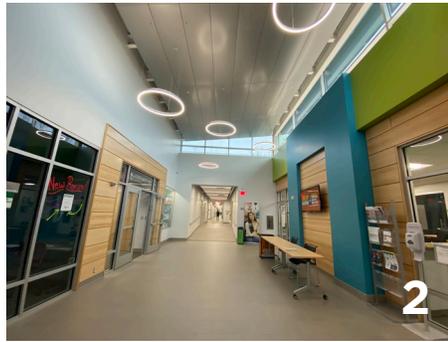
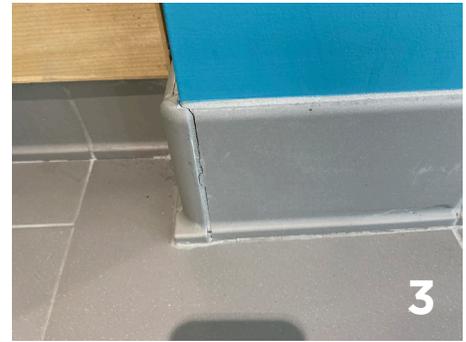
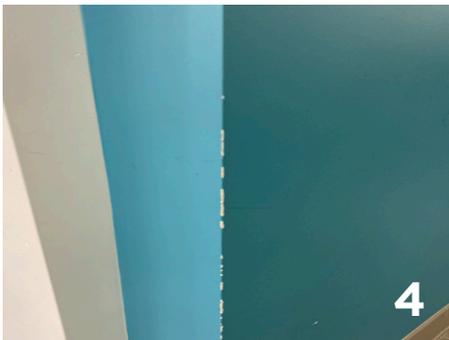
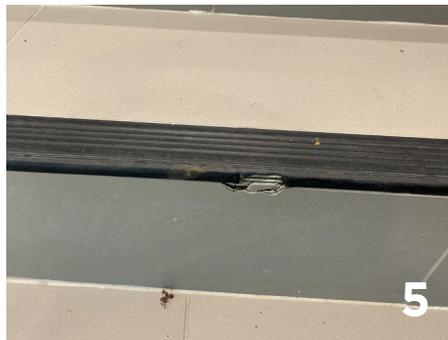
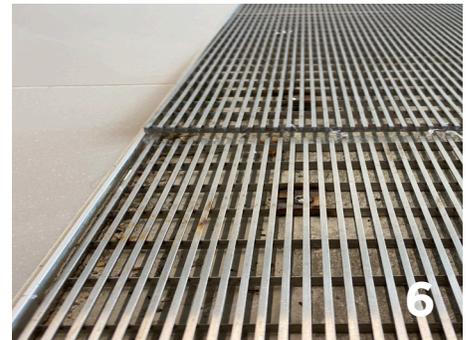
- The adhesive on felt acoustical panels/tack surfaces has failed. In some locations, the felt trims are completely missing.

- Persist with ongoing calibration of lighting sensors and HVAC systems.
- Remedy the failure of adhesive on the felt panels. The trim pieces have shrunken; even if re-affixed they would not fit the panels. It is recommended that the manufacturer be contacted and offered an opportunity to correct this defect. Trims of another material, such as hardwood, would be a durable solution.
- Address the minor wear-and-tear damage to walls, stair treads, and walk-off grates.
- Install films on portions of the office interior windows to provide visual privacy. This work is reportedly in progress.
- Provide gaskets at the glass office doors to isolate sound.

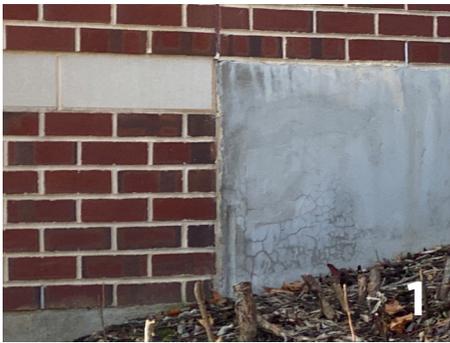
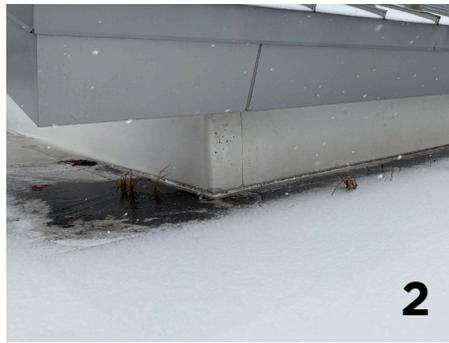
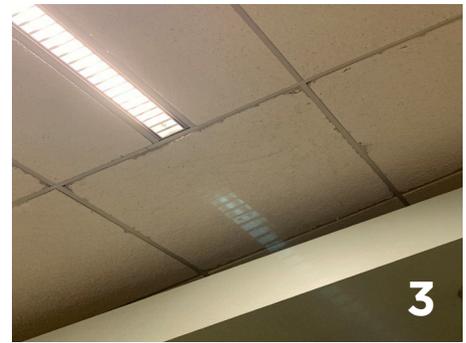
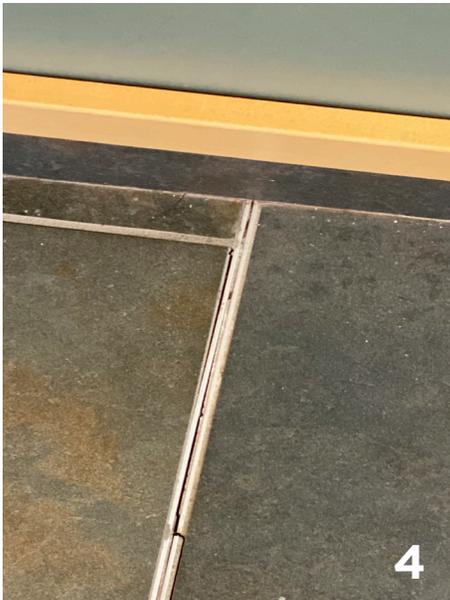
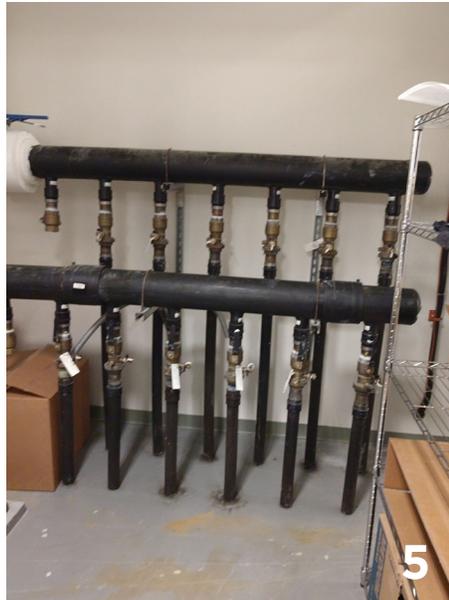
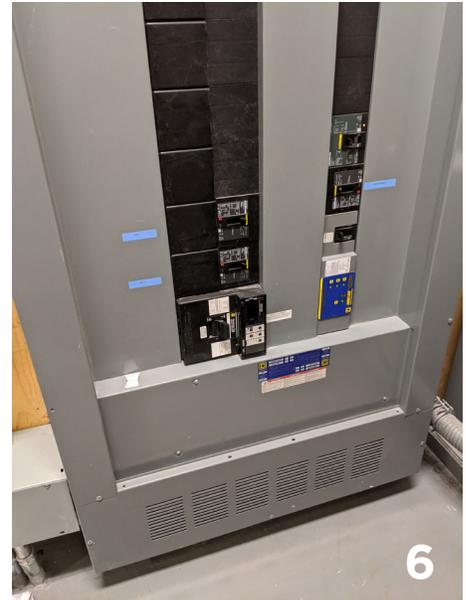
- Minor cracks are present in the parge coat at foundation levels (1).
- There is pooling, built up debris, and some vegetation growth on the roof (2).

- The edges of some ceiling tiles are beginning to degrade (3).
- There is a small crack at a joint in the tile floor (4).

The ground-source heat pump system and the VENMAR CES dedicated outdoor air system with an energy recovery wheel for building ventilation were reported to be in good condition (5). No repairs or replacements are required at this time.

Continue regular maintenance to preserve the good condition of this building. Replace damaged ceiling tiles with attic stock or matching tiles from the original manufacturer. Repair minor cracks in tile grout.

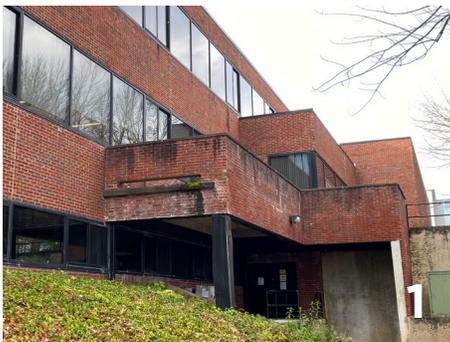
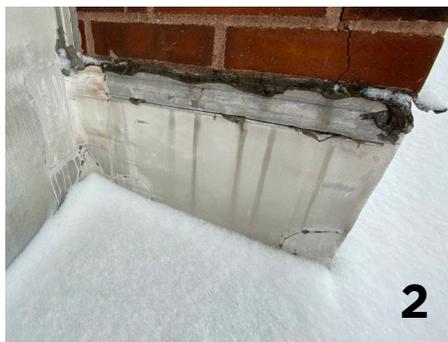
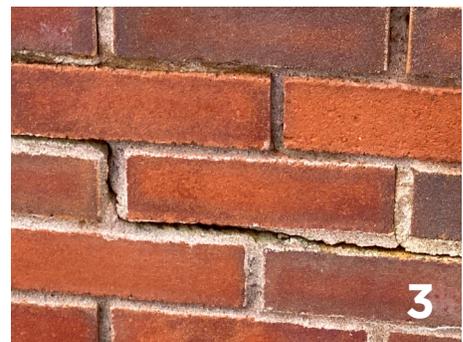
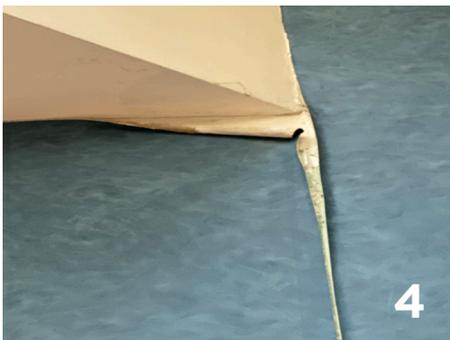
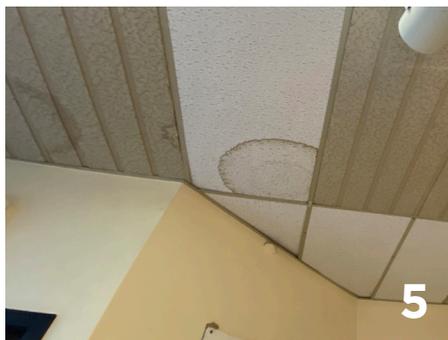
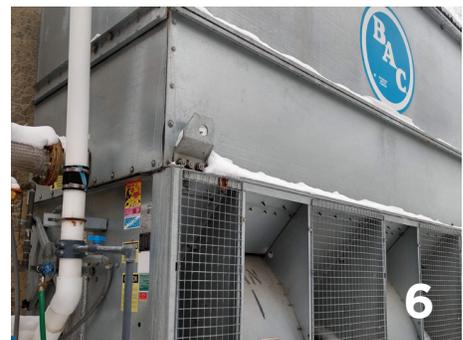
- Over time mildew and algae have accumulated on the brick masonry. The northern section around the loading dock does not receive direct sunlight and as a result is the most severely affected (1).

- There are areas around the building and on the roof where sealant is cracked and deteriorated (2).
- There are several areas where mortar is cracked, which could introduce water into the wall system and affect structural integrity over time (3).

- Several floor and wall finishes, such as the wall paper and vinyl flooring, are scuffed or peeling (4).
- Finishes in high traffic areas have sustained damage from repeated impact of desks, chairs and other equipment. Built in fixtures, such as the lockers on the second floor and the washing stations in the art rooms, show substantial wear and tear.
- Ceiling tiles have been damaged by water and impact (5). Over time, mismatched tiles have been installed to replace damaged ones.
- There are several areas where carpet is worn, stained, frayed, or torn.

- Comprehensive accessibility improvements
- Updates to finishes and lighting
- Addition of room-darkening shades to reduce glare
- Strategic upgrades of aging mechanical and electrical systems to improve operating efficiency
- Repair superficial cracks in masonry to prevent further deterioration. Areas of severe through-wall cracks in masonry should be remediated professionally under guidance of an architect and engineer.

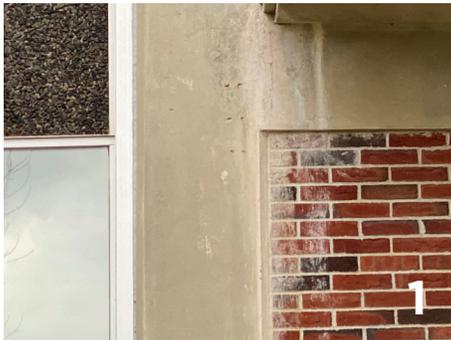
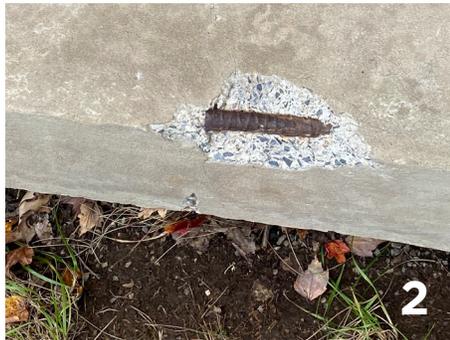
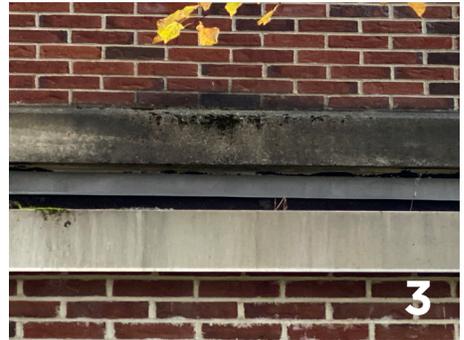
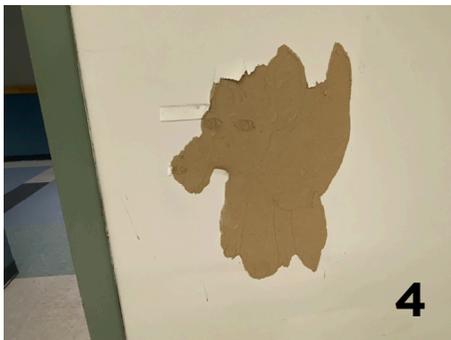
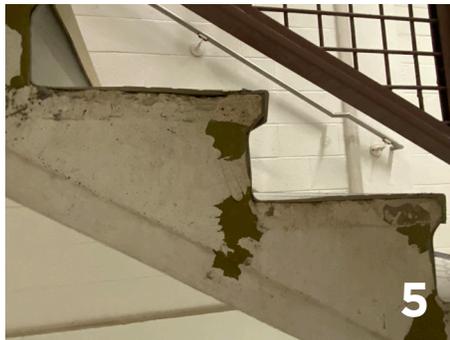
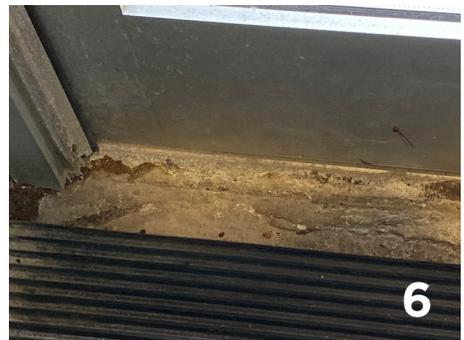
- Exterior concrete structural elements and overhangs are cracked, which has allowed moisture into the structural system. As a consequence, spalling has occurred. Exposed steel reinforcing is present in many locations. Weakened concrete can fall from the building, which is a safety concern (1, 2).
- Black mildew stains are present on exterior masonry walls. Sometimes, such stains are merely cosmetic. However, their location at the bottoms of wall cavities at Eisenhart suggest possible persistent moisture within the wall system (3).
- Windows and spandrel panels are original to the building, are dated in appearance, and are not energy efficient.

- New Square D panelboards (8)
- Wall pack emergency lights
- Horizontal data cabling
- Simplex 4100U Fire Alarm Control Panel.

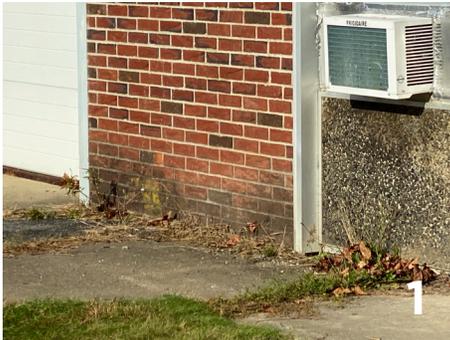
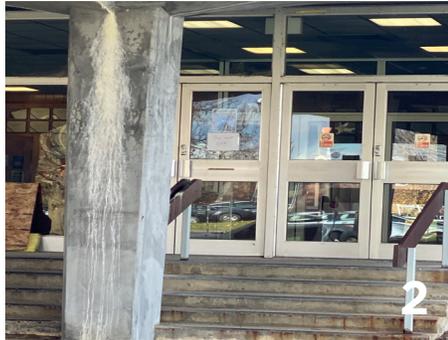
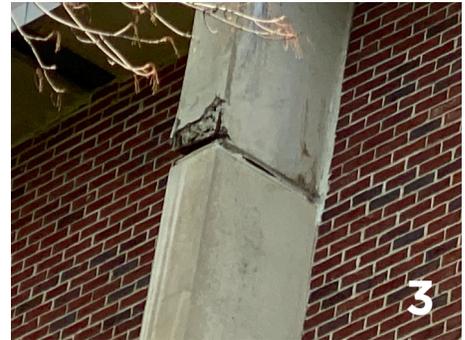
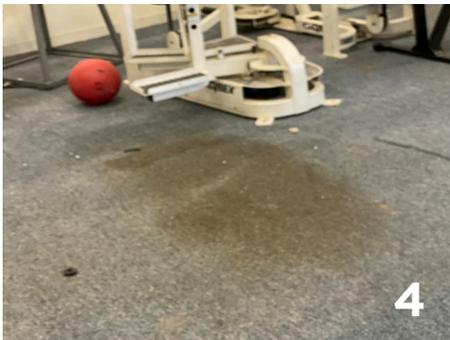
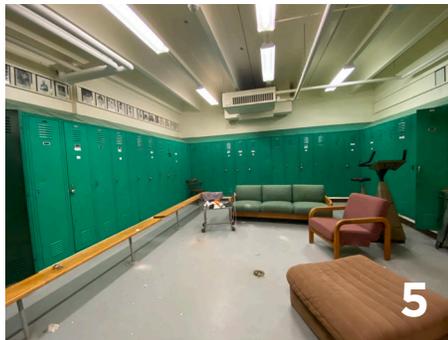
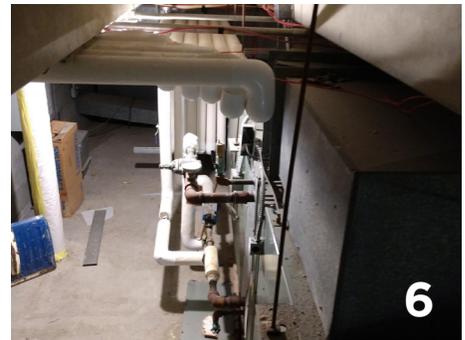
- Staining and algae around the building foundation suggest that there is not sufficient drainage away from the building. These areas likely remain wet for too long following rain storms or snow melt (1).
- Areas of severe efflorescence suggest persistent moisture within the concrete structural system (2).
- Exterior concrete structural elements and overhangs are cracked, which has allowed moisture into the structural system. As a consequence, spalling has occurred. Exposed steel reinforcing is present in many locations (3).
- The windows are in fair to poor condition and are not energy efficient. Occupants apply packing tape to prevent drafts.

- Acoustical tiles display water and impact damage. The ceilings in the team locker rooms are in disrepair. Pieces of the ceiling fall to the ground in chunks or

- The painted finish on locker room floors is chipping and peeling. The original resilient tile flooring in corridors is worn. There is rust on the tiles surrounding the showers.
- Carpet in several rooms is frayed, torn and stained (4).
- The furniture and built-in fixtures in the locker rooms including lockers, benches, couches and chairs are aging. Some are original to the building (5). Many of the lockers are damaged and several are no longer operable as a result of long-term use.

Except for the gymnasium itself, this building is heated by small, heating-only air-handling units all of which are in working order. There are two PK non-condensing gas-fired boilers in a boiler room which is separated from the remainder of the building (6). These boilers could be replaced by condensing gas boilers as an energy conservation measure. Although these boilers were installed when the campus was converted from electric to natural gas in the 1990's, they are not in good condition and should be considered for upgrade.

There is no sprinkler system in this building. The 100MBH, RBI, gas-fired, domestic water heater serves the showers and bathrooms in the building (7). The domestic hot water system was reported to need repairs. The primary water supply and waste removal systems are original to the building. Components could require replacement if a comprehensive renovation takes place. Updated fixtures could improve water efficiency.

The horizontal data cabling is the only electrical system reported to be in good condition. The fluorescent lighting, which does not have automatic controls, and the wall pack emergency lights are both in fair condition. The remaining GE switchgear and older GE panelboards are in poor condition (8).

- Inspect roofs, copings, flashings, and plumbing for potential sources of moisture within wall cavities that could lead to efflorescence. Remedy leaks, if any are discovered.
- Clean the walls where algae is present and apply a suppressant to prevent future accumulation. If comprehensive renovations take place, re-grade around the building to provide better drainage away from the foundation.
- Repair superficial cracks in concrete and masonry to prevent further deterioration. Areas of severe through-wall cracks in masonry and areas of spalling where structural steel is exposed should be remediated professionally under guidance of an architect and engineer.
- A comprehensive renovation, including addition of an elevator and complete renovation of the lower level, is required.
- Provide air conditioning.
- Due to assembly occupancy, consider adding sprinklers as a safety measure.

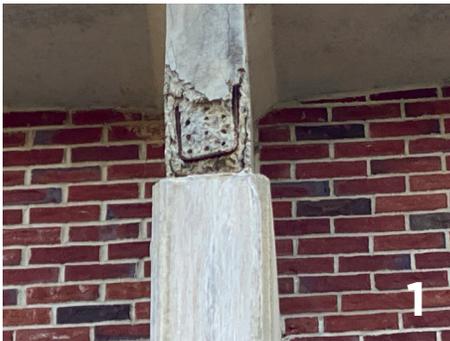
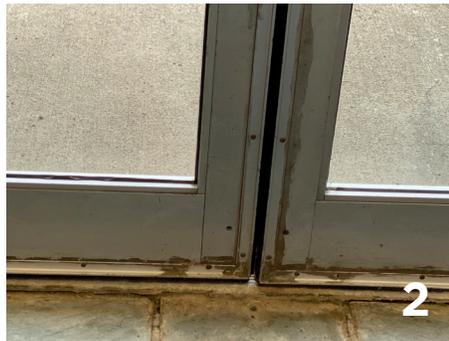
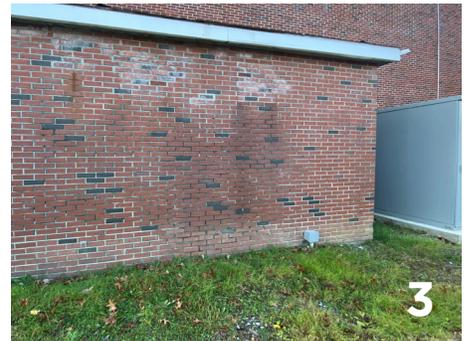
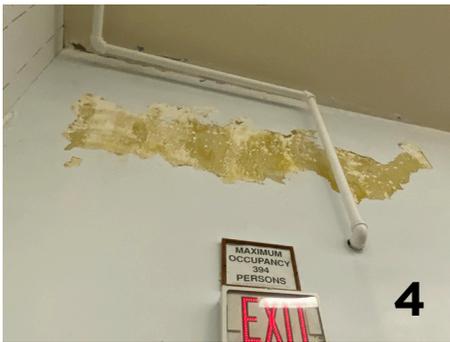
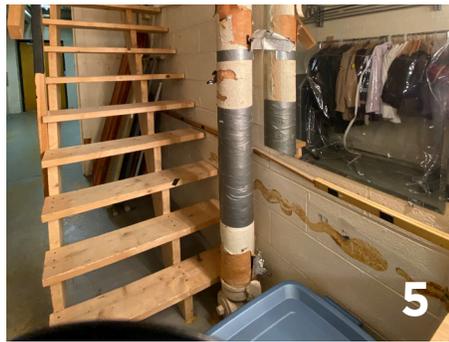
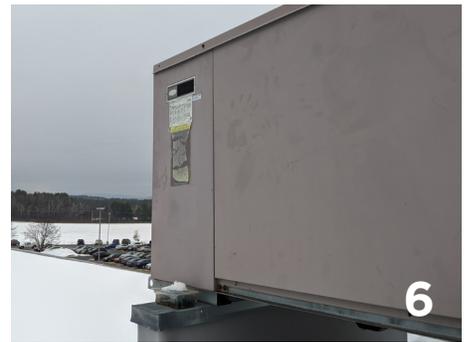
- Efflorescence, cracks, and spalling are present on concrete walls, overhangs, and structural elements. Weakened concrete can fall from the building, which is a safety concern (1).
- Vestibule doors are rusted (2). Door and window systems are inefficient and are at the end of their useful lives.
- Areas of efflorescence on exterior masonry walls suggests persistent moisture within wall cavities (3).

- The general level of finish is utilitarian and lacks the formality expected for college ceremonies and assemblies.
- Paint on the ceilings and walls is chipped and peeling in some locations (4).
- Broadloom carpet at the theatre entrance is wrinkled and stained.
- The stage and backstage areas in the Humanities Building are crowded with stored items.

- Several pipes have damaged insulation or lack insulation entirely (5).
- Music practice and instruction rooms have insufficient sound insulation.

A comprehensive renovation of the Humanities Building is required. The finishes should be upgraded and modernized. Space reconfiguration should address storage deficiencies, lack of modern performance equipment and support spaces, and poor sound isolation. Systems and components that are aging or no longer functional should be repaired or replaced.

Repair superficial cracks in concrete and masonry to prevent further deterioration. Areas of severe through-wall cracks in masonry and areas of spalling where structural steel is exposed should be remediated professionally under guidance of an architect and engineer.

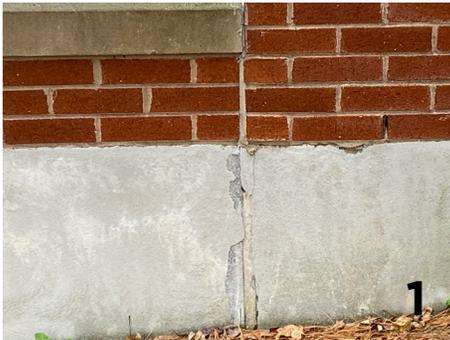
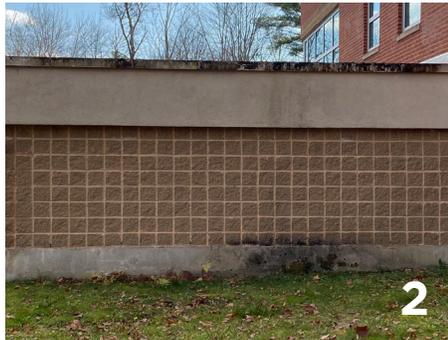
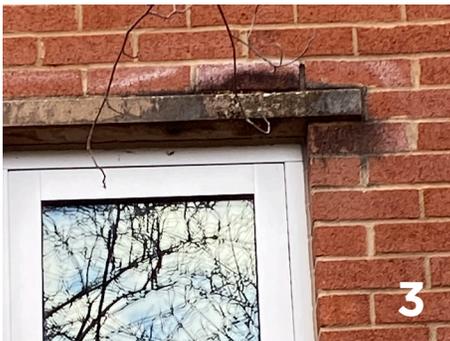
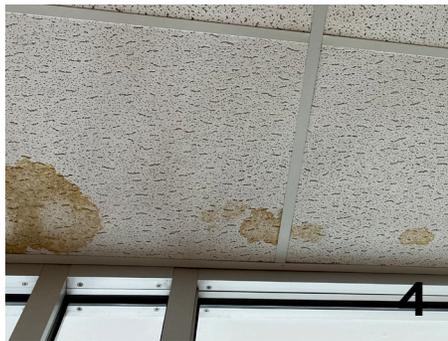
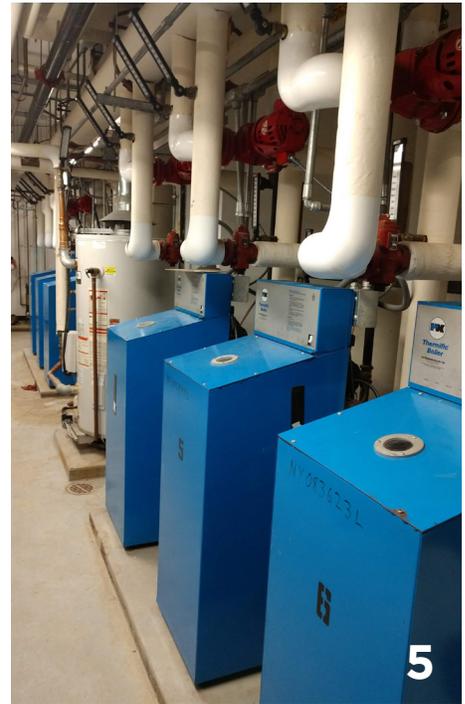
The exterior of Scoville Learning Center shows signs of moisture infiltration.

- Inspect roofs, copings, flashing, masonry, and plumbing for sources of moisture within wall cavities. Remedy leaks. Clean and repair damaged masonry and mortar.
- Clean exterior masonry of black mildew and algae and apply a suppressant to prevent future accumulation.
- Repair superficial cracks in masonry to prevent further deterioration. Areas of severe through-wall cracks in masonry should be remediated professionally under guidance of an architect and engineer.
- Provide vertical grab bars in the toilet rooms.
- Replace worn finishes.
- It was reported that noisy activities on the first floor disrupt the quiet study area on the second floor. Acoustical separation is needed.
- Users suggest updating finishes, furnishings, and presentation equipment in the Bishop Community Conference Center.

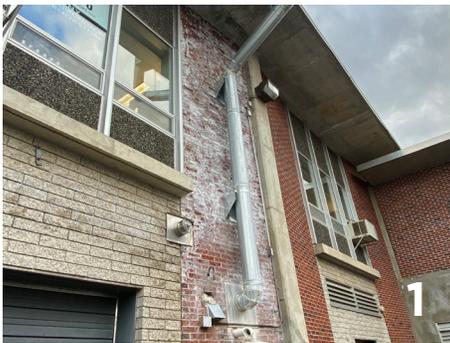
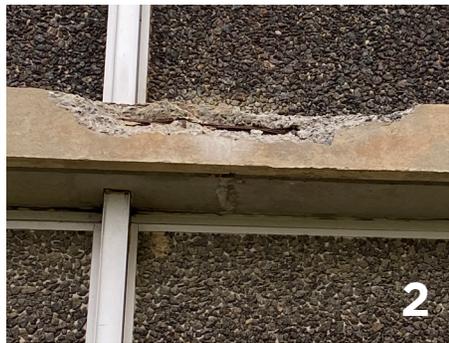
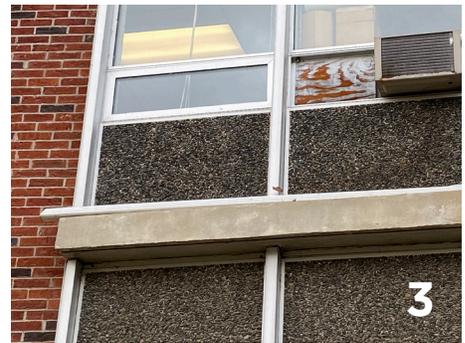
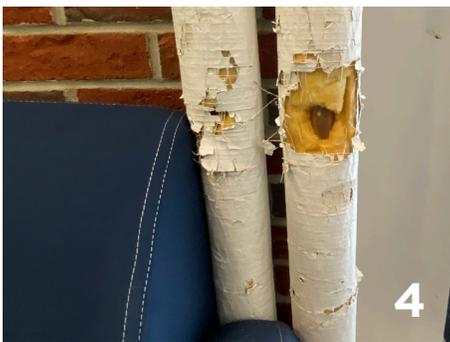
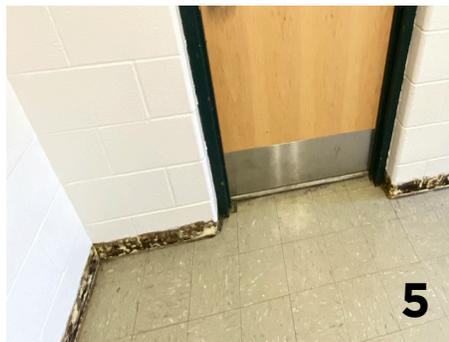
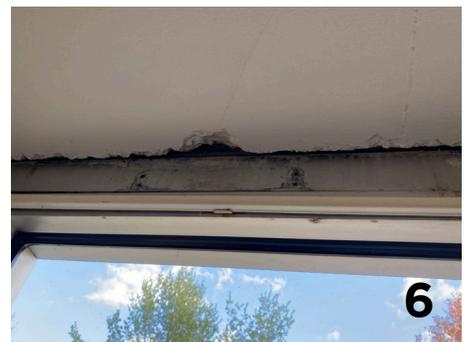
- Areas of efflorescence on exterior masonry suggest persistent moisture within wall cavities. Moist air is being forced through the north wall due to high humidity and temperature variation from the kitchen and dishroom (1).
- Exterior concrete structural elements and overhangs are cracked, which has allowed moisture into the structural system. As a consequence, spalling has occurred. Exposed steel reinforcing is present in many locations. Weakened concrete can fall from the building, which is a safety concern (2).
- Gutters along the roof edge are damaged and have been temporarily patched in certain locations (3).
- The building envelope exhibits signs of leaks which could become more frequent or cause permanent damage if not addressed:
- Water damage at exterior soffit.
- Ponding on roof and persistent reported leaks at roof penetrations.

- Exposed pipes have damaged insulation (4).
- High traffic has led to damage in areas such as stairwells and corridors. Scuffing on walls is present; sections of tile and rubber base are damaged or missing, leaving behind cracks or black adhesive at the bottom of some walls (5).
- Concrete surface voids were observed on several stair risers.
- Over time cracks have formed on mortar in isolated sections of interior CMU walls.
- On the main floor, there is significant damage to the gypsum board ceiling above one of the office windows, possibly due to condensation (6).
- Throughout the building, acoustic ceiling tiles are in good to fair condition. There are few instances where tiles have been damaged by water, cracking, or are beginning to sag.

The newer GE panelboards for partial electric distribution, automatic LED lighting, horizontal data cabling, and the Simplex 4100 ES Fire Alarm Control Panel are all in excellent condition. The Challenger panelboard and wall pack emergency lights were reported to be in good condition. The remaining 1500kVA unit and older GE panelboards are in fair to poor condition (8).

- Efflorescence on the north wall outside the kitchen is likely due to moisture from dish washing and cooking. Consult an engineer to add mechanical dehumidification to the space. Remove built-up efflorescence. During renovations, reconstruct the interior of the wall to replace the moisture barrier and prevent future moisture movement through the wall.

- Repair superficial cracks in concrete and masonry to prevent further deterioration. Areas of severe through-wall cracks in masonry and areas of spalling where structural steel is exposed should be remediated professionally under guidance of an architect and engineer.

- Interior elements such as gouged pipe insulation, cracked window sealant, damaged rubber and tile wall base, wall and floor scuffs, and broken or stained ceiling tiles should be replaced or repaired wherever damage is present.

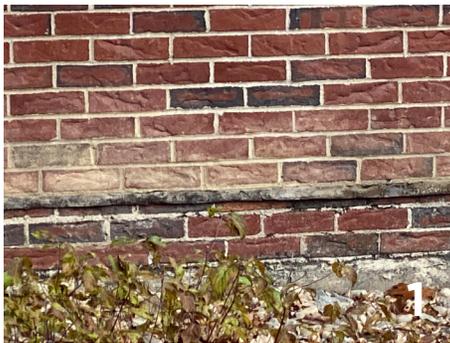
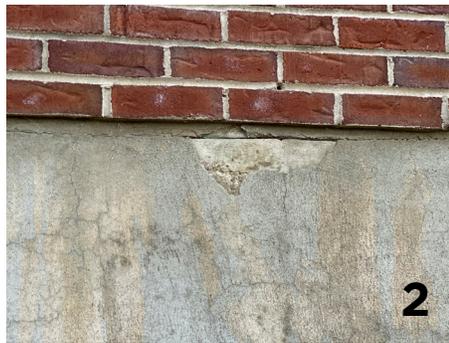
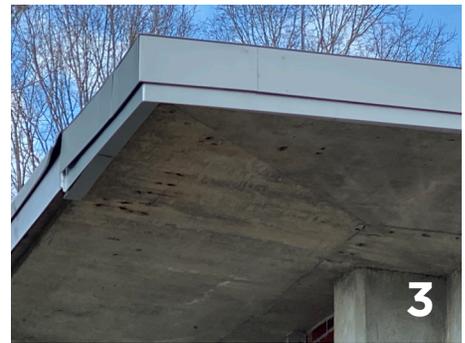
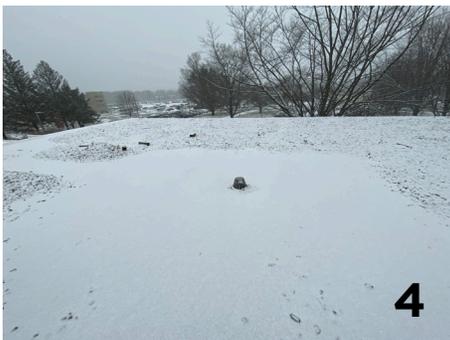
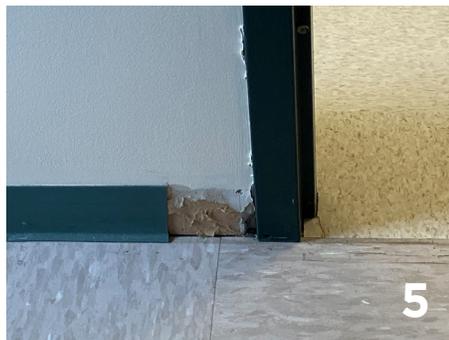
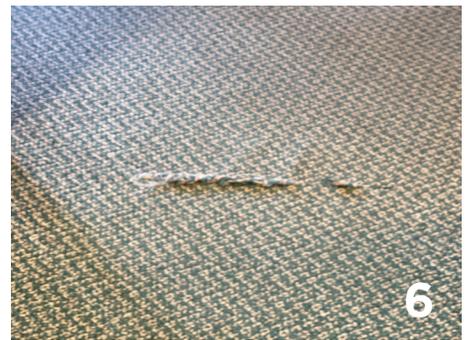
- Efflorescence (1) is present at the base of some masonry walls.
- Cracking in the parge coat at the foundation was observed (2).
- Some rust and discoloration is showing on concrete overhangs and structure, indicating moisture has infiltrated the structural system (3).
- At the building's southeast corner, metal coping and fascia cladding is incomplete (3).
- Sealant has begun to deteriorate around windows.
- Exterior doors are worn from weather and long term use.
- Areas where stone ballast has been moved on the roof indicate places where leaks have been reported (4). The roof on Warren Hall is in fair to poor condition and has led interior damage.

- Doors and frames are scuffed and damaged. Rubber bases are worn and or missing (5).
- The broadloom carpet is fraying or torn in several spots (6).

Domestic hot water for the building is provided by a 40 gallon A.O. Smith water heater, installed in 2008 (7) and does not require replacement or repair at this time. There is not a sprinkler system in this building. Plumbing fixtures have been recently updated, yet components of the plumbing system that are original to the building may be near the end of their useful lives. There is no toilet room on the ground level.

The Eaton panelboards for electrical distribution, LED lighting with automatic controls (9), and the horizontal data cabling are all in excellent condition. Wall pack emergency lights and the Simplex 4100U Fire Alarm Control panel are in good condition. The 600A Westinghouse distribution panelboard served a portion of the building and is in fair condition (8).

- Inspect roofs, copings, flashings, and plumbing for potential sources of moisture within wall cavities that could lead to efflorescence. Remedy leaks, if any are discovered.

- Repair superficial cracks in concrete and masonry to prevent further deterioration. Areas of severe through-wall cracks in masonry and areas of spalling where structural steel is exposed should be remediated professionally under guidance of an architect and engineer.

- The exterior doors that are rusted and showing signs of deterioration should be repaired or replaced.
- The basement requires comprehensive renovation.

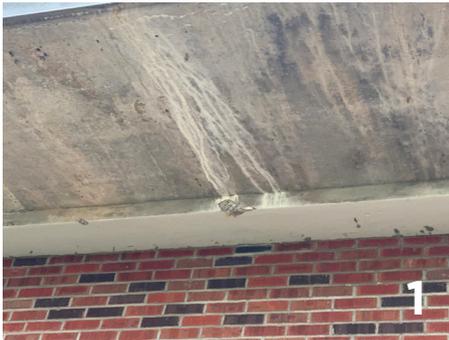
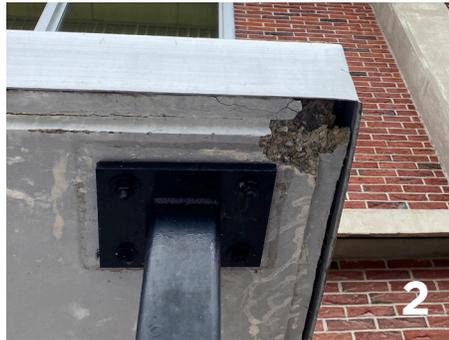
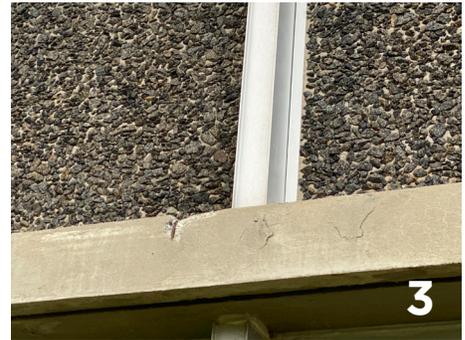
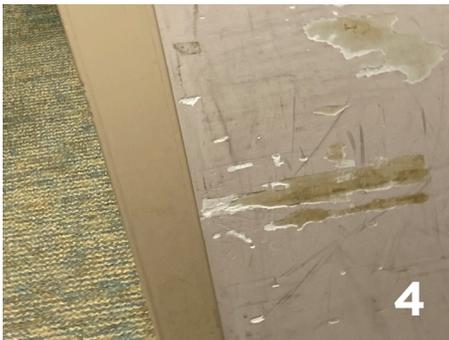
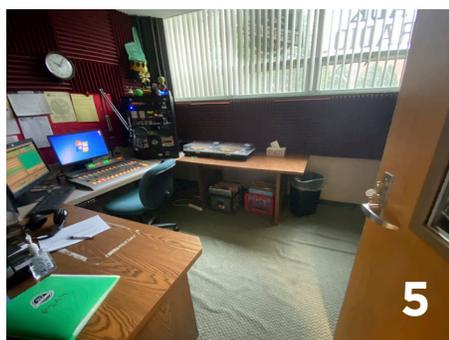
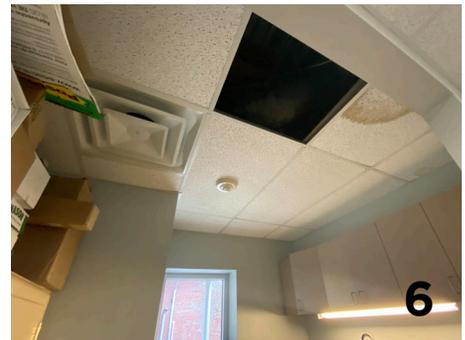
- Efflorescence, cracks and spalling are present on concrete overhangs and structure (1, 2, 3).
- Exterior concrete structural elements and overhangs are cracked, which has allowed moisture into the structural system. As a consequence, spalling has occurred. Exposed steel reinforcing is present in many locations. Weakened concrete can fall from the building, which is a safety concern.
- Windows and spandrel panels are original to the building, are dated in appearance, and are not energy efficient.

There are no reported problems with the gas-fired A.O. Smith water heater (8). There is no sprinkler system in this building. Some plumbing fixtures have been recently replaced, but the primary water supply and waste removal systems are original to the building. Components could require replacement if a comprehensive renovation takes place. Updated fixtures could improve water efficiency.

- Repair superficial cracks in concrete and masonry to prevent further deterioration. Areas of severe through-wall cracks in masonry and areas of spalling where structural steel is exposed should be remediated professionally under guidance of an architect and engineer.
- Windows and spandrel panels should be replaced with modern energy efficient units with thermal breaks.
- Update finishes, furnishings and lighting, except in recently renovated areas.
- Replace drinking fountains with modern units in accessible locations. Building users have requested bottle fillers.
- Toilet rooms should be renovated to include clear floor space, vertical grab bars, and sink pipe insulation.
- Replace non-compliant handrails in certain stairwells.
- Update signage.
- Replace remaining knob door hardware.

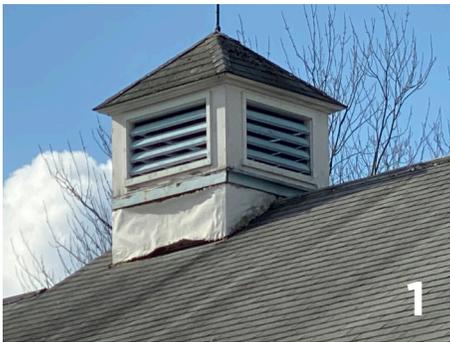
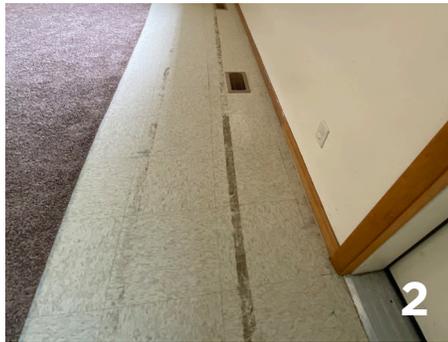
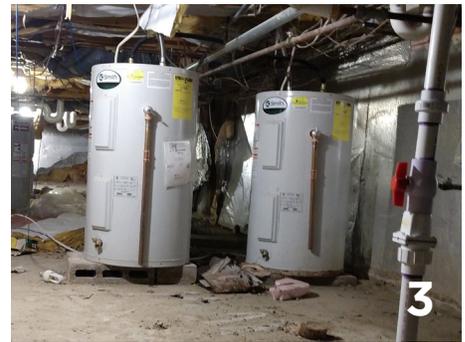
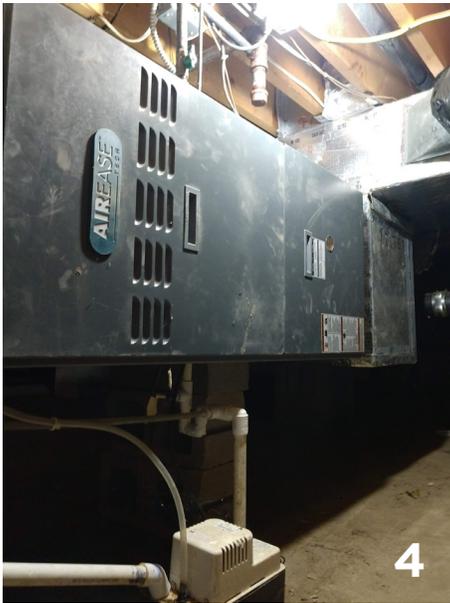
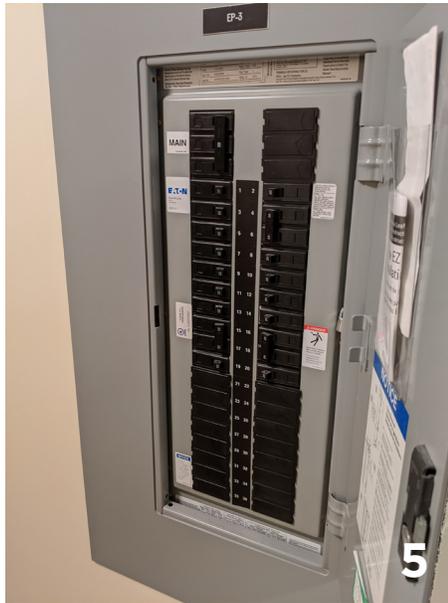
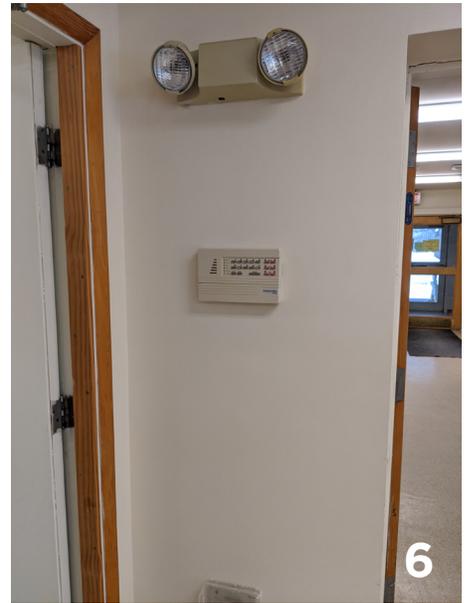
The decorative cupola is in poor condition (1). Vinyl siding on the rear of the building is mismatched to the addition. Tennis courts south of the building are raised, creating a berm at the edge of the playgrounds which sheds water toward the building.

The interior is in good condition. Adhesive was applied to the floor in one location and its remnants remain (2).

The Center is served by gas-fired furnaces in the basement crawl space that are in good condition (4).

The several small, electric domestic water heaters in the basement crawl space were installed in 2015 (3). They are in good condition. There is not sprinkler system in the building.

The Eaton or Square D panelboards for electrical distribution throughout the building is currently in excellent condition (5). Both the fluorescent lighting (without automatic controls) and the wall pack emergency lights are in fair condition (6). No problems were reported with the 90A feeder from the adjacent maintenance buildings. The lighting in the 2015 addition/renovation remains in good condition.

The toilet rooms in the 1998 and 1993 portions of the building lack vertical grab bars and sink pipe insulation, which is not compliant with the New York State Building Code or 2010 ADA Standards for Accessible Design. These minor deficiencies could be remedied by College staff.

Routine maintenance should continue on both the interior and exterior of this building. Modification to the toilet rooms such as installing vertical garb bars and sink pipe insulation would bring the facility into full compliance with accessibility standards.

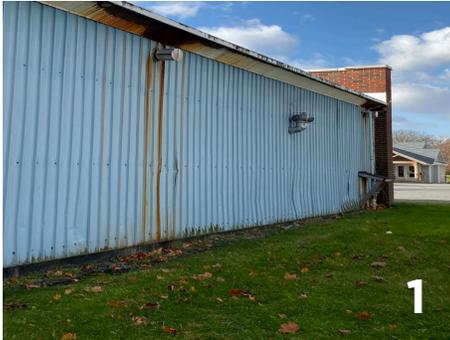
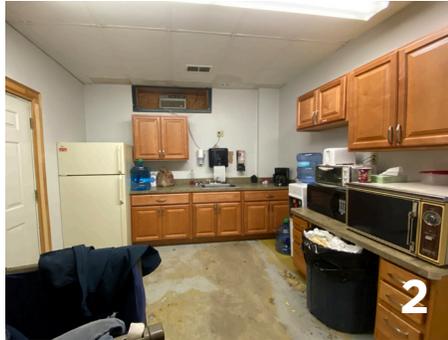
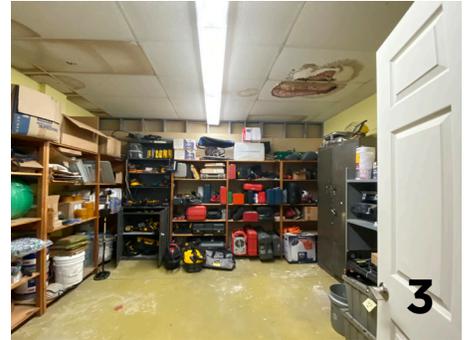
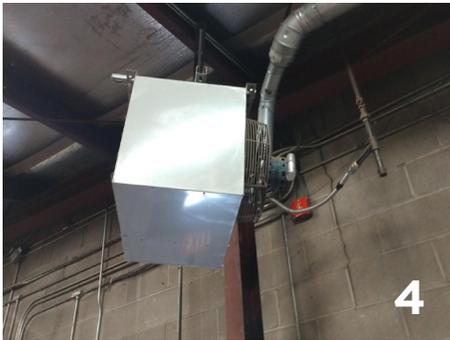
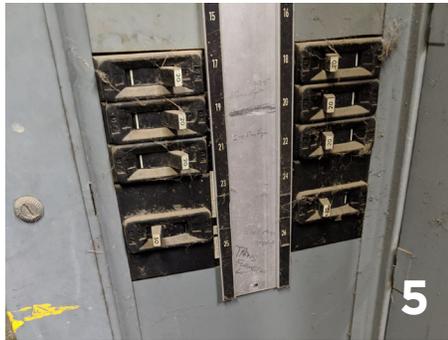
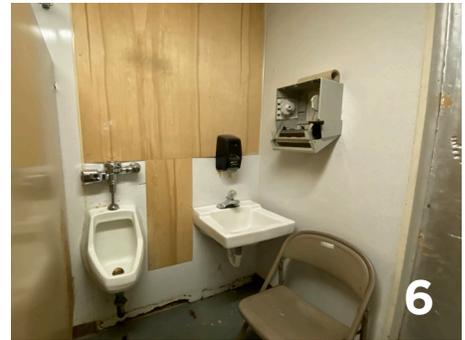
Exterior conditions of both Maintenance Buildings are fair to poor. Deterioration of the building envelope could expose the structural systems to moisture, prompting decay (1).

- Concrete floors throughout the building are in poor condition (2).
- Most of the acoustic ceiling tiles show signs of water damage, are sagging, cracked, or missing (3).
- Storage rooms are in poor condition, although shelving is sturdy and organized (3).
- There is a door that is blocked by the laundry machines.

The gas-fired and electrical unit heaters were not reported to require repairs at this time (4). There is no mechanical system for ventilation in these buildings. The only form of ventilation is natural, through the use of open windows or doors.

One of the buildings is served by a 175A Square D distribution panelboard in fair condition. The other building is served by a 175A Federal Pacific Electric distribution panelboard in fair to poor condition (5). Fluorescent lighting without automatic controls was generally observed to be in use throughout the buildings and is in fair condition. Local fire alarm devices were observed and are in good condition.

The toilet room is in poor condition and is not compliant with current ADA standards (6). Some corridors and passages are too narrow to provide adequate clear floor space at door push or pull sides.

The College's maintenance facility should be relocated to a site that is more suitable for loud, unsightly activities. The two structures are at the end of their useful lives and should be considered for demolition.
