JOINT MEETING of the  
WARREN COUNTY ECONOMIC  
GROWTH & DEVELOPMENT and  
HIGHER EDUCATION and  
FINANCE COMMITTEES and  
WASHINGTON COUNTY  
COMMUNITY COLLEGE and  
FINANCE COMMITTEES

## Facilities Master Plan

# SUNY Adirondack

640 Bay Road  
Queensbury, NY 12804

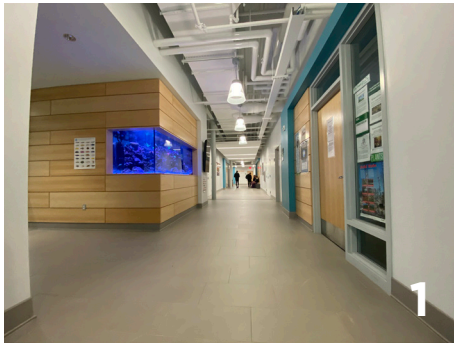
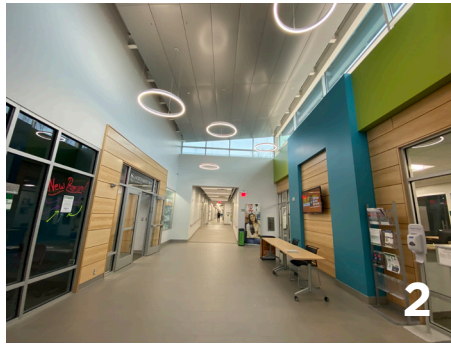
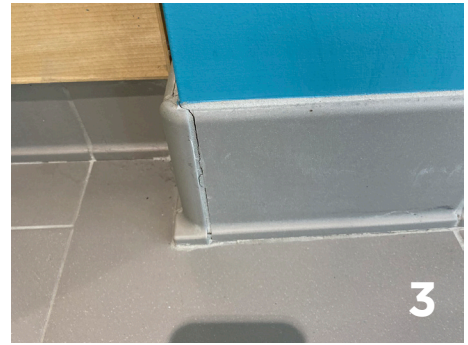
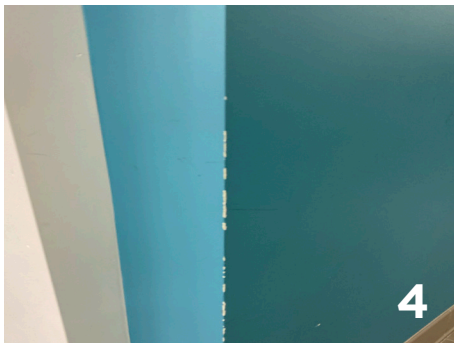
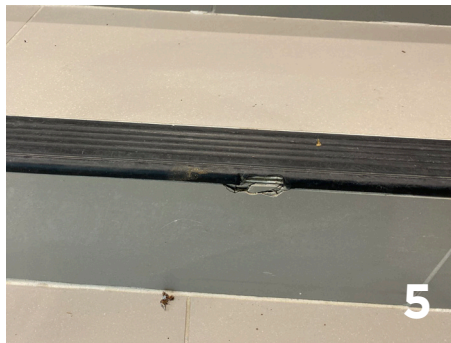
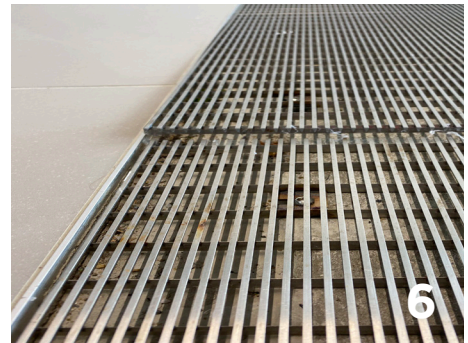
- The adhesive on felt acoustical panels/tack surfaces has failed. In some locations, the felt trims are completely missing.

- Persist with ongoing calibration of lighting sensors and HVAC systems.
- Remedy the failure of adhesive on the felt panels. The trim pieces have shrunk; even if re-affixed they would not fit the panels. It is recommended that the manufacturer be contacted and offered an opportunity to correct this defect. Trims of another material, such as hardwood, would be a durable solution.
- Address the minor wear-and-tear damage to walls, stair treads, and walk-off grates.
- Install films on portions of the office interior windows to provide visual privacy. This work is reportedly in progress.
- Provide gaskets at the glass office doors to isolate sound.

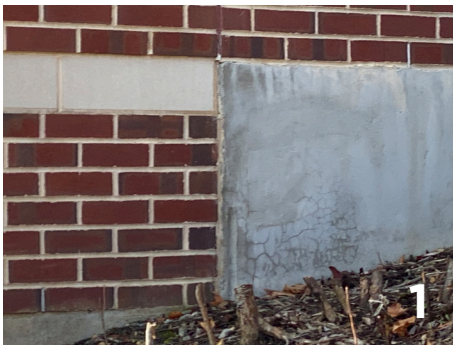
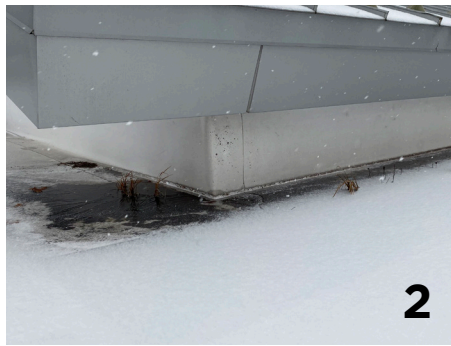
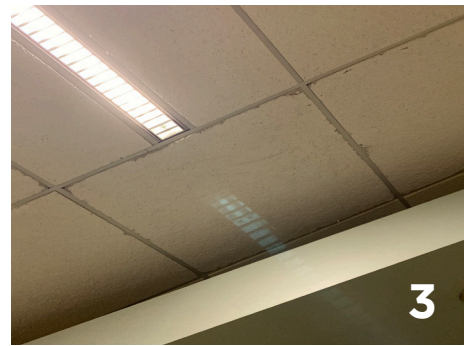
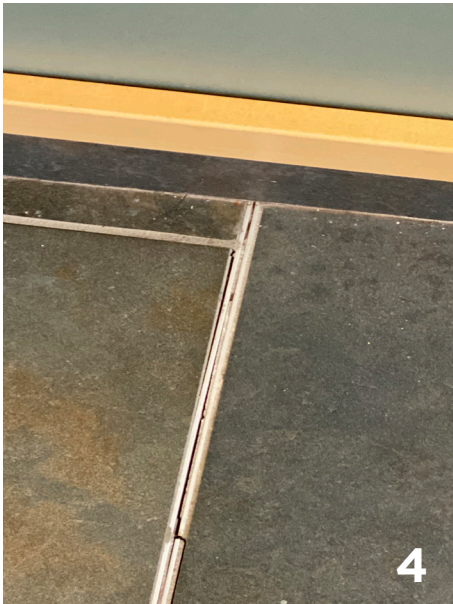
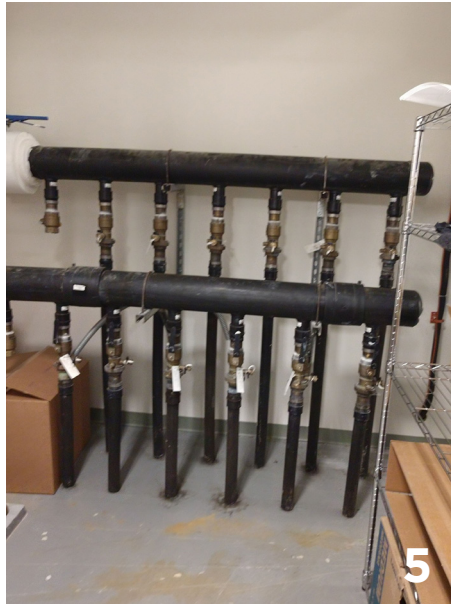
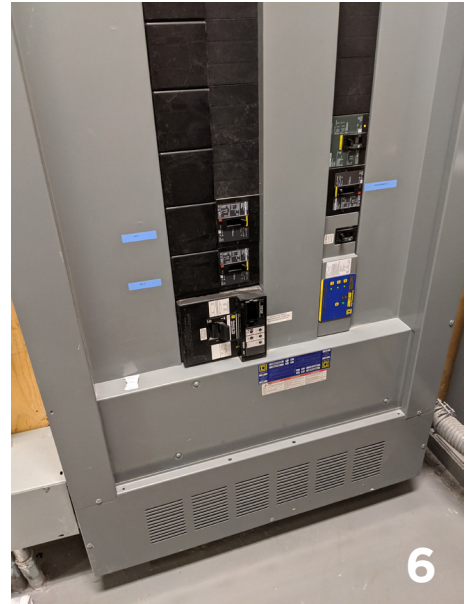
- Minor cracks are present in the parge coat at foundation levels (1).
- There is pooling, built up debris, and some vegetation growth on the roof (2).

- The edges of some ceiling tiles are beginning to degrade (3).
- There is a small crack at a joint in the tile floor (4).

The ground-source heat pump system and the VENMAR CES dedicated outdoor air system with an energy recovery wheel for building ventilation were reported to be in good condition (5). No repairs or replacements are required at this time.

Continue regular maintenance to preserve the good condition of this building. Replace damaged ceiling tiles with attic stock or matching tiles from the original manufacturer. Repair minor cracks in tile grout.

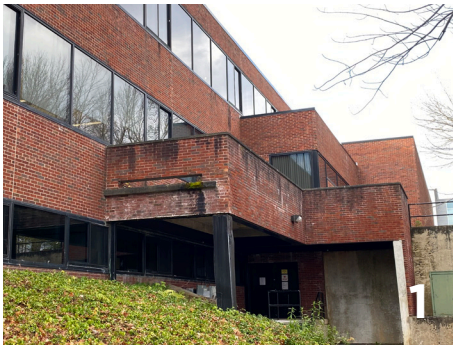
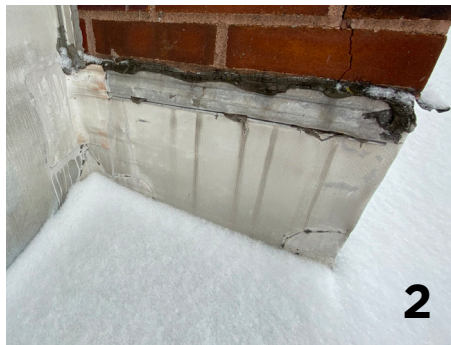
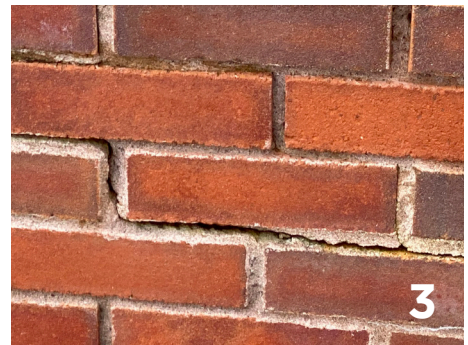
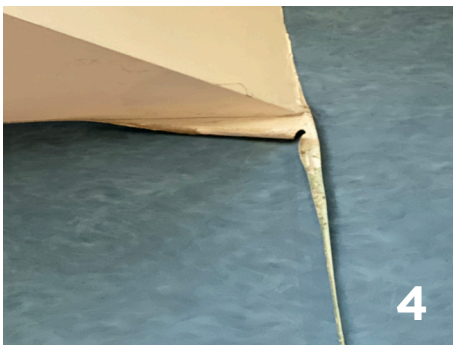
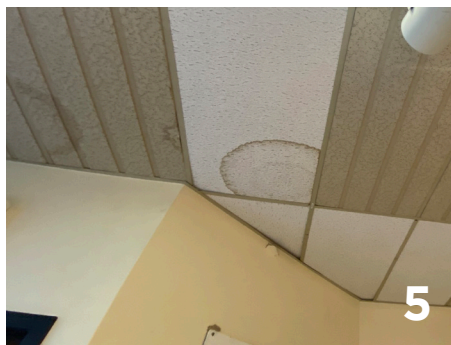
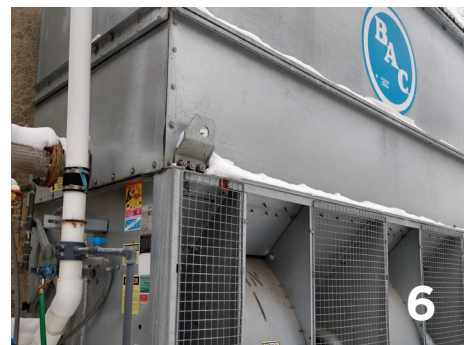
- Over time mildew and algae have accumulated on the brick masonry. The northern section around the loading dock does not receive direct sunlight and as a result is the most severely affected (1).

- There are areas around the building and on the roof where sealant is cracked and deteriorated (2).
- There are several areas where mortar is cracked, which could introduce water into the wall system and affect structural integrity over time (3).

- Several floor and wall finishes, such as the wall paper and vinyl flooring, are scuffed or peeling (4).
- Finishes in high traffic areas have sustained damage from repeated impact of desks, chairs and other equipment. Built in fixtures, such as the lockers on the second floor and the washing stations in the art rooms, show substantial wear and tear.
- Ceiling tiles have been damaged by water and impact (5). Over time, mismatched tiles have been installed to replace damaged ones.
- There are several areas where carpet is worn, stained, frayed, or torn.

- Comprehensive accessibility improvements
- Updates to finishes and lighting
- Addition of room-darkening shades to reduce glare
- Strategic upgrades of aging mechanical and electrical systems to improve operating efficiency
- Repair superficial cracks in masonry to prevent further deterioration. Areas of severe through-wall cracks in masonry should be remediated professionally under guidance of an architect and engineer.

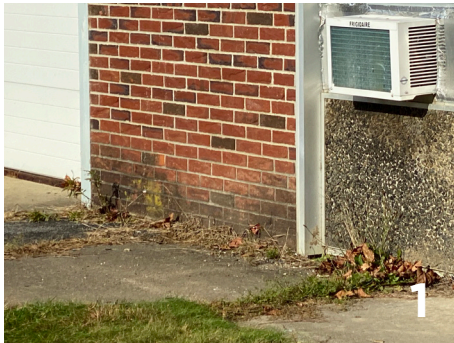
- Staining and algae around the building foundation suggest that there is not sufficient drainage away from the building. These areas likely remain wet for too long following rain storms or snow melt (1).
- Areas of severe efflorescence suggest persistent moisture within the concrete structural system (2).
- Exterior concrete structural elements and overhangs are cracked, which has allowed moisture into the structural system. As a consequence, spalling has occurred. Exposed steel reinforcing is present in many locations (3).
- The windows are in fair to poor condition and are not energy efficient. Occupants apply packing tape to prevent drafts.

- Inspect roofs, copings, flashings, and plumbing for potential sources of moisture within wall cavities that could lead to efflorescence. Remedy leaks, if any are discovered.
- Clean the walls where algae is present and apply a suppressant to prevent future accumulation. If comprehensive renovations take place, re-grade around the building to provide better drainage away from the foundation.
- Repair superficial cracks in concrete and masonry to prevent further deterioration. Areas of severe through-wall cracks in masonry and areas of spalling where structural steel is exposed should be remediated professionally under guidance of an architect and engineer.
- A comprehensive renovation, including addition of an elevator and complete renovation of the lower level, is required.
- Provide air conditioning.
- Due to assembly occupancy, consider adding sprinklers as a safety measure.

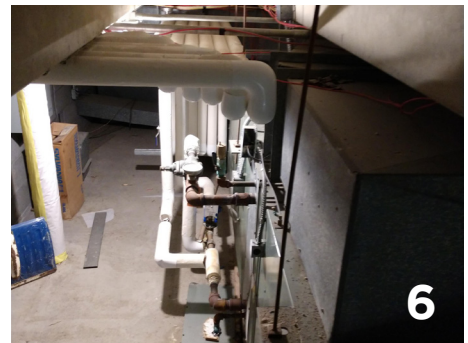
Except for the gymnasium itself, this building is heated by small, heating-only air-handling units all of which are in working order. There are two PK non-condensing gas-fired boilers in a boiler room which is separated from the remainder of the building (6). These boilers could be replaced by condensing gas boilers as an energy conservation measure. Although these boilers were installed when the campus was converted from electric to natural gas in the 1990's, they are not in good condition and should be considered for upgrade.

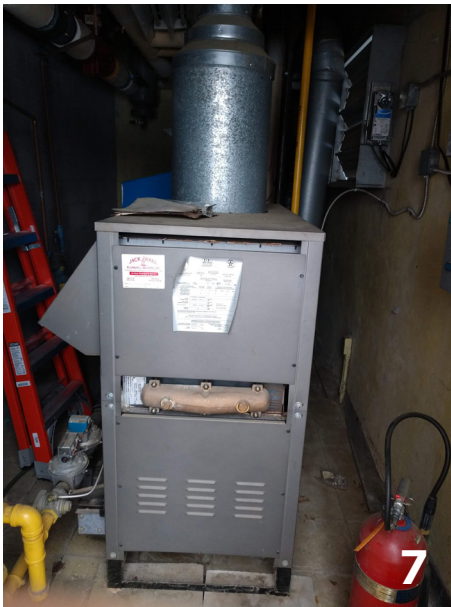
There is no sprinkler system in this building. The 100MBH, RBI, gas-fired, domestic water heater serves the showers and bathrooms in the building (7). The domestic hot water system was reported to need repairs. The primary water supply and waste removal systems are original to the building. Components could require replacement if a comprehensive renovation takes place. Updated fixtures could improve water efficiency.

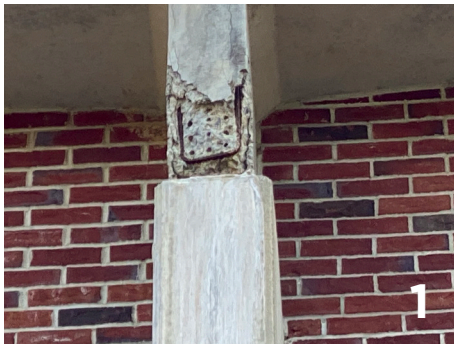
- Efflorescence, cracks, and spalling are present on concrete walls, overhangs, and structural elements. Weakened concrete can fall from the building, which is a safety concern (1).
- Vestibule doors are rusted (2). Door and window systems are inefficient and are at the end of their useful lives.
- Areas of efflorescence on exterior masonry walls suggests persistent moisture within wall cavities (3).

Repair superficial cracks in concrete and masonry to prevent further deterioration. Areas of severe through-wall cracks in masonry and areas of spalling where structural steel is exposed should be remediated professionally under guidance of an architect and engineer.

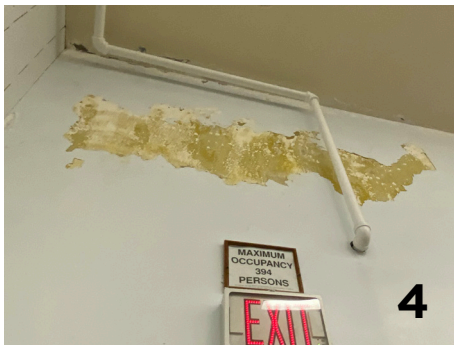
- The general level of finish is utilitarian and lacks the formality expected for college ceremonies and assemblies.
- Paint on the ceilings and walls is chipped and peeling in some locations (4).
- Broadloom carpet at the theatre entrance is wrinkled and stained.
- The stage and backstage areas in the Humanities Building are crowded with stored items.

A comprehensive renovation of the Humanities Building is required. The finishes should be upgraded and modernized. Space reconfiguration should address storage deficiencies, lack of modern performance equipment and support spaces, and poor sound isolation. Systems and components that are aging or no longer functional should be repaired or replaced.

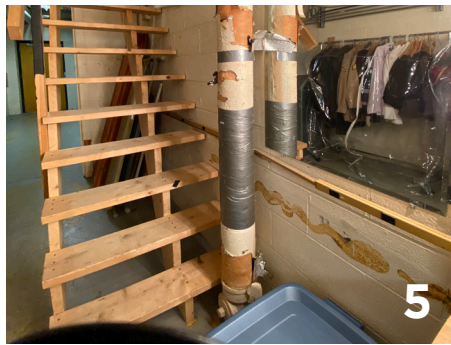
- Several pipes have damaged insulation or lack insulation entirely (5).
- Music practice and instruction rooms have insufficient sound insulation.

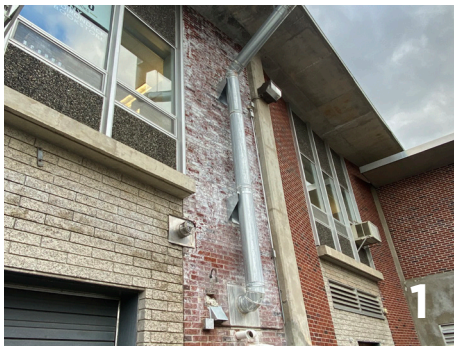
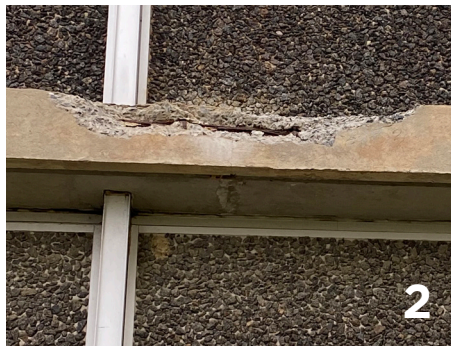
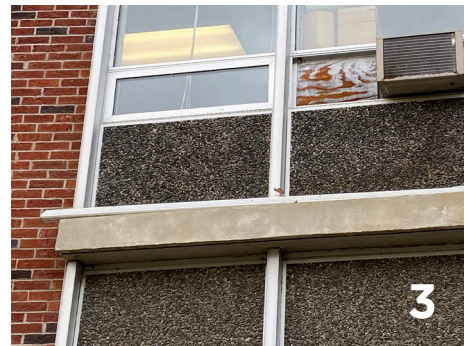
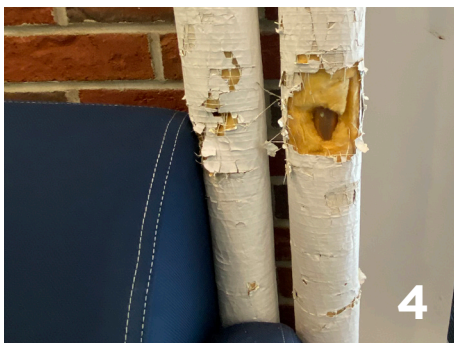
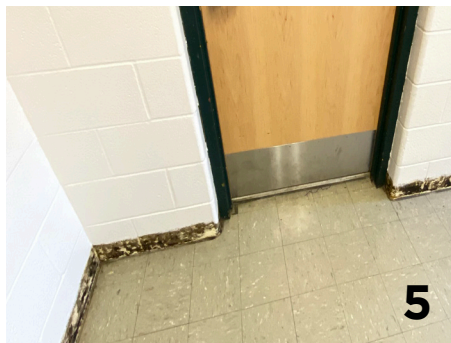
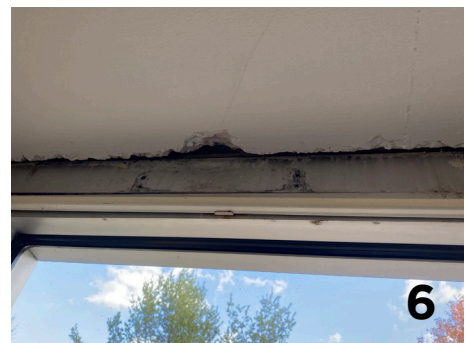
- Areas of efflorescence on exterior masonry suggest persistent moisture within wall cavities. Moist air is being forced through the north wall due to high humidity and temperature variation from the kitchen and dishroom (1).
- Exterior concrete structural elements and overhangs are cracked, which has allowed moisture into the structural system. As a consequence, spalling has occurred. Exposed steel reinforcing is present in many locations. Weakened concrete can fall from the building, which is a safety concern (2).
- Gutters along the roof edge are damaged and have been temporarily patched in certain locations (3).
- The building envelope exhibits signs of leaks which could become more frequent or cause permanent damage if not addressed:
- Water damage at exterior soffit.
- Ponding on roof and persistent reported leaks at roof penetrations.

- Exposed pipes have damaged insulation (4).
- High traffic has led to damage in areas such as stairwells and corridors. Scuffing on walls is present; sections of tile and rubber base are damaged or missing, leaving behind cracks or black adhesive at the bottom of some walls (5).
- Concrete surface voids were observed on several stair risers.
- Over time cracks have formed on mortar in isolated sections of interior CMU walls.
- On the main floor, there is significant damage to the gypsum board ceiling above one of the office windows, possibly due to condensation (6).
- Throughout the building, acoustic ceiling tiles are in good to fair condition. There are few instances where tiles have been damaged by water, cracking, or are beginning to sag.

The newer GE panelboards for partial electric distribution, automatic LED lighting, horizontal data cabling, and the Simplex 4100 ES Fire Alarm Control Panel are all in excellent condition. The Challenger panelboard and wall pack emergency lights were reported to be in good condition. The remaining 1500kVA unit and older GE panelboards are in fair to poor condition (8).

- Efflorescence on the north wall outside the kitchen is likely due to moisture from dish washing and cooking. Consult an engineer to add mechanical dehumidification to the space. Remove built-up efflorescence. During renovations, reconstruct the interior of the wall to replace the moisture barrier and prevent future moisture movement through the wall.

- Interior elements such as gouged pipe insulation, cracked window sealant, damaged rubber and tile wall base, wall and floor scuffs, and broken or stained ceiling tiles should be replaced or repaired wherever damage is present.

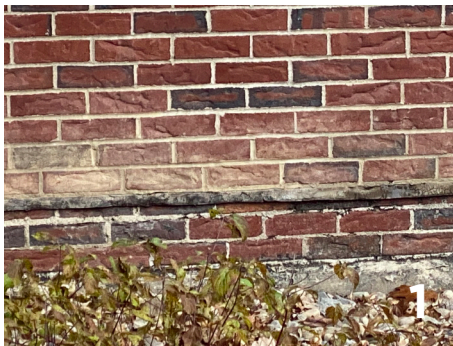
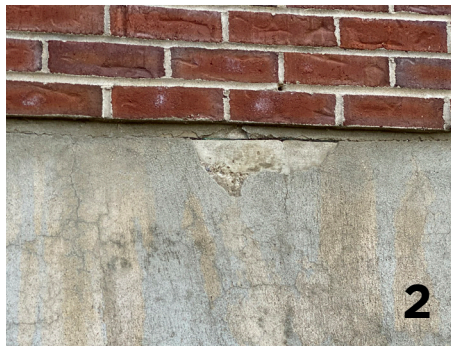
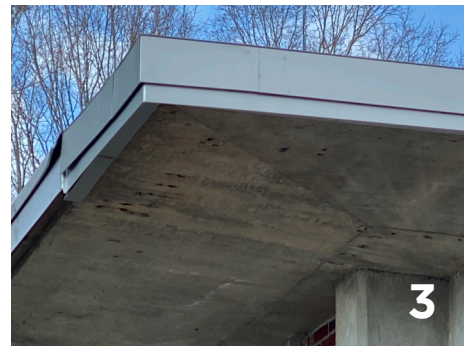
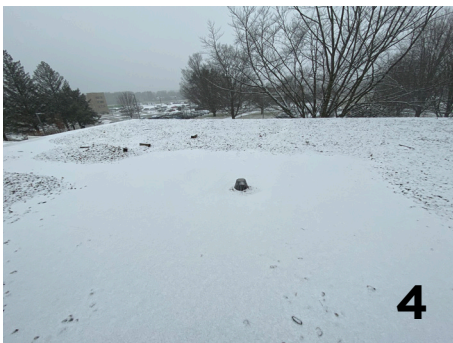
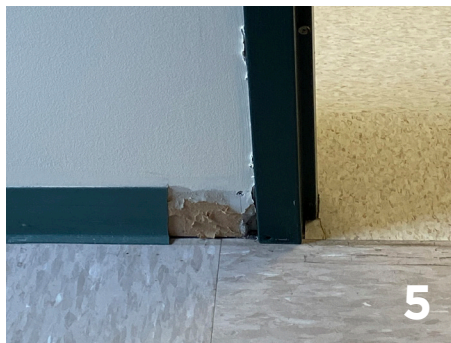
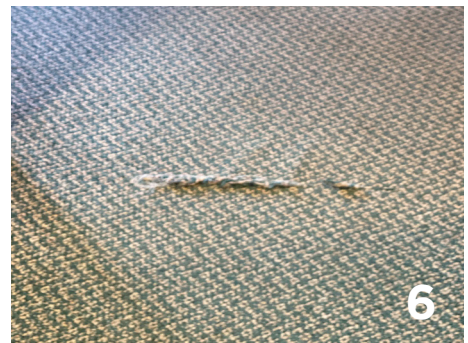
- Efflorescence (1) is present at the base of some masonry walls.
- Cracking in the parge coat at the foundation was observed (2).
- Some rust and discoloration is showing on concrete overhangs and structure, indicating moisture has infiltrated the structural system (3).
- At the building's southeast corner, metal coping and fascia cladding is incomplete (3).
- Sealant has begun to deteriorate around windows.
- Exterior doors are worn from weather and long term use.
- Areas where stone ballast has been moved on the roof indicate places where leaks have been reported (4). The roof on Warren Hall is in fair to poor condition and has led interior damage.

- Doors and frames are scuffed and damaged. Rubber bases are worn and or missing (5).
- The broadloom carpet is fraying or torn in several spots (6).

Domestic hot water for the building is provided by a 40 gallon A.O. Smith water heater, installed in 2008 (7) and does not require replacement or repair at this time. There is not a sprinkler system in this building. Plumbing fixtures have been recently updated, yet components of the plumbing system that are original to the building may be near the end of their useful lives. There is no toilet room on the ground level.

The Eaton panelboards for electrical distribution, LED lighting with automatic controls (9), and the horizontal data cabling are all in excellent condition. Wall pack emergency lights and the Simplex 4100U Fire Alarm Control panel are in good condition. The 600A Westinghouse distribution panelboard served a portion of the building and is in fair condition (8).

- Inspect roofs, copings, flashings, and plumbing for potential sources of moisture within wall cavities that could lead to efflorescence. Remedy leaks, if any are discovered.

- Repair superficial cracks in concrete and masonry to prevent further deterioration. Areas of severe through-wall cracks in masonry and areas of spalling where structural steel is exposed should be remediated professionally under guidance of an architect and engineer.

- The exterior doors that are rusted and showing signs of deterioration should be repaired or replaced.
- The basement requires comprehensive renovation.

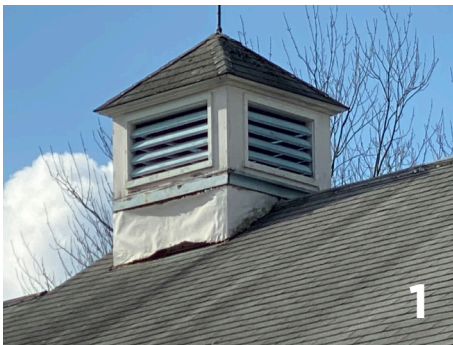
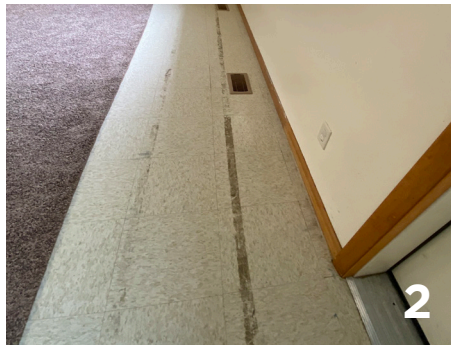
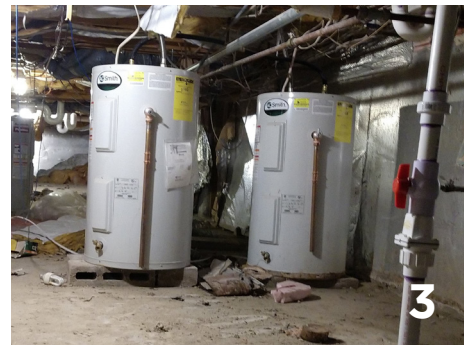
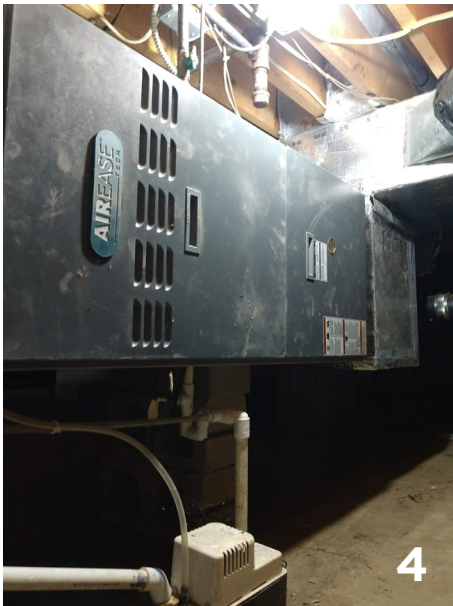
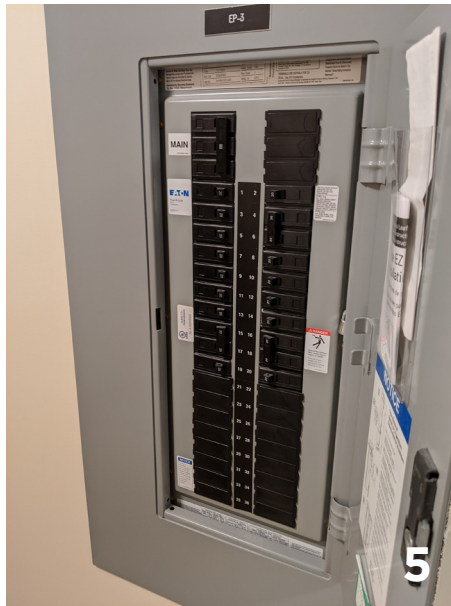
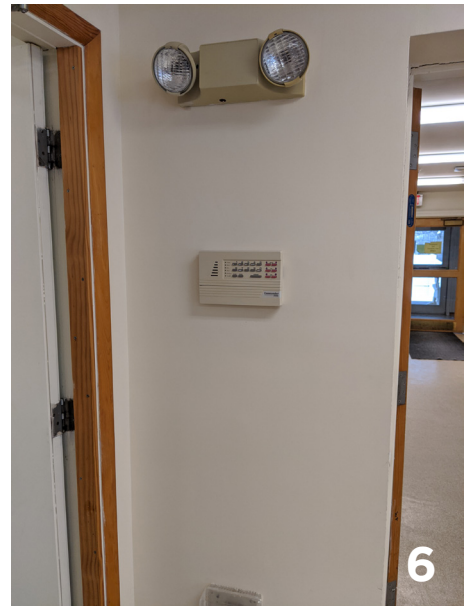
The interior is in good condition. Adhesive was applied to the floor in one location and its remnants remain (2).

The Center is served by gas-fired furnaces in the basement crawl space that are in good condition (4).

The several small, electric domestic water heaters in the basement crawl space were installed in 2015 (3). They are in good condition. There is not sprinkler system in the building.

The Eaton or Square D panelboards for electrical distribution throughout the building is currently in excellent condition (5). Both the fluorescent lighting (without automatic controls) and the wall pack emergency lights are in fair condition (6). No problems were reported with the 90A feeder from the adjacent maintenance buildings. The lighting in the 2015 addition/renovation remains in good condition.

The toilet rooms in the 1998 and 1993 portions of the building lack vertical grab bars and sink pipe insulation, which is not compliant with the New York State Building Code or 2010 ADA Standards for Accessible Design. These minor deficiencies could be remedied by College staff.

Routine maintenance should continue on both the interior and exterior of this building. Modification to the toilet rooms such as installing vertical garb bars and sink pipe insulation would bring the facility into full compliance with accessibility standards.

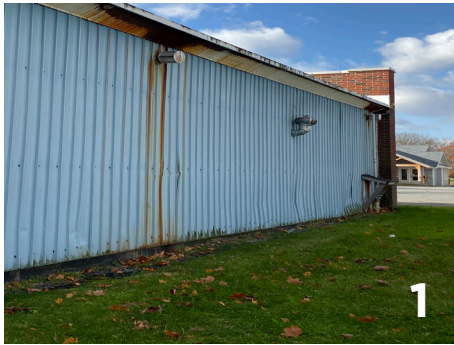
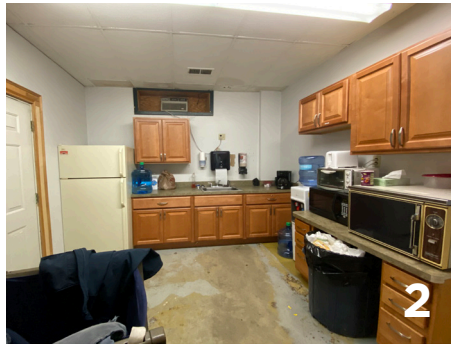
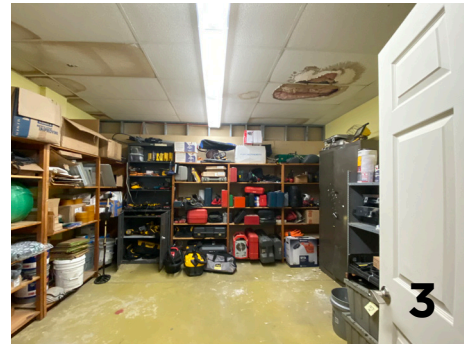
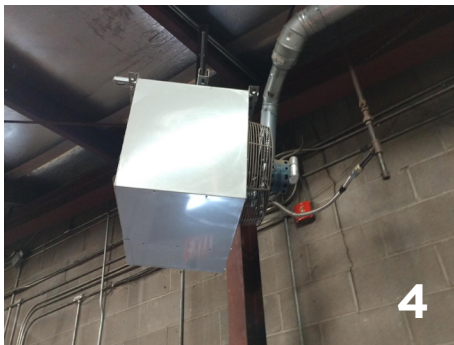
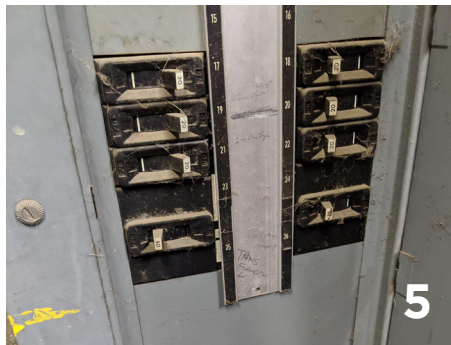
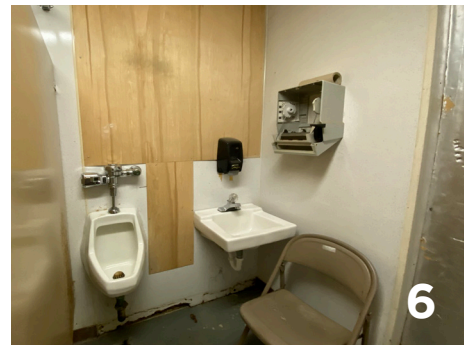
Exterior conditions of both Maintenance Buildings are fair to poor. Deterioration of the building envelope could expose the structural systems to moisture, prompting decay (1).

- Concrete floors throughout the building are in poor condition (2).
- Most of the acoustic ceiling tiles show signs of water damage, are sagging, cracked, or missing (3).
- Storage rooms are in poor condition, although shelving is sturdy and organized (3).
- There is a door that is blocked by the laundry machines.

The gas-fired and electrical unit heaters were not reported to require repairs at this time (4). There is no mechanical system for ventilation in these buildings. The only form of ventilation is natural, through the use of open windows or doors.

One of the buildings is served by a 175A Square D distribution panelboard in fair condition. The other building is served by a 175A Federal Pacific Electric distribution panelboard in fair to poor condition (5). Fluorescent lighting without automatic controls was generally observed to be in use throughout the buildings and is in fair condition. Local fire alarm devices were observed and are in good condition.

The toilet room is in poor condition and is not compliant with current ADA standards (6). Some corridors and passages are too narrow to provide adequate clear floor space at door push or pull sides.

The College's maintenance facility should be relocated to a site that is more suitable for loud, unsightly activities. The two structures are at the end of their useful lives and should be considered for demolition.
